Natural England Commissioned Report NECR140

New Forest SSSI Geomorphological Survey Overview

Annex G: Roe Inclosure South Restoration Plan - SSSI Unit 117

1 Roe Inclosure South Restoration Plan - SSSI Unit 117

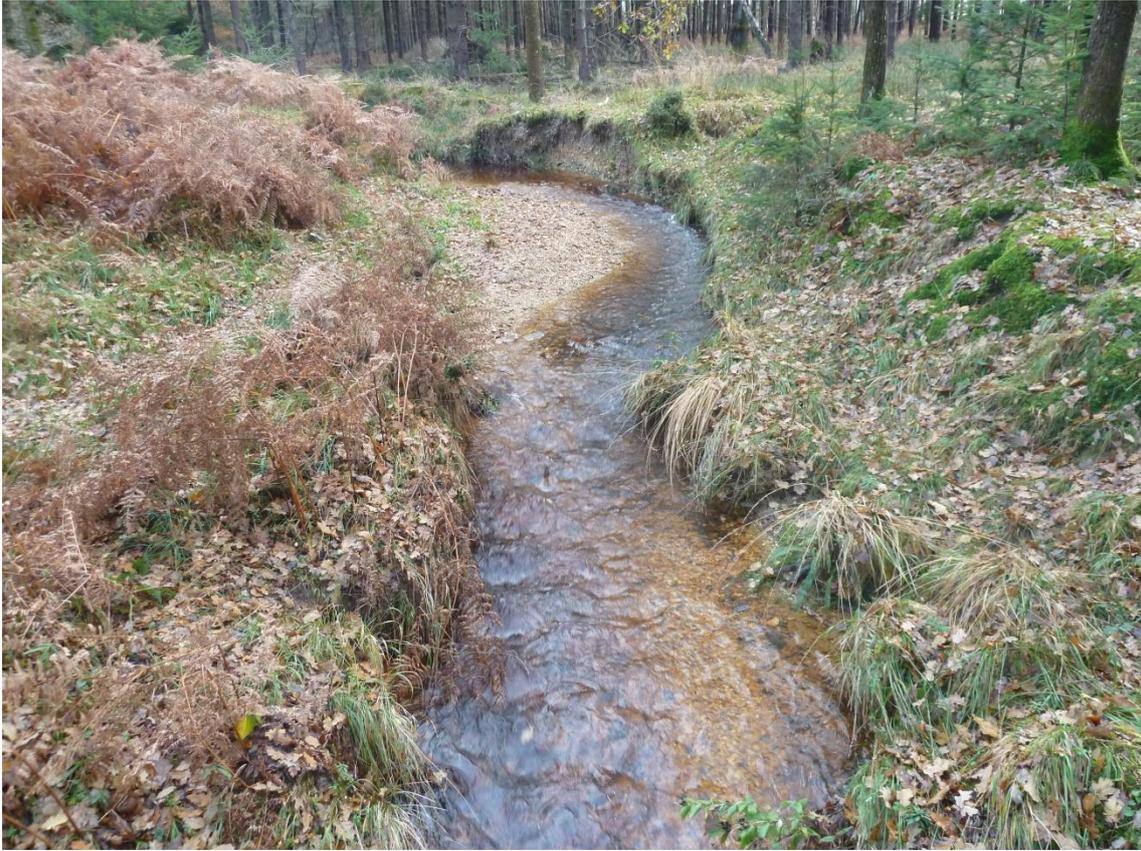
The stream within SSSI Unit 117 is an active single thread channel with strong gravel inputs (Figure 1-2). Some reaches are accumulating significant gravels shoals (Figure 1-3).

Figure 1-2: Active single thread channel characteristics

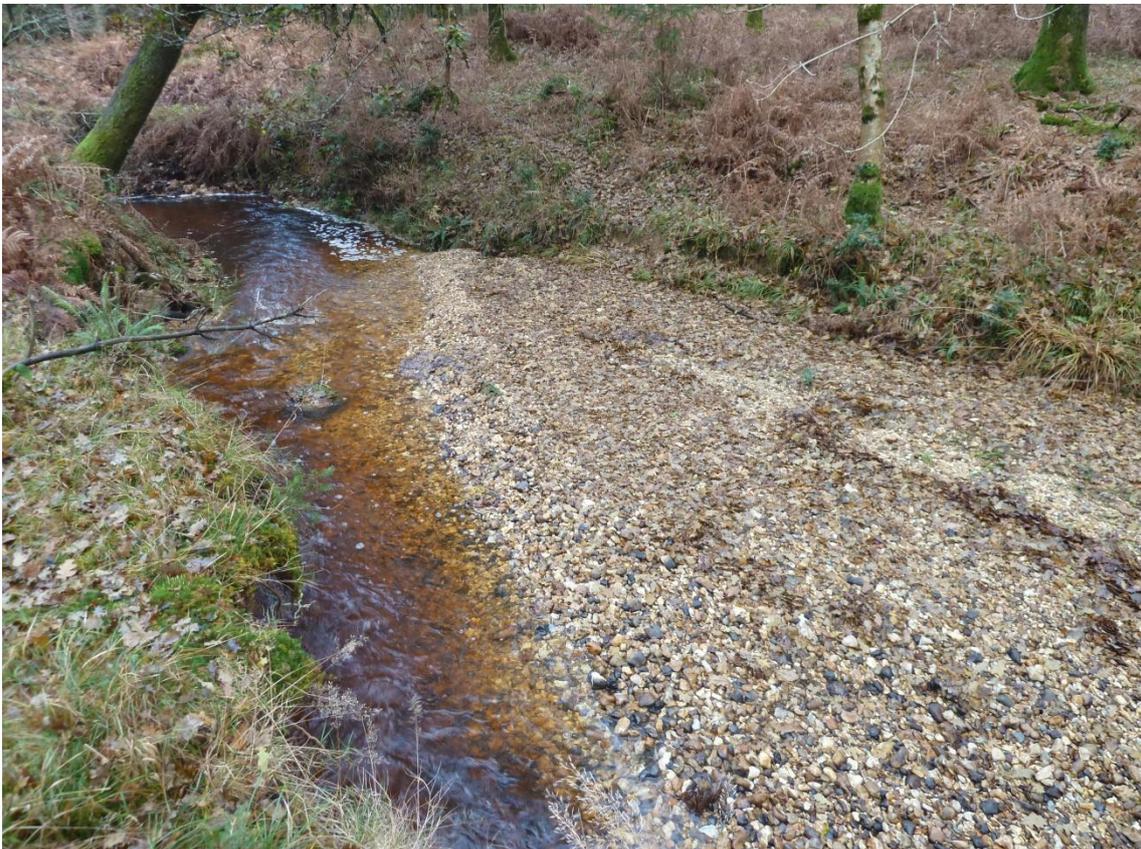
Figure 1-3: Gravel shoal development in some locations

The strong supply of gravels has resulted in significant gravel feature growth within the channel in the form of mid channel bars, lateral bars, transverse bars and point bars (Figure 1-3 and Figure 1-6). Some of the bar features have stabilised and vegetated in places (Figure 1-9). Poor connectivity with the floodplain means that the pattern of erosion and deposition is exaggerated (as a result of incision and embankments) meaning gravel feature growth has been enhanced locally in areas where widening can readily occur.

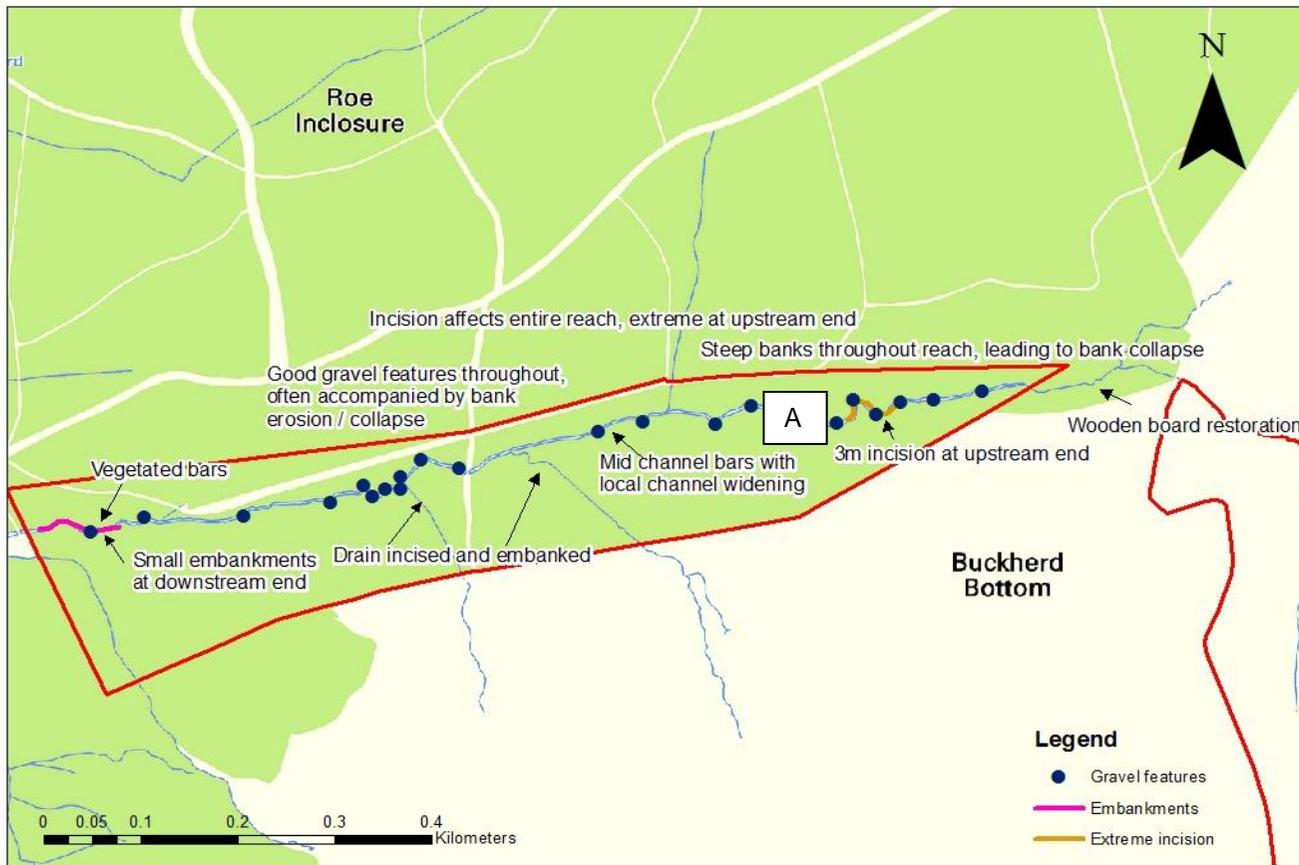
Figure 1-4: Current hydromorphic conditions and pressures

The result of poor floodplain connectivity and the modified flow regime, in a responsive river type, has been vertical incision. Ditching of the upper catchment (Figure 1-4 - A) will have impacted on the flood flow regime of the watercourse creating a more responsive system where flood peaks are concentrated and increased and water enters the main channel more efficiently. The degree of artificial drain creation is shown in Appendix A and is impacting significantly on the flow regime. This effectively creates a higher energy system more capable of erosion and sediment transport.

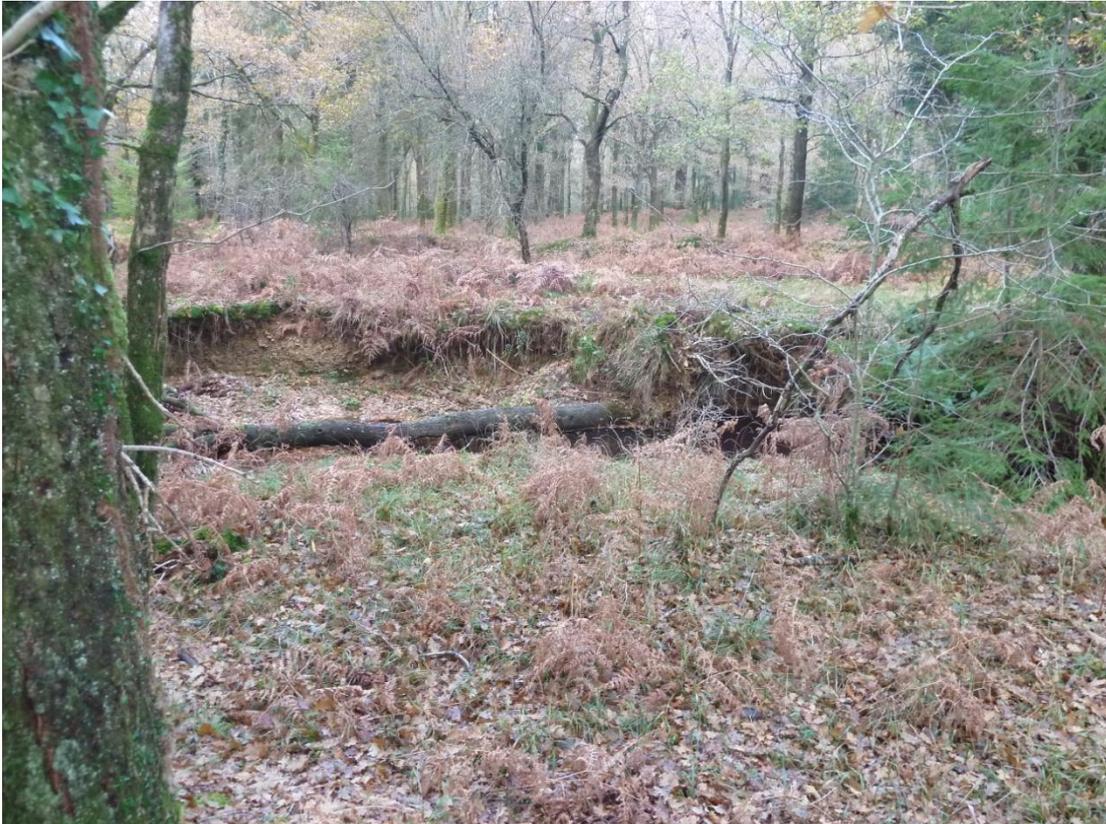
The stream has a moderate gradient and has been subject to channel straightening in the past. Straightening of the watercourse has occurred and this has had a profound effect on the nature and functioning of the river. The length of watercourse will have been shortened leading to a steepening of the system and the associated dredging will have over-deepened the channel. This in combination will have increased flood shear stress levels promoting erosion (Figure 1-5).

Figure 1-5: Bank erosion common along reach

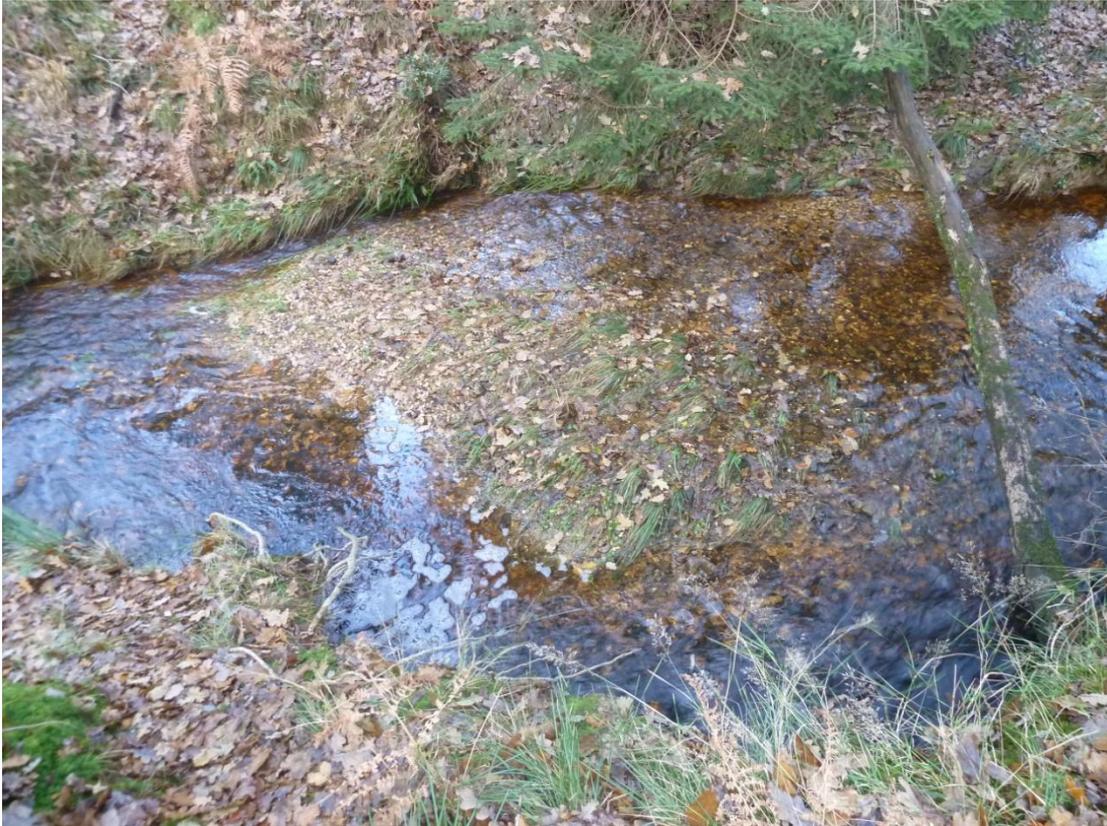
Where the channel banks are stronger (due to the presence of more resistant boulder clays rather than fluvio-glacial gravels or where riparian woody vegetation is dense enough to provide a coherent resistant root mat) erosive energy will have been concentrated into vertical incision into the bed leading to an over-deep channel. Where the banks are less resistant (due to tree clearance, presence of gravels etc.) lateral erosion will also have occurred. This is evident in the more wandering sections. Often in rivers with moderate to high energy, lateral erosion and widening is also associated with bar deposition concentrating flows around gravel shoals and promoting further lateral activity (Figure 1-6).

Figure 1-6: Bar growth with associated channel widening and some evidence of colonisation by vegetation

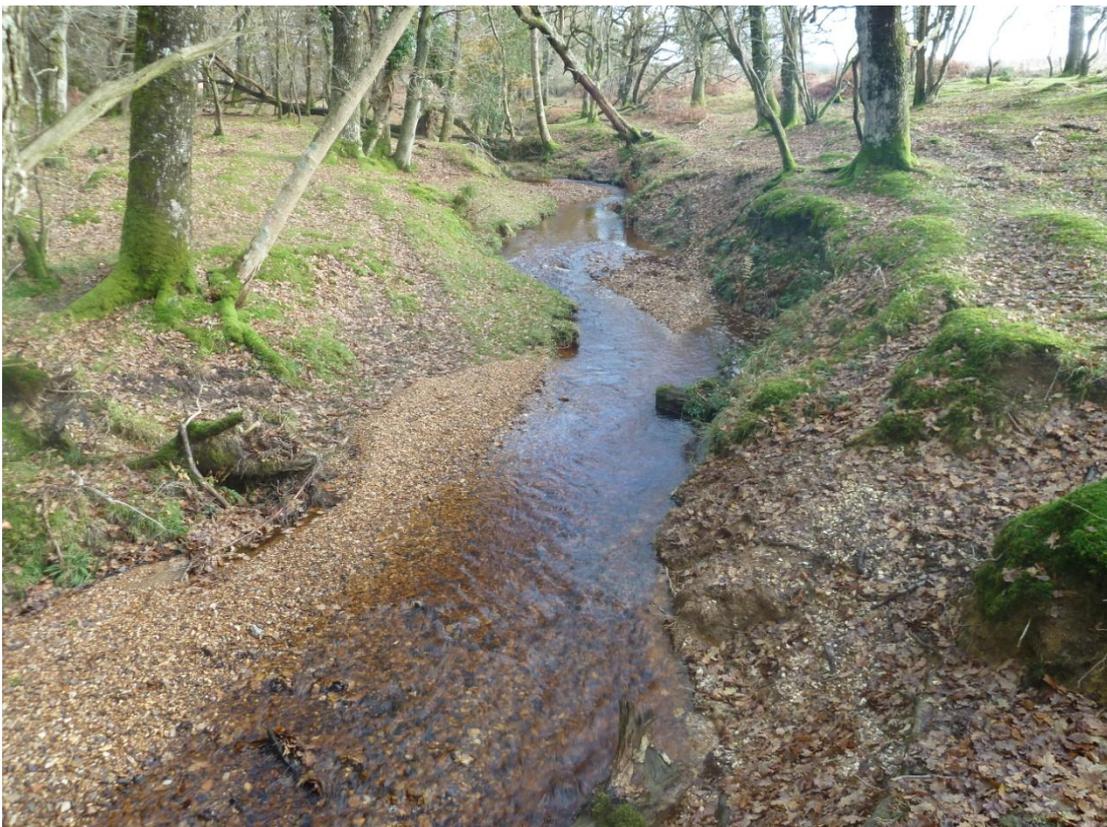
The initial impact of straightening would have been incision along significant lengths of the wooded watercourse (Figure 1-7) and channel widening across areas with erodible banks. This initial incision episode is likely to have caused the knick point development moving through the tributary / drain systems (Figure 1-8).

Figure 1-7: Upstream incision levels

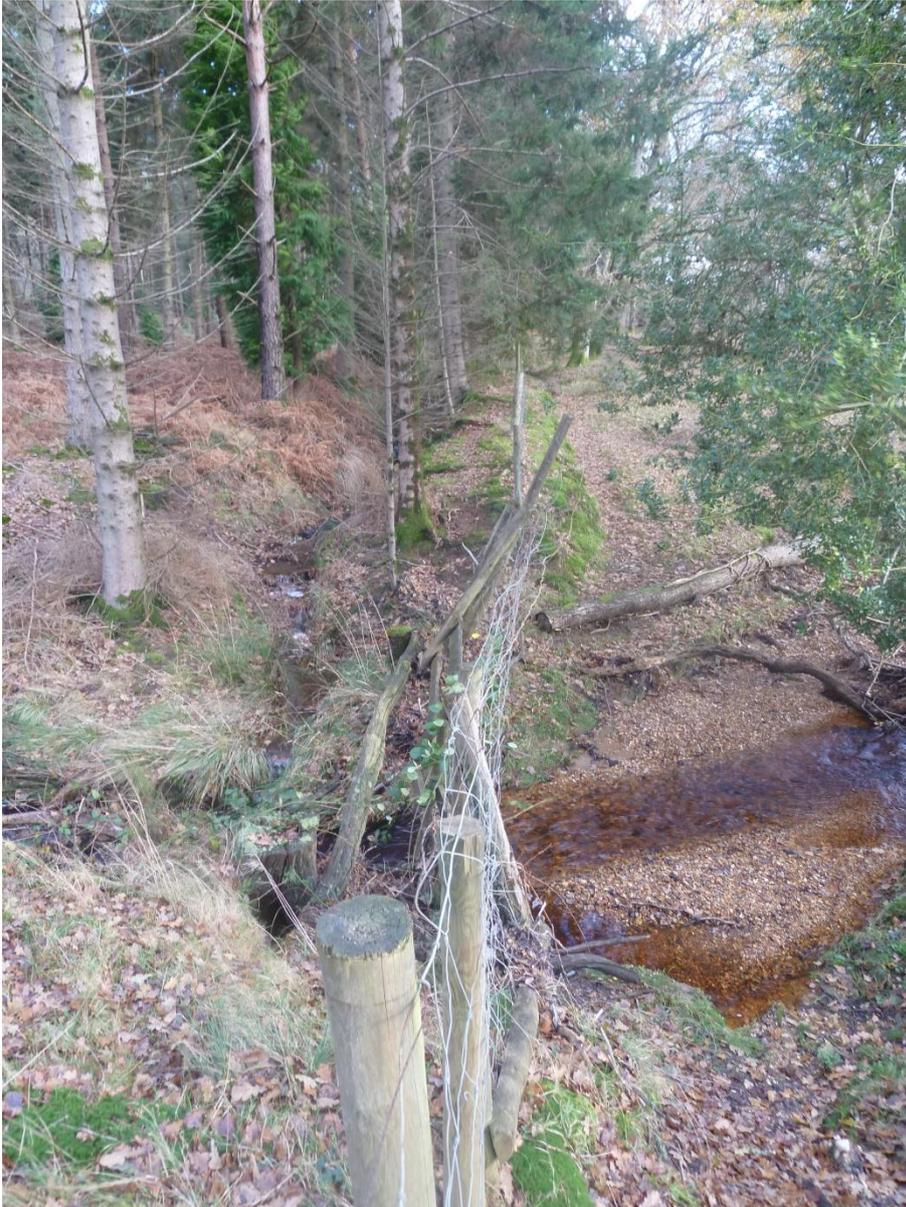
There has been incision up to 3m (from bank top to stream bed level) in the upper reaches of this unit. Erosive energy is contained within the banks rather than spread across the floodplain at higher flows resulting in bed erosion. This creates oversteep banks that are prone to collapse through undercutting, as well as further reducing floodplain connectivity. This is exaggerated in some locations by the presence of embankments on the bank tops. As a result of incision in the stream, connecting drains are also incised in some locations, and in many cases incision within the drains is also impacted by embankments on the bank edge of the drains (Figure 1-8).

Figure 1-8: Some incision in left bank drain, with embankments

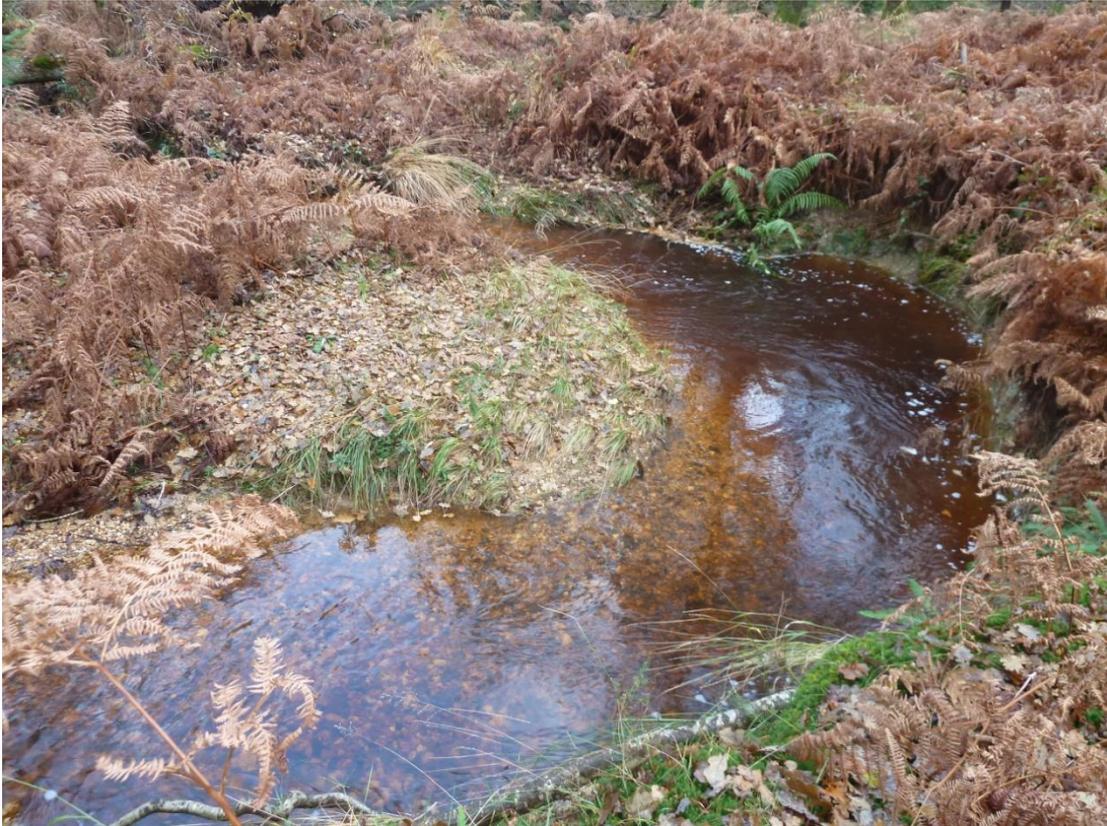
Figure 1-9: Bar vegetative colonisation

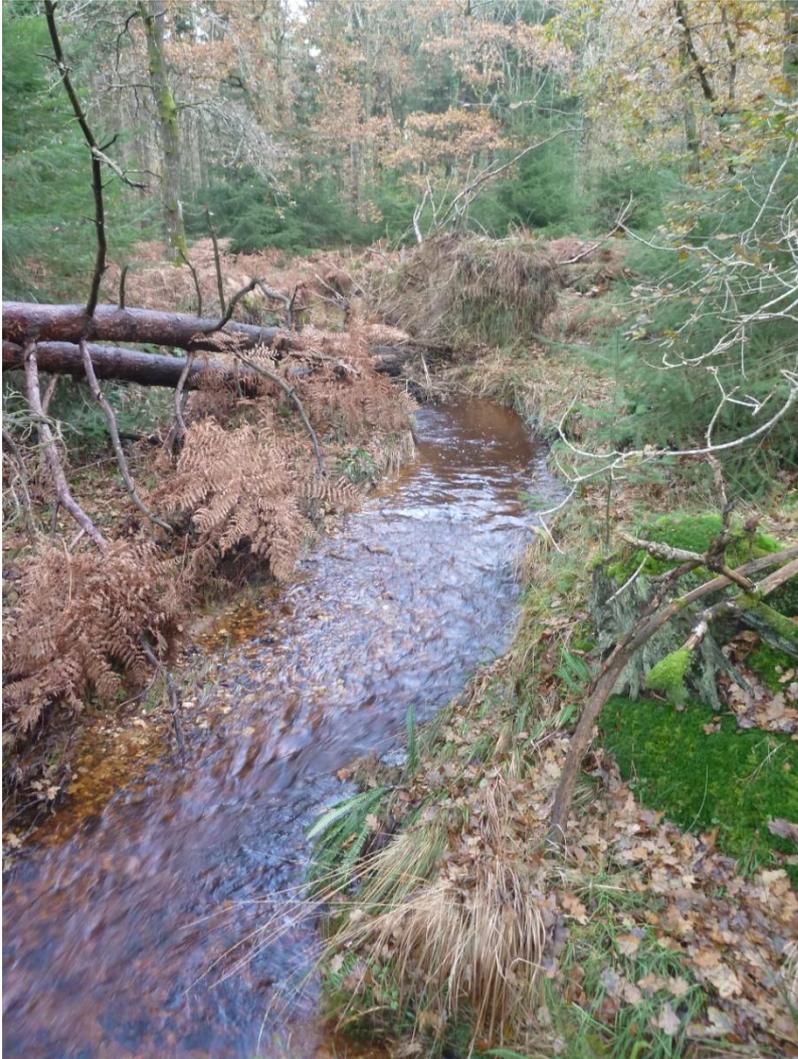
Natural woody debris features are also evident along the channel, which have often been created as a result of local bank erosion / collapse (Figure 1-10). These create short lengths of impounded watercourse that does improve floodplain connectivity significantly. These provide useful analogue features for the restoration plan.

Figure 1-10: Natural woody debris jams

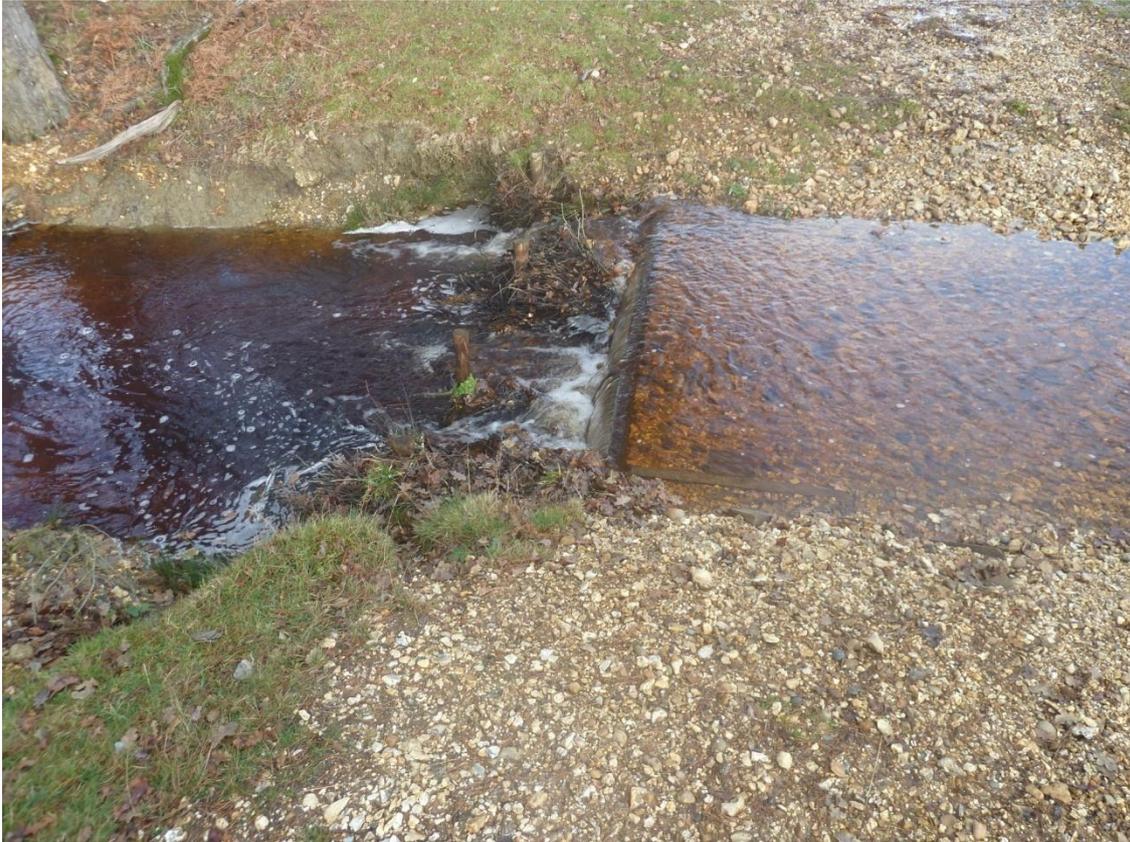
In the upper reach of this unit, wooden boards have been installed in the channel (Figure 1-11), presumably to try and manage the incision to prevent it migrating upstream and impacting Unit 95 which is a mire. Some of these have failed (Figure 1-12) and others remain intact (Figure 1-13).

Figure 1-11: Wooden board incision management

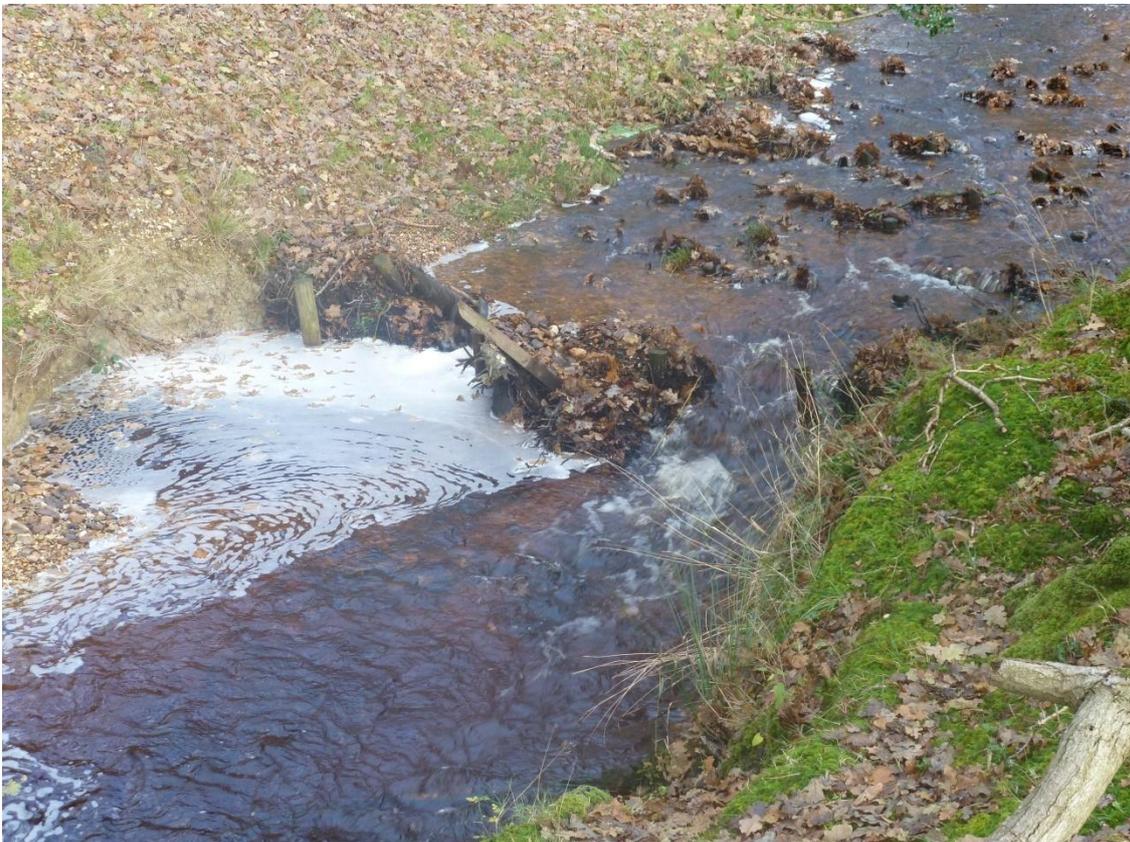
Figure 1-12: Failed wooden boards

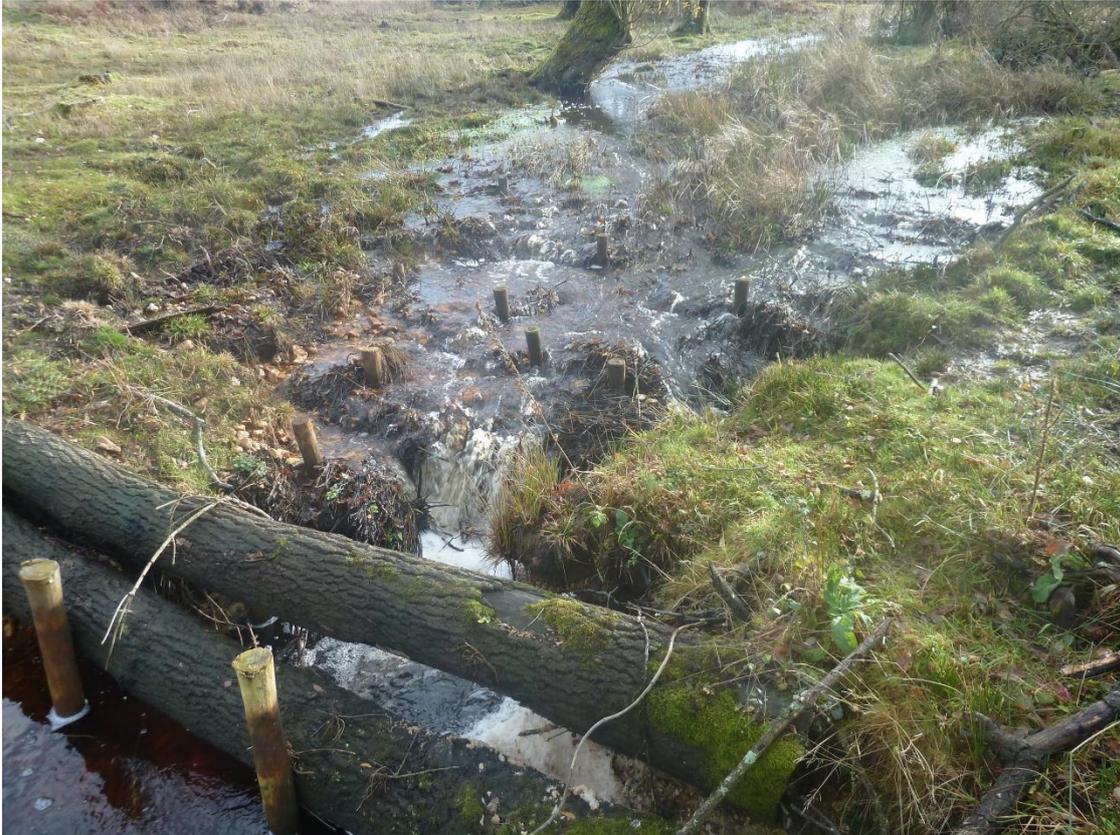
Figure 1-13: Pinned log and staked bail restoration

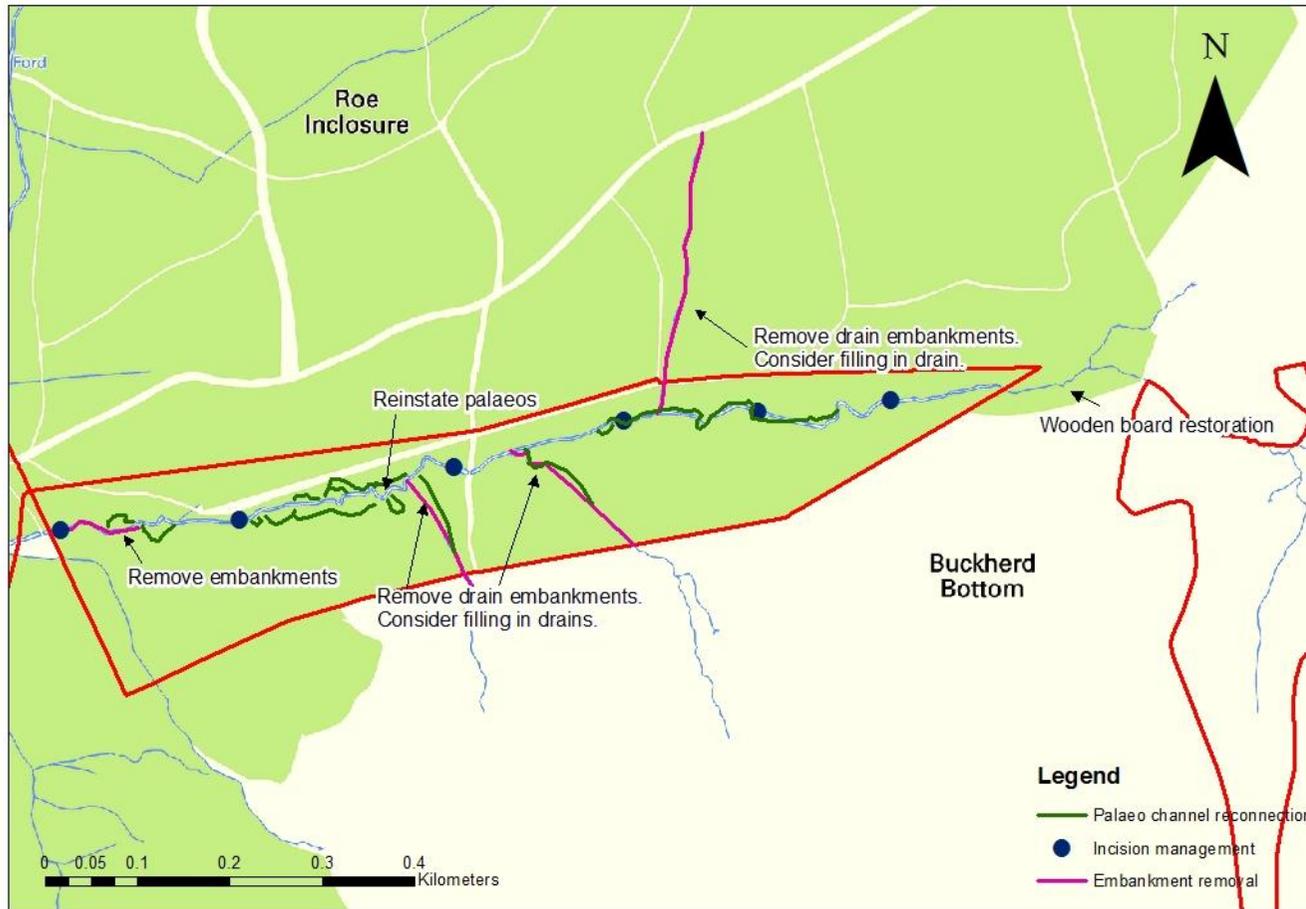
Figure 1-15: Proposed restoration measures for SSSI Unit 117

Significant palaeo channels have been identified in Figure 1-15 and show where reconnection could be possible through some of the proposed restoration measures in Table 1-2. These have been identified from the audit and supplied LIDAR. Reconnecting these whilst maintaining the existing channel will encourage anastomosed network development.

A summary of the current pressures, unmitigated impacts and restoration proposals is given in Table 1-2 and shown in Figure 1-15.

The major straightened / modified drainage channels are identified in Figure 1-15. Other minor modifications could be considered for infilling and Appendix A should be used for reference.
