Natural England Commissioned Report NECR143

Latchmore Brook Restoration Options Appraisal

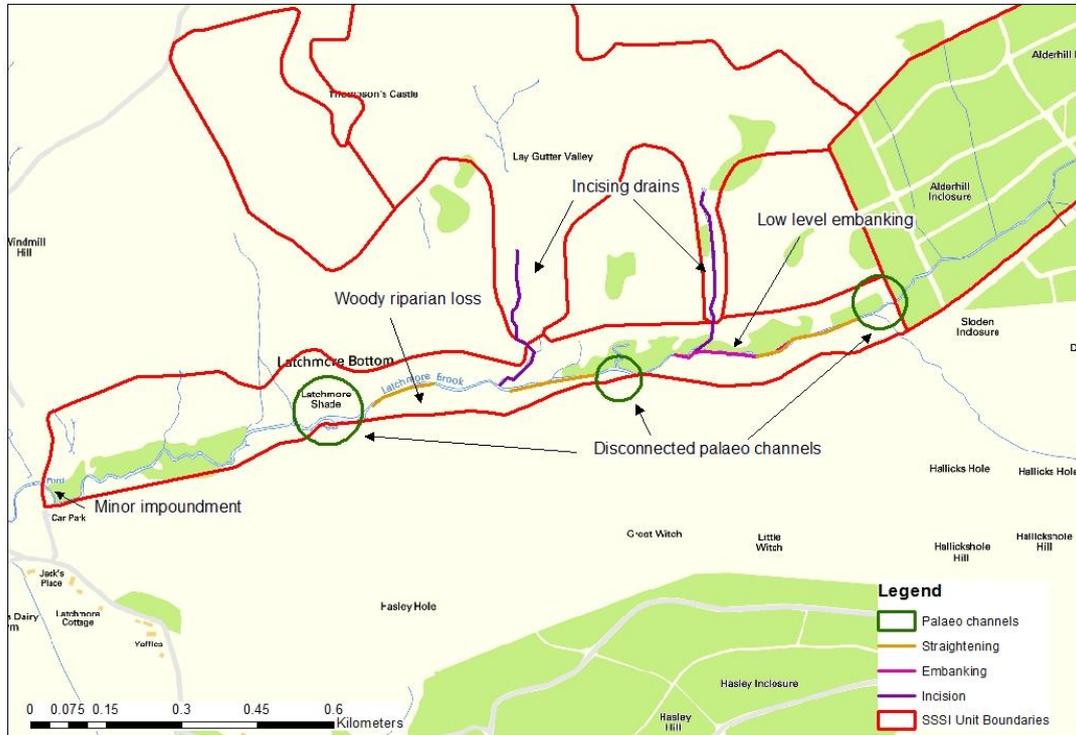
Figure 2-8: Current hydromorphic conditions and pressures

The natural anastomosed channel network has been extensively modified through the SSSI unit with historic channel straightening along considerable lengths of the watercourse. The channel has reacted to this straightening by initially cutting down into the bed, creating an incised single channel. This will have increased flood shear stress levels promoting local erosion, particularly where flows are concentrated around in-channel bars (Figure 2-9). Subsequent resupply of gravels from upstream has resulted in a general over-filling of the channel in the middle reaches to create a shallow plane bed system, leading to frequent floodplain inundation. This channel state is not stable and will be subject to a renewed period of scour and disconnection as part of the general damped erosion/deposition cyclic response to the straightening.

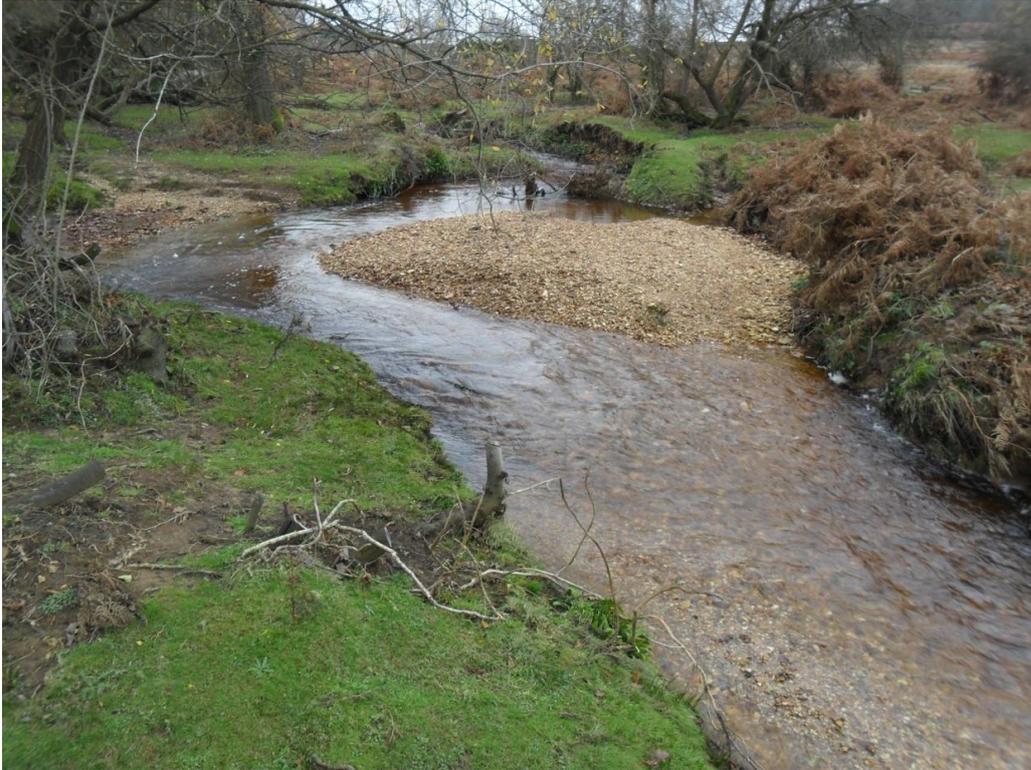
Figure 2-9: Local flow concentration and bank erosion linked to gravel bars on Latchmore Brook

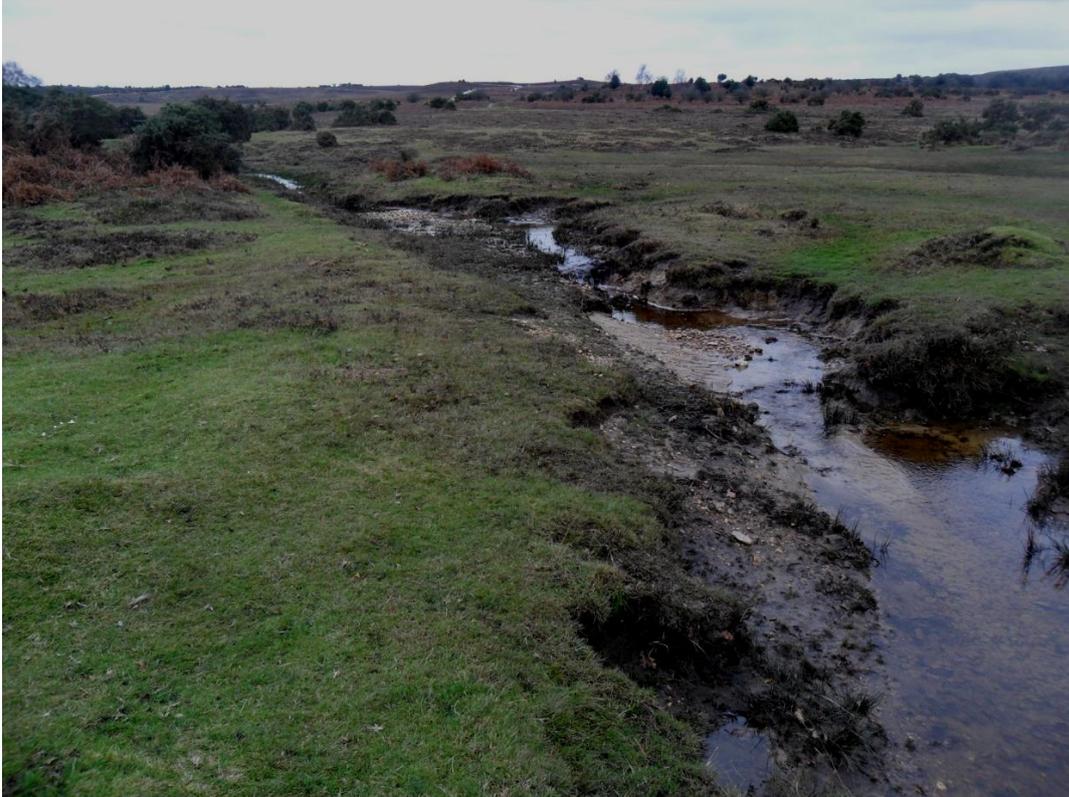
Figure 2-14: Knick point erosion on the tributary channels of Latchmore Brook

The initial impact of straightening would have been incision along significant lengths of the wooded watercourse and wandering behaviour across the cleared zone. This initial incision episode is likely to have caused the knick point development moving through the tributary / drain systems.

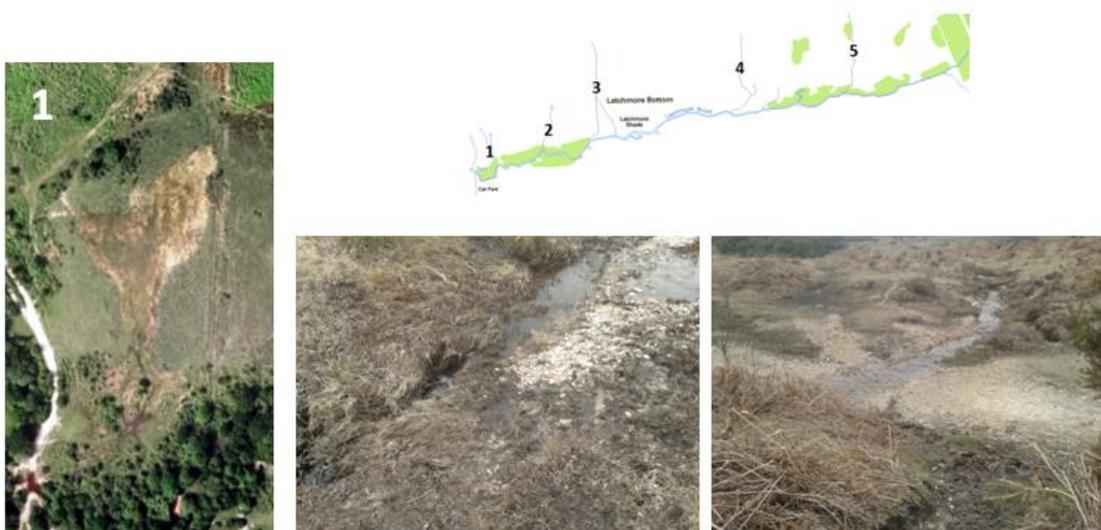
Figure 2-15: Condition of drainage line 1, Latchmore Brook

This area is unstable and is currently delivering large volumes of mixed sediment to Latchmore Brook (Figure 2-15).

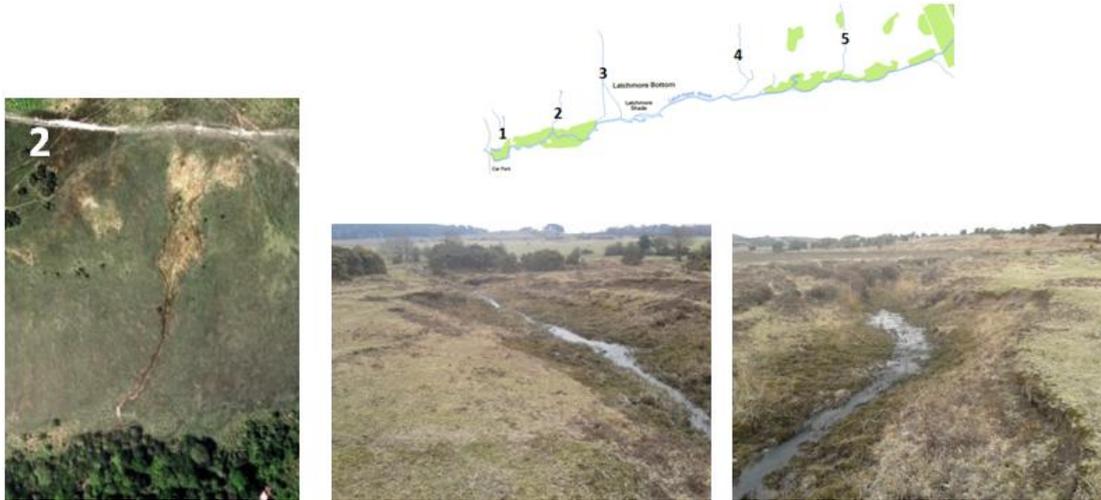
Figure 2-16: Condition of drainage line 2, Latchmore Brook

This area is unstable and is currently delivering large volumes of mixed sediment to Latchmore Brook (Figure 2-16). It would appear that the instability has spread through multiple headward erosion upstream of an artificial straight drain that is now a distinct incised, single thread channel. Low elevation knick points are present along the incised reach although there appears to have been infilling and reduced activity recently.

Restoration should be concentrated in the upper reaches.

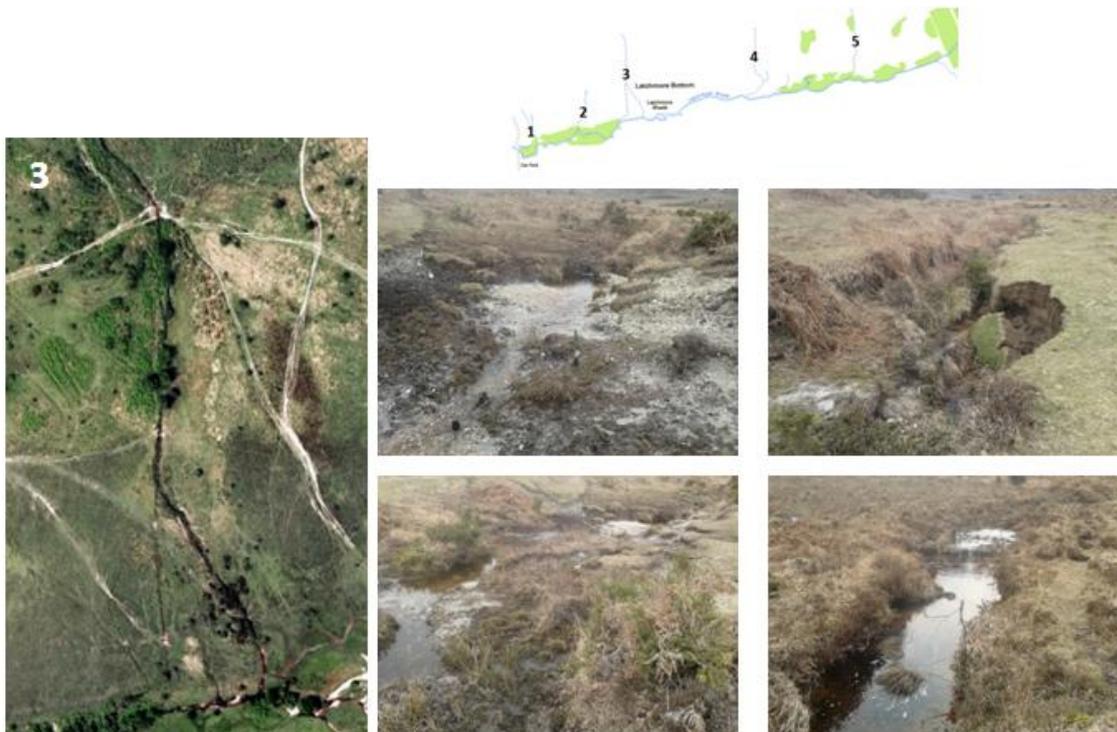
Figure 2-17: Condition of drainage line 3, Latchmore Brook

This channel is unstable along much of its length extending into the mire systems (Figure 2-17). It was probably a cut channel and breached the fluvio-glacial sediments forming a natural dam to the upper valley and seepage mires. Local restoration attempts aimed at controlling knick point erosion using staked heather bales have failed due principally to outflanking. Excess drainage of the seepage mires is occurring and will continue if not controlled.

Several major knick points are present along the incised reach with significant active vertical incision and more minor lateral erosion observed on site.

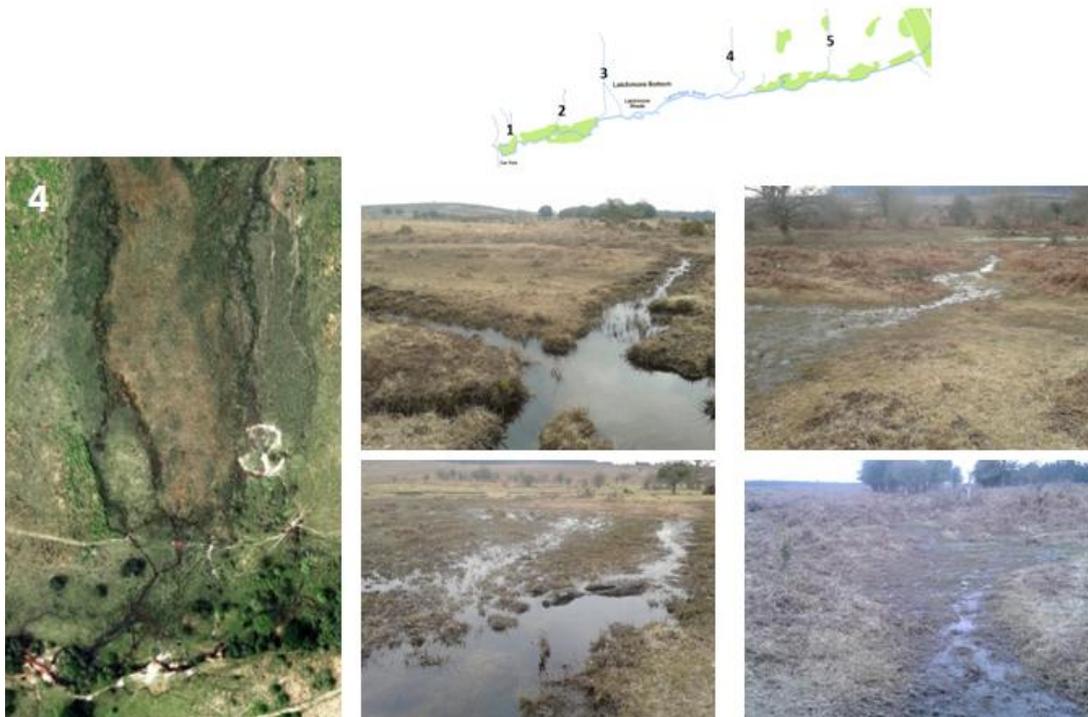
Figure 2-18: Condition of drainage line 4, Latchmore Brook

This and several smaller local drainage lines are presently stable and are characterised by poorly defined channels, diffuse surface flow and an aggrading fan distributary network entering the Latchmore Brook.

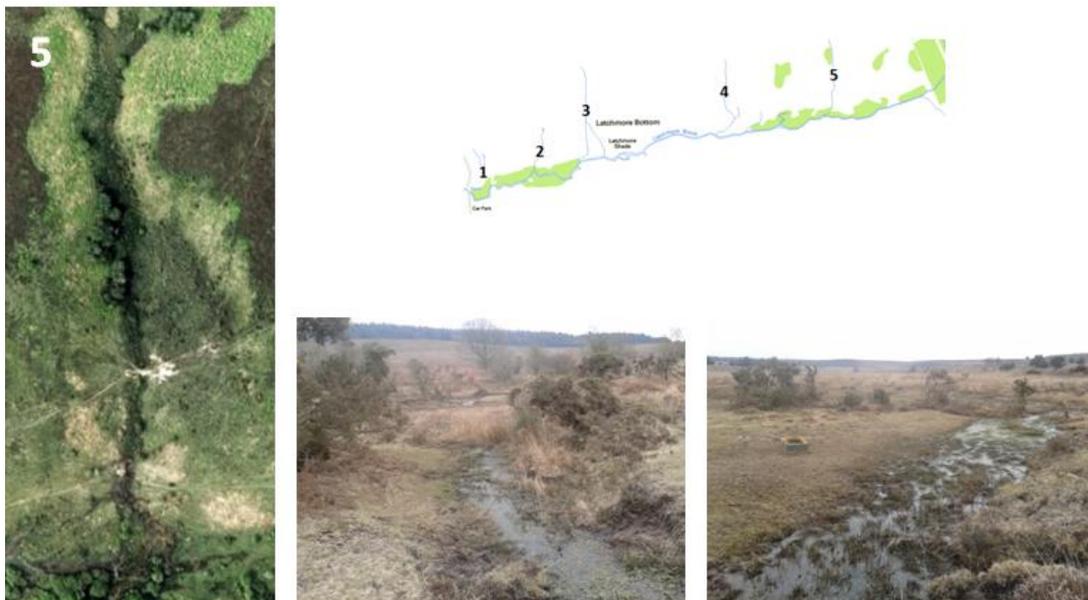
Figure 2-19: Condition of drainage line 5, Latchmore Brook

This and several smaller local drainage lines are presently stable and are characterised by poorly defined channels, diffuse surface flow and an aggrading fan distributary network entering the Latchmore Brook.

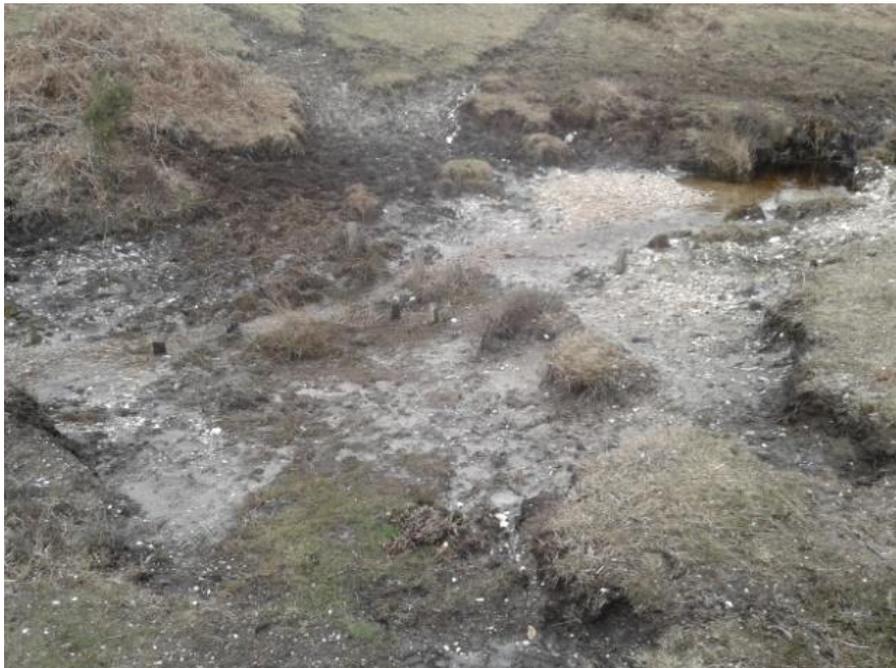
Heather bale dams have been tried previously (Figure 5-1) but have failed progressively due to undercutting and outflanking in these steep high energy systems. As such similar approaches should be avoided as they are unsustainable here. Successful sensitive restoration on such high energy systems has not been reported.

Figure 5-1: Failed heather bale dam on steep tributary of Latchmore Brook

It is suggested that an alternative design be considered that mimics the naturally stable seepage mire transitions zones present elsewhere. Breaches in glacially derived mineral barriers extending across the area to the north of the river should be repaired to recreate the lower energy peat forming conditions behind the obstruction. Flows exiting past the barrier are naturally diffuse with the majority of the discharge occurring as throughflow. This should be mimicked with the upstream section and upper layer of the breach repair unfilled with heather bales to encourage internal flow and occasional diffuse surface flow. This is summarised in Figure 4-17.
