# **Natural England Commissioned Report NECR141**

# New Forest SSSI Ecohydrological Survey Overview

Annex A: Holmhill Bog, Silver Stream, Redhill Bog, White Moor, North Weir, Trenley Lawn and Hincheslea Bog

First published 06 March 2014

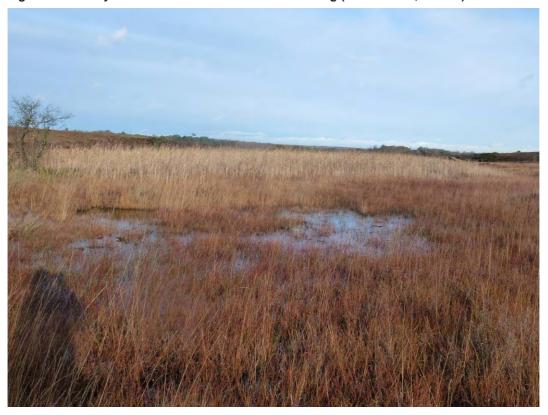
Figure 1-3: Trough in valley side supporting a wetland in Holmhill Bog (NGR 426435, 102010)

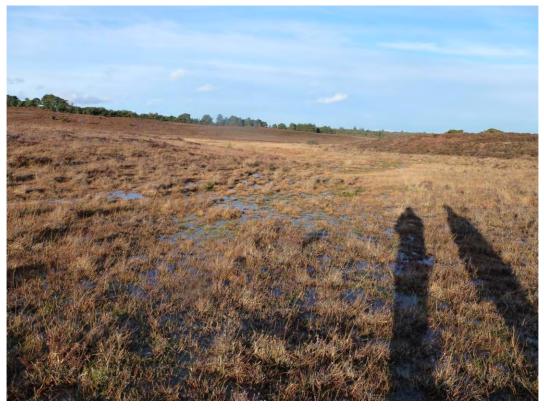
Figure 1-4: Redhill bog looking down the valley (note: the mire does not cover the upper reaches of the valley bottom) (NGR 426850, 101850)

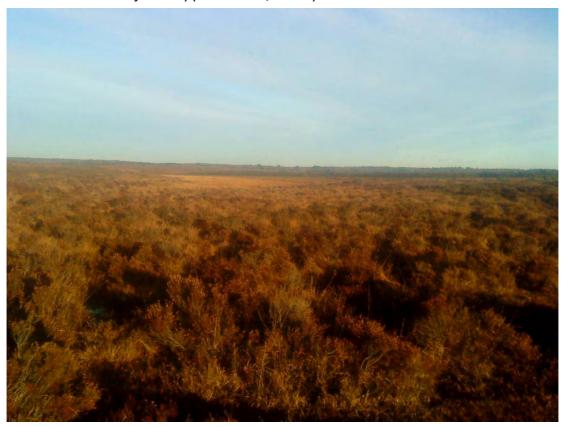
Silver Stream forms the lower limb of the Y shaped valley, like Holmhill, it contains significant peat deposits in the base of the valley, however, a large drain has been cut along the eastern base of the valley edge. This has severely degraded the bog and led to the loss of the domed surface. This drainage continues into the lower parts of Holmhill and Redhill Bog, although the drain appears to have been blocked in these reaches. At the junction of these limbs is a causeway (with bridged sections) this has caused the removal of the bog in these areas through erosion.

Figure 1-5: Drainage ditch down the side of Silver Stream (NGR 426885, 102390)

- Silver Stream
  - A large drain has been cut down the side of a valley bottom wetland with significant peat deposits. The drain appears to be eroding its bed into the underlying bedrock. Naturally, the valley bottom would have contained a slight dome of peat with water slowly draining around the outside edges of the dome (as it does currently on Holmhill Bog) but now contains a dry, very degraded bog. At the top of the area is a causeway which is damaging the mire:

- Silver Stream,
  - Given the size and power of the drain that has been cut through Silver Stream
    a full restoration plan should be developed. The difficulty is that blocking the
    drain and diverting flow back onto the remaining valley mire might lead to
    significant erosional problems, especially for the remaining valley mire peat;

- Options for restoration could include:
    - Infilling of the ditch along its whole length,
      - It is unlikely that there was a watercourse along the base of this valley so infilling the drain might restore the site to something close to the original system;

- Regular blocking of the ditch with steel pile dams,
      - There is a 5m fall (banktop level from LIDAR from the drain and the top to the bottom. If a dam was to be installed every 0.5m, 10 weirs would be required along the length of the drain;

- Full restoration designs for the site would require a geomorphological assessment due to the erosional power of the existing drain.
- Upper White Moor,

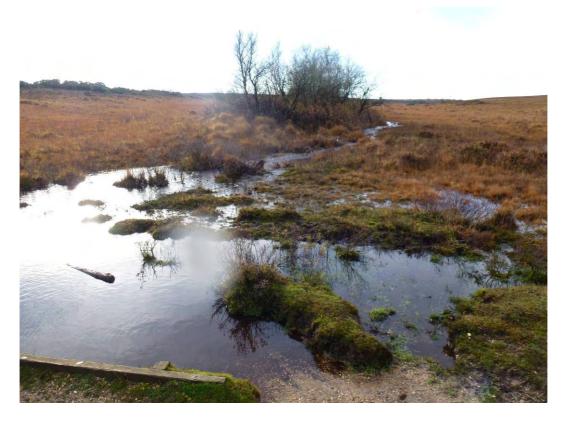
Figure 1-6: Photo from bridge at junction of the valleys- scrub shows evidence of drainage in lower part of Holmhill Bog - the foreground shows that erosion has removed the peat deposits around the causeway (NGR 426770, 102240)

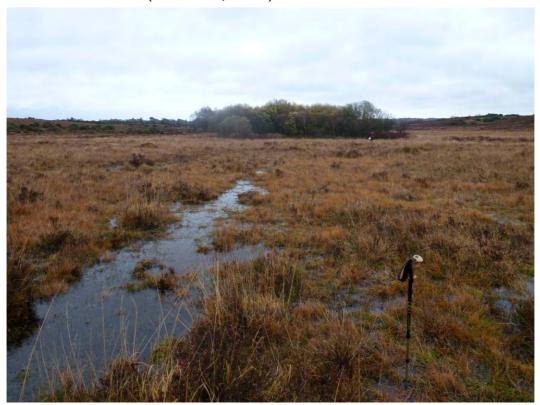
Figure 1-7: Valley head wetland at White Moor - woodland in distance surrounds the valley bottom drain (NGR 427390, 101870)

- Upper White Moor
  - Drainage has occurred over the majority of White Moor, however in the upper valley this has only produced degraded heath rather than lawn habitat. There is a large central drain and valley side lawn drains that are draining the wetlands;

- Restoration objectives should be developed for the whole of Upper White Moor to identify areas for specific target habitats. In areas of degraded mire it is recommended that:

- The valley side grips be regularly blocked with earth plugs;
  - The centre drain should be blocked with steel weirs. The number will be dependent on the length of centre drain that the restoration objectives require to be blocked;

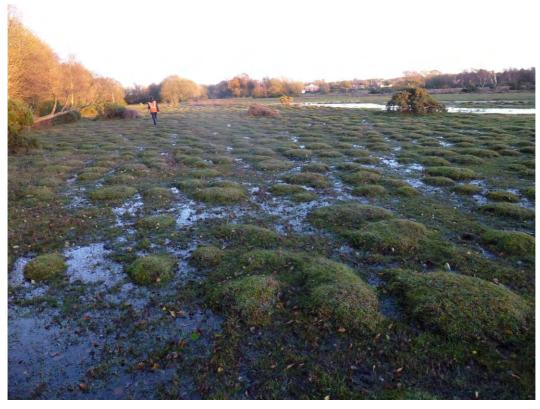
Figure 1-8: Lawn area downstream of White Moor (NGR 428320, 101800)

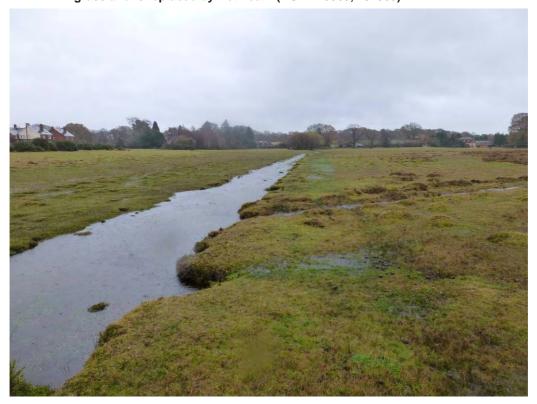
Figure 1-9: Lawn Drainage at South Weirs Road (Unit 511 boundary: note right of picture where grassland is replaced by wet heath (NGR 428565, 101585)

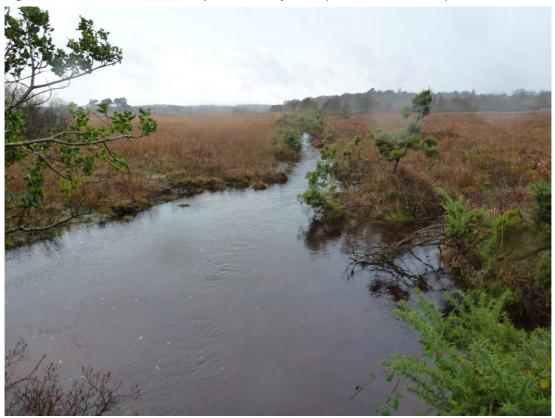
Figure 1-12: Centre Drain in lower part of Trenley Lawn (NGR 428485, 101005)

- Trenley Lawn
  - A large central drain has caused the upper part of Trenley Lawn to convert to wet grassland, the lower part resembles drained mire;
- Hincheslea Causeways

- Trenley Lawn,
  - Restoration objectives should be developed for this area to determine target habitats.
- Hincheslea Causeways,
  - It is likely to be best to keep the causeways as they are. However, the slight gulleying that has occurred where water is channelled from the edge mires through the bridged sections, should be protected with wooden plank dams.

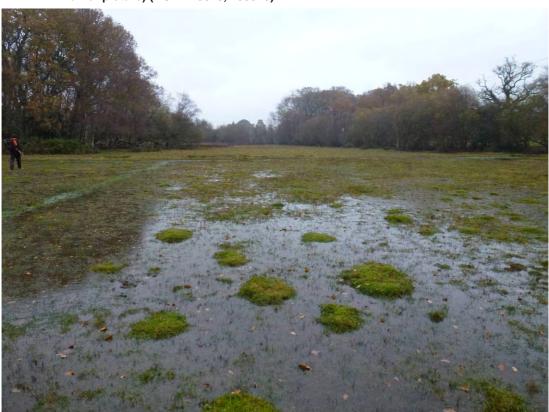
Figure 1-13: Lawn covered valley in South East of Assessment Area (note small surface drain in left of picture) (NGR 428640, 100978)
