# New Forest SSSI Geomorphological Survey Overview

Annex N: Cowleys Heath Central Restoration Plan - SSSI Unit  
423

# 1 Cowleys Heath Central Restoration Plan - SSSI Unit 423

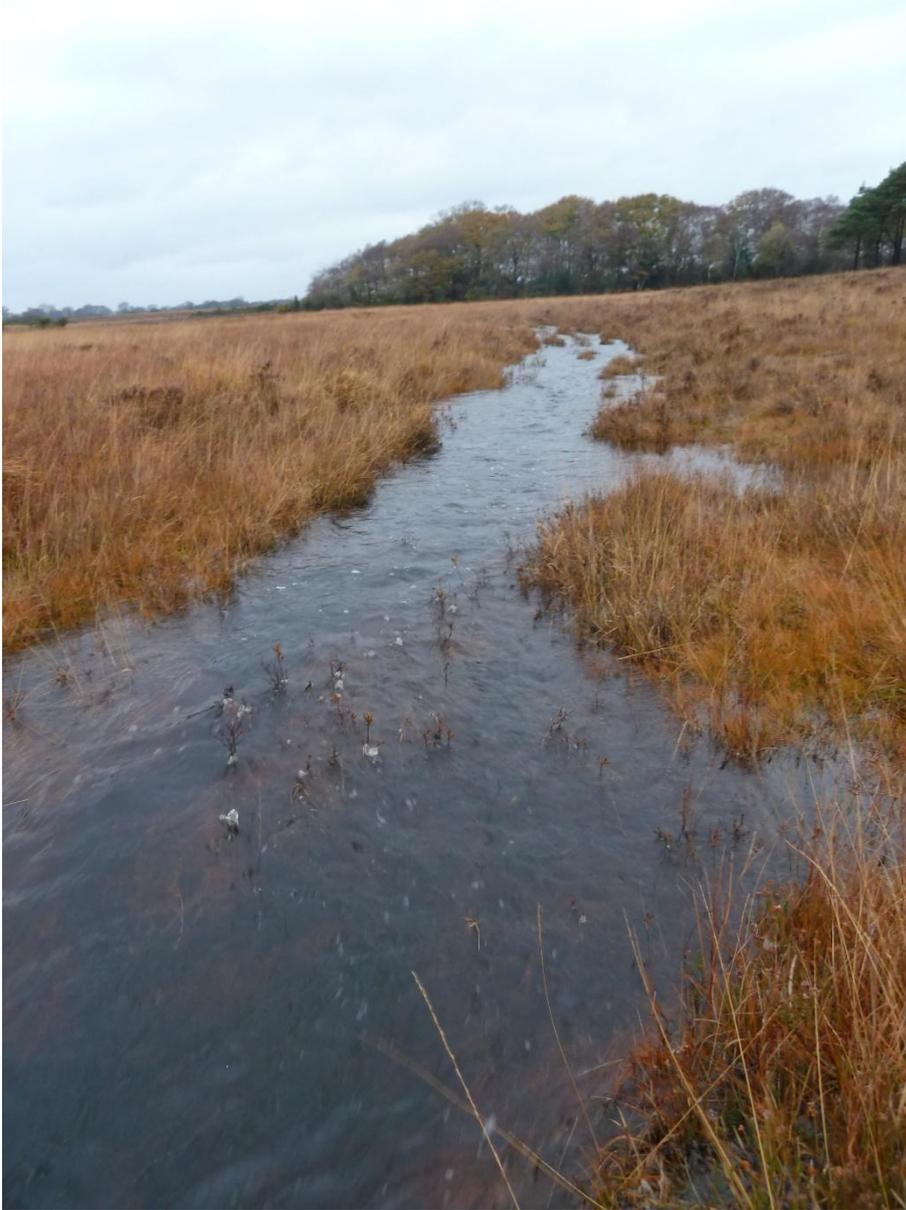
The stream within SSSI Unit 423 is a mainly a passive single thread channel (Figure 1-2), switching to sections of reduced gradient multi branch / spreading networks where floodplain connectivity is improved (Figure 1-3). There are generally low inputs of gravel to the stream locally and from upstream sources, with limited bank erosion. As a result the dominant material on the channel bed is fine sediment / silt (Figure 1-5), with only small sections of exposed gravel (in the single thread sections in upstream mire area). In the downstream section, the stream has a better defined channel and is more active, with evidence of incision (Figure 1-4). The floodplain is also confined in the stream section at the downstream end of the floodplain, limiting floodplain connectivity.

Figure 1-2: Passive single thread channel characteristics in *Molinia* Mire (M25a)

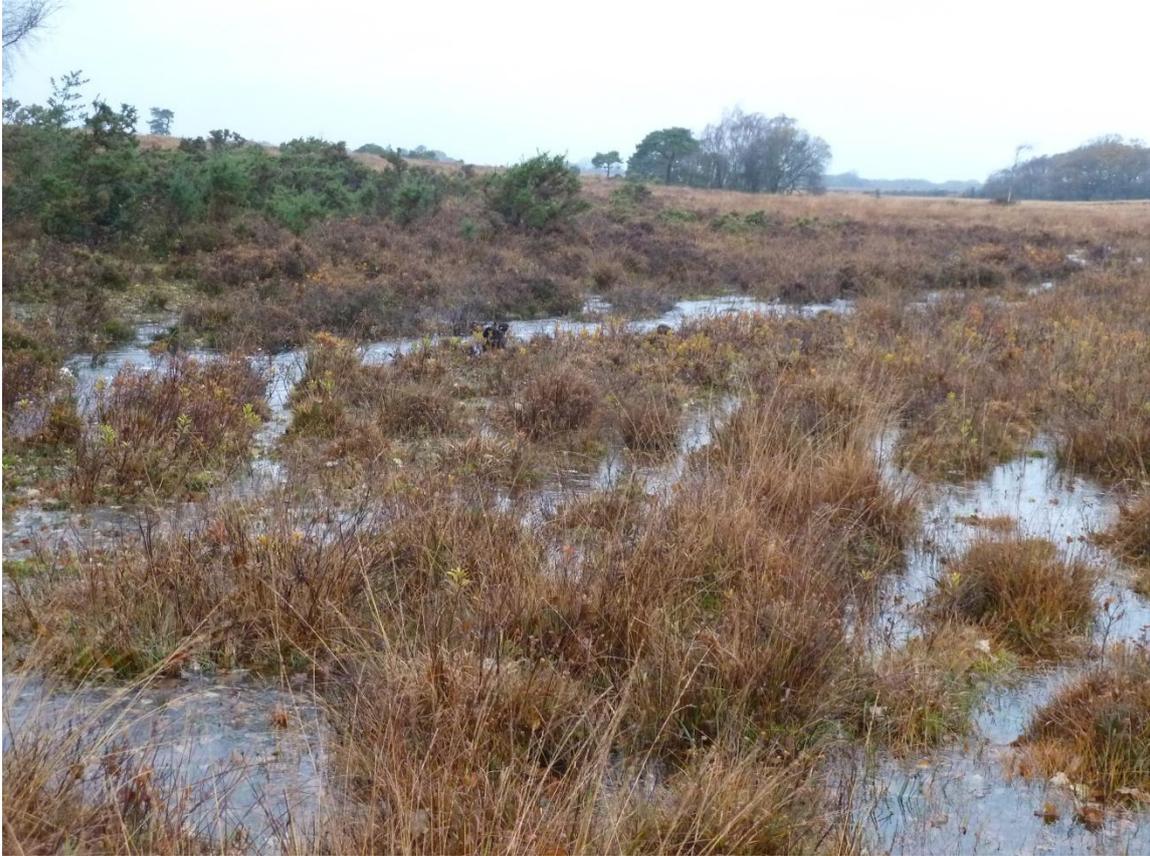
Figure 1-3: Multi branch / spreading sections on wet heath (M16a) and mire (M25a) boundary

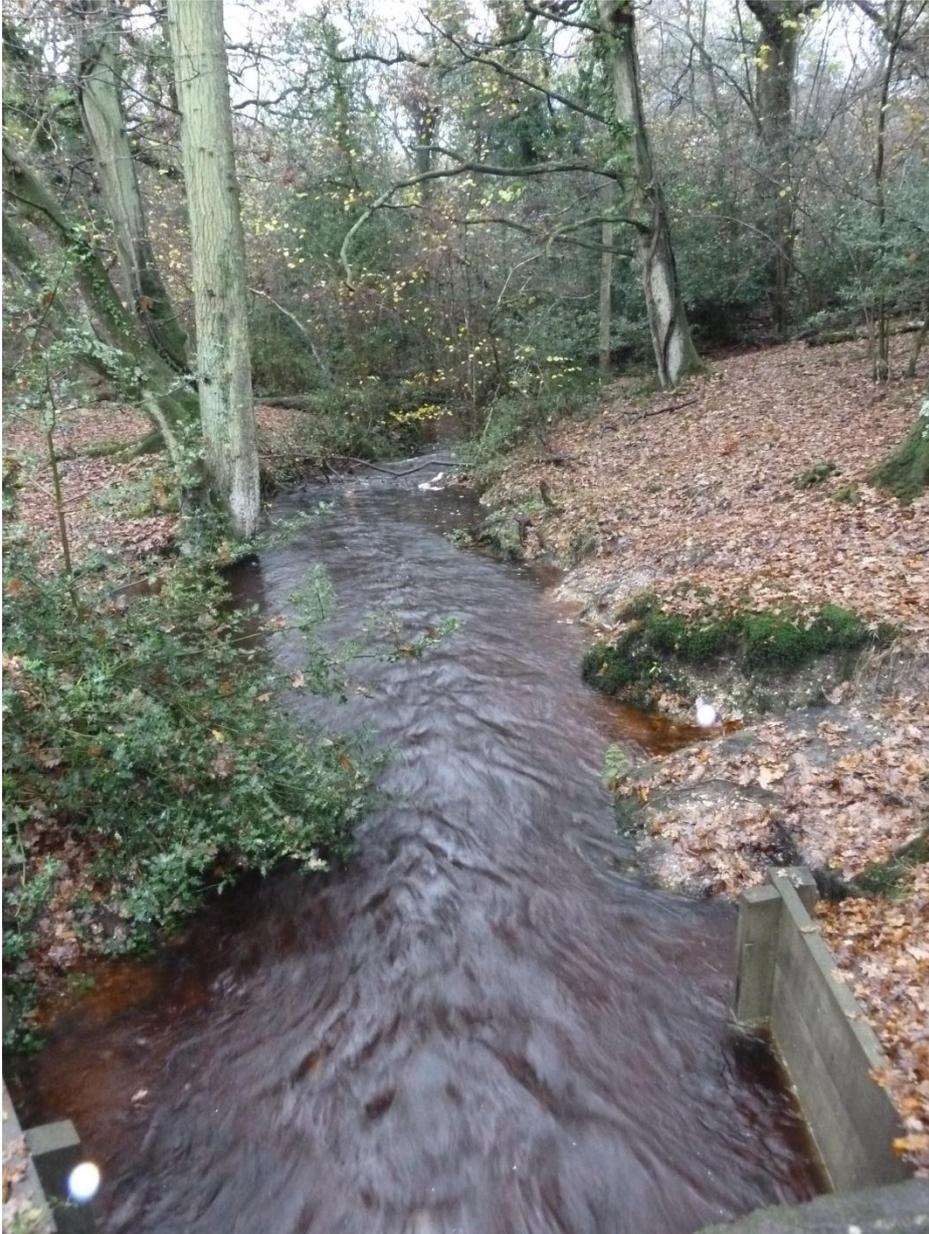
Figure 1-4: Active stream section downstream in W10a woodland

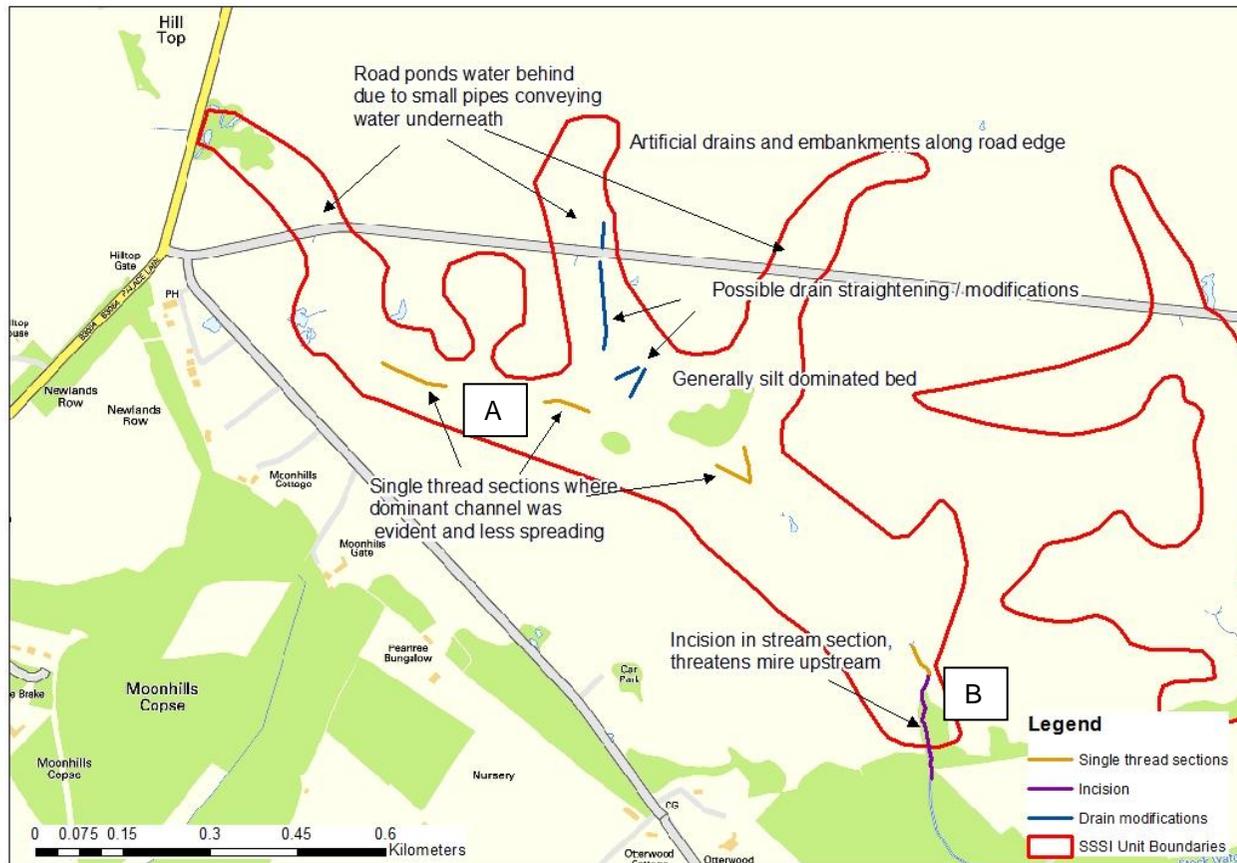
Figure 1-5: Current hydromorphic conditions and pressures

The unit in the middle to upper reaches has a generally low gradient (Figure 1-5 - A), particularly in the multi-thread / spreading sections where there is no clear dominant channel and water spreads over a wide area. In the single thread sections, the gradient is still generally low (although does steepen downstream), with only minor local increases at riffles where occasional gravel bed sections are exposed (Figure 1-6). Outside of these locally energetic areas, the bed is generally silt dominated due to the low gradients (Figure 1-7). As a result of the generally low gradients and in combination with little incision within the mire section of the unit, bank erosion is limited.

Targeted restoration of natural drainage paths should refer to Appendix A and Figure 1-5.

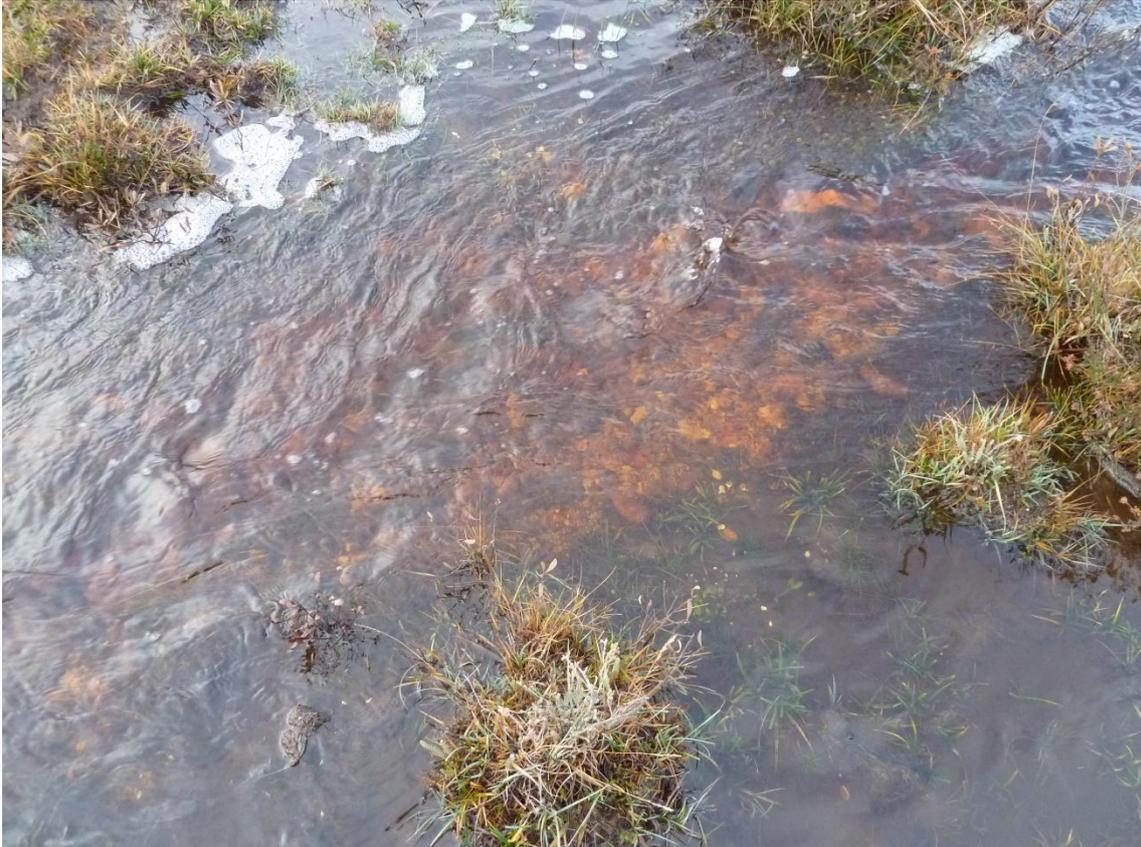
Figure 1-6: Small gravel bed sections downstream

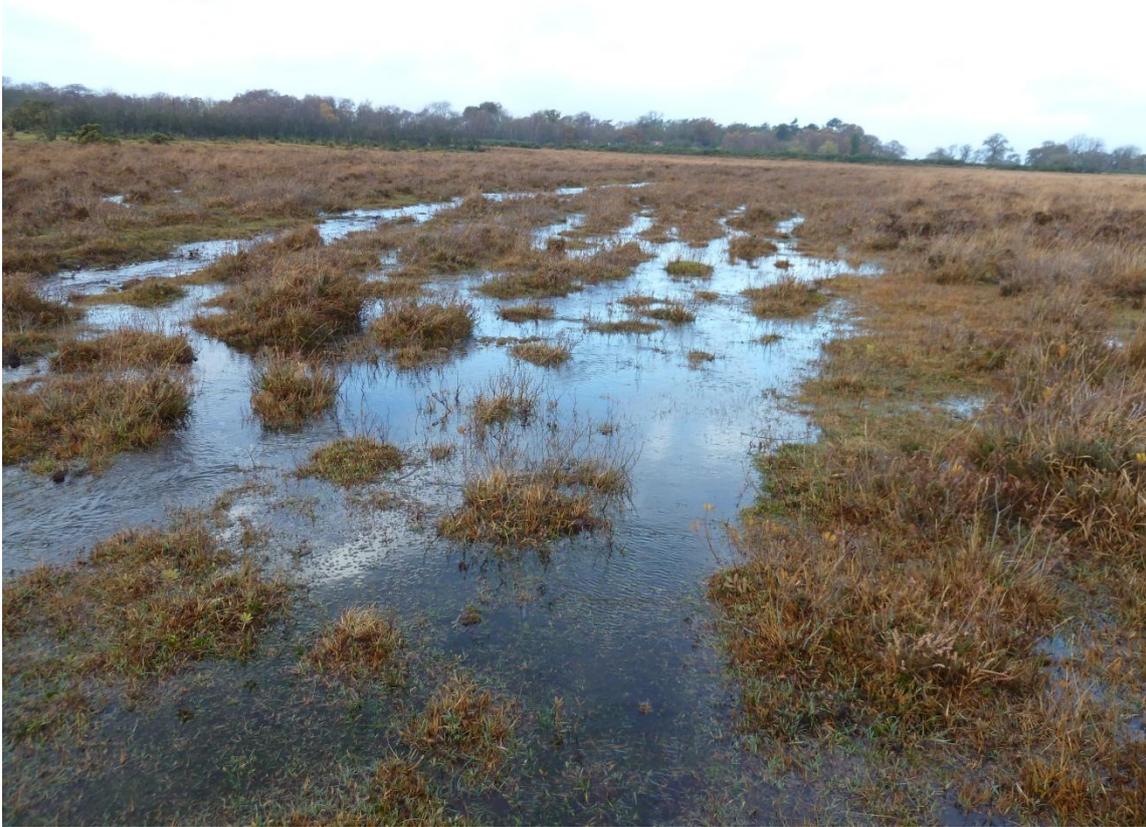
Figure 1-7: Silty and ephemeral vegetation bed channel characteristics

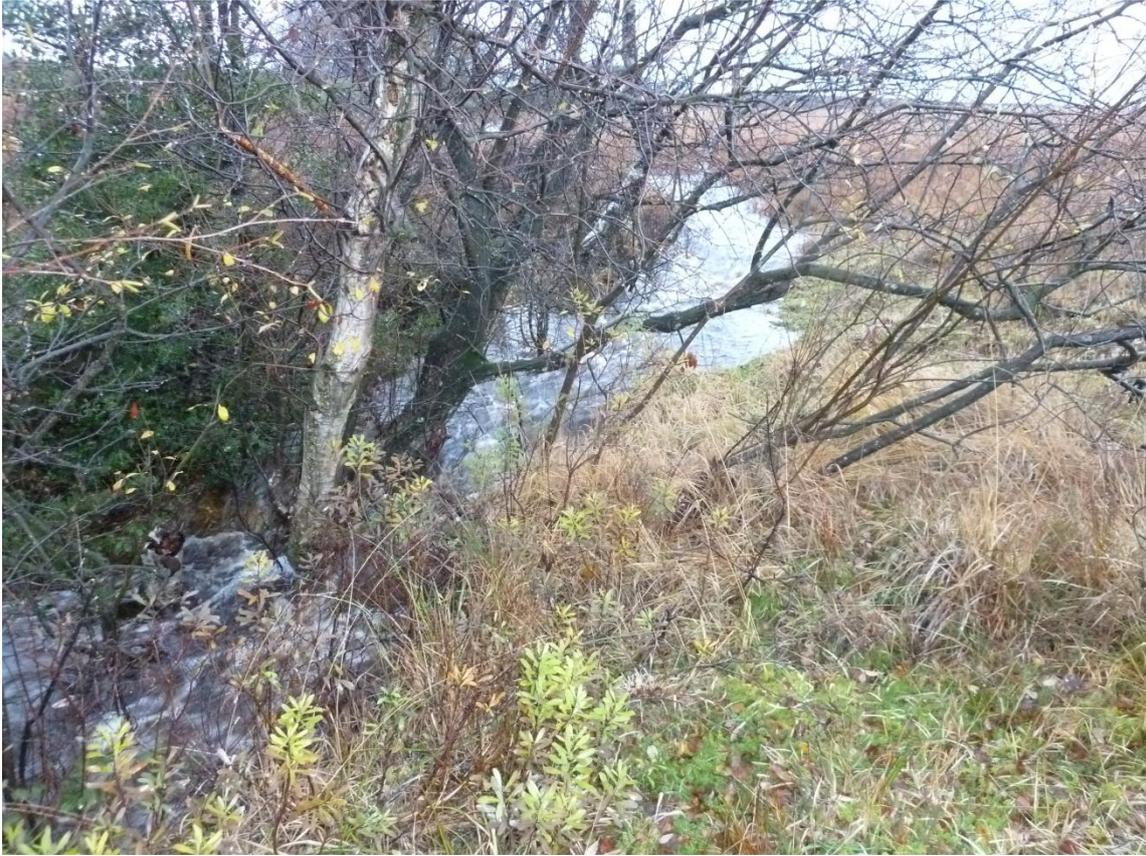
In the downstream reaches of the unit, the channel is more active with possibly some past channel straightening towards the Stock Water outside of the SSSI unit boundary. This will have resulted in some loss of channel length leading to a steeper channel, and resulting in increased flood shear stress levels promoting erosion of the channel bed. This incision is seen at several locations along the downstream reaches (Figure 1-5 - B and Figure 1-8). Incision is enhanced where the channel banks are stronger (due to the presence of more resistant boulder clays rather than fluvio-glacial gravels or where riparian woody vegetation is dense enough to provide a coherent resistant root mat). The major incision point is currently being temporarily prevented from migrating upstream by a live woody debris jam (Figure 1-8).

Figure 1-8: Incision in downstream riparian woodland stream section

Incision is a continuing process in the downstream single thread reach and threatens to migrate further upstream if not managed. This would threaten the mire areas of this unit through bed and water level lowering, groundwater lowering and consequential floodplain drying.

Woody debris jams could be used to manage the incision in the downstream single thread reaches as these would naturally occur in the wooded riparian corridor in this area (Figure 1-10).

Woody debris jams must extend into the adjacent banks to ensure longer term functioning.

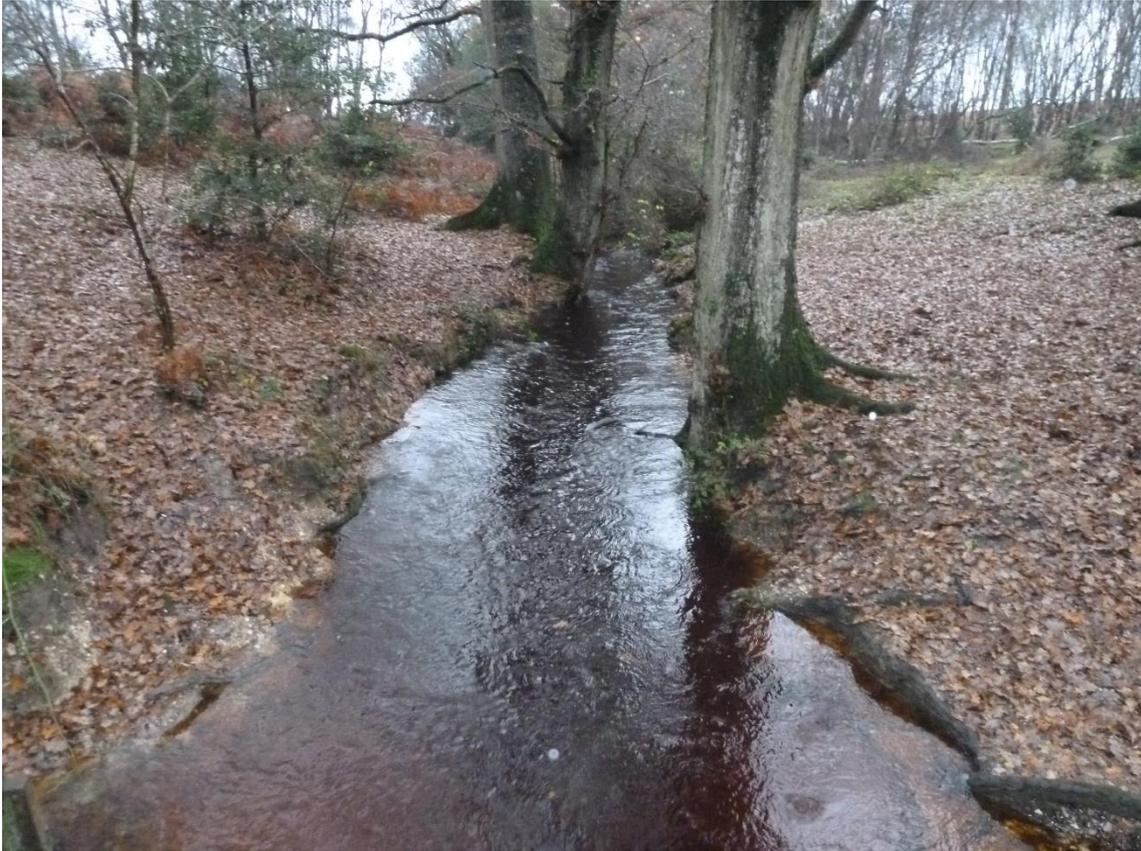
There are no significant gravel shoals or features within this unit, with morphologic units limited to riffles and runs where there are minor increases in gradient locally and particularly in the downstream single thread sections where there are more local gravel sources. The stream section of the unit at the downstream end is considered to be a transporting reach to the Stock Water, as a result of the confined floodplain (Figure 1-9) and relatively steep gradient. Therefore, significant stores of gravels are unlikely to be seen in this section under restored conditions and conditions are in line with current processes.

Figure 1-9: Stream section in W10a woodland showing confined floodplain

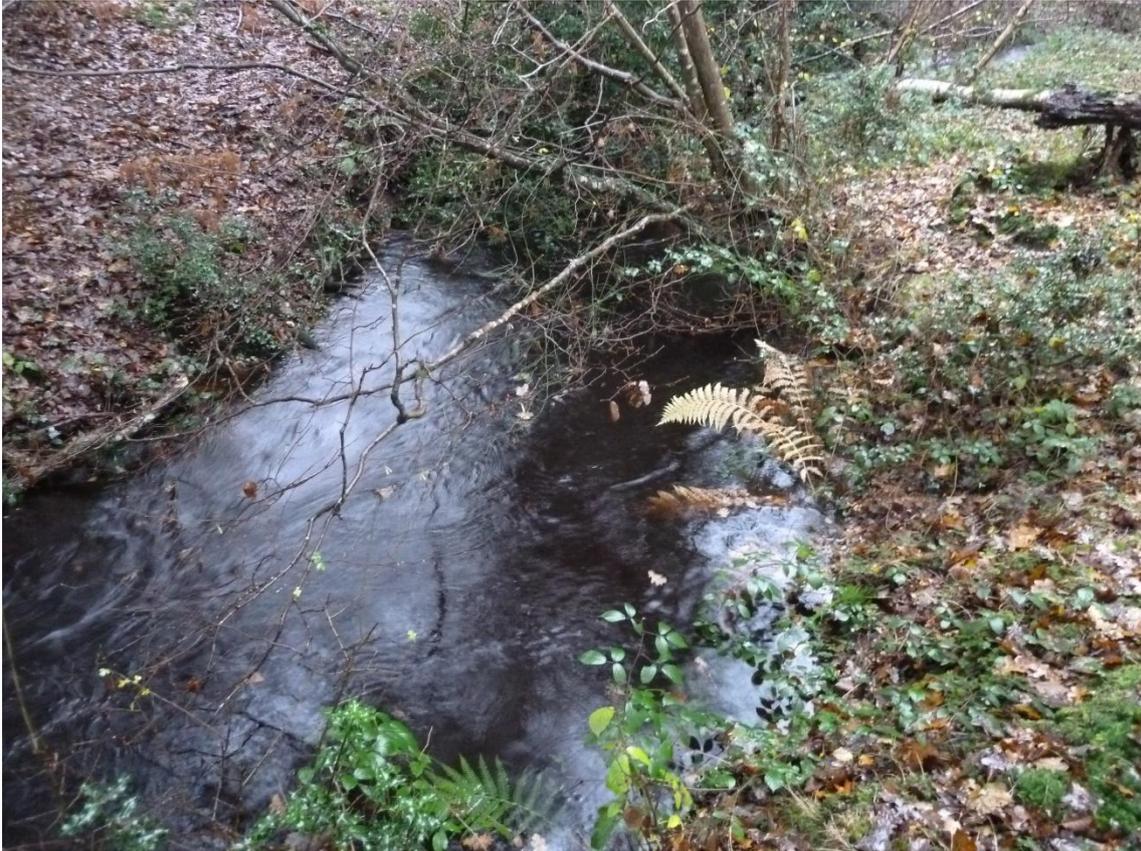
Figure 1-10: Natural woody debris jams in downstream reach

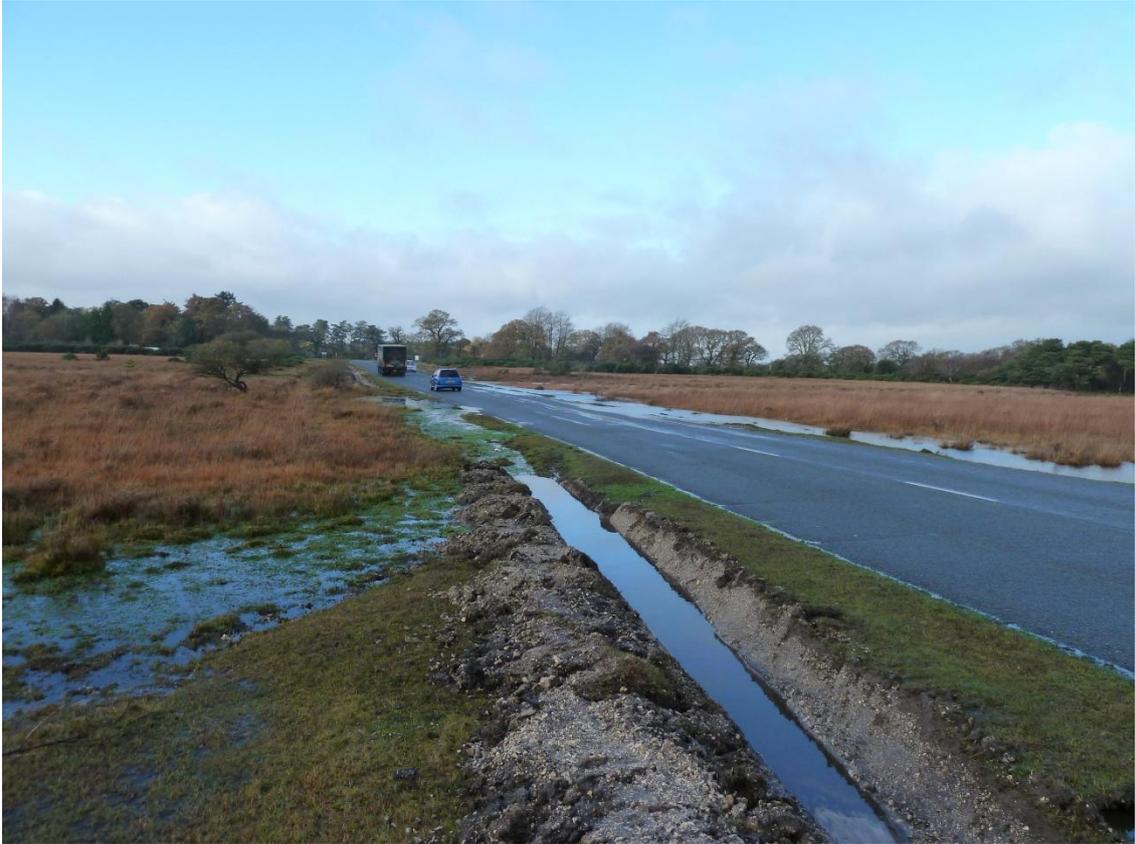
The artificial drains along the road (Figure 1-11) do impact the natural flow routes through the SSSI unit (from upstream to downstream), often concentrating flows at certain points into the surrounding drainage network. There is no evidence of this causing significant incision at present, although this may be a risk in the longer term. The structures that convey flow underneath the road (believed to be small pipes) promote ponding of water upstream of the road due to the backwater effects of the structures and their limited conveyance capacity (Figure 1-12).

Figure 1-11: Road drains concentrating flows into the SSSI unit via a Soakway (M29) community

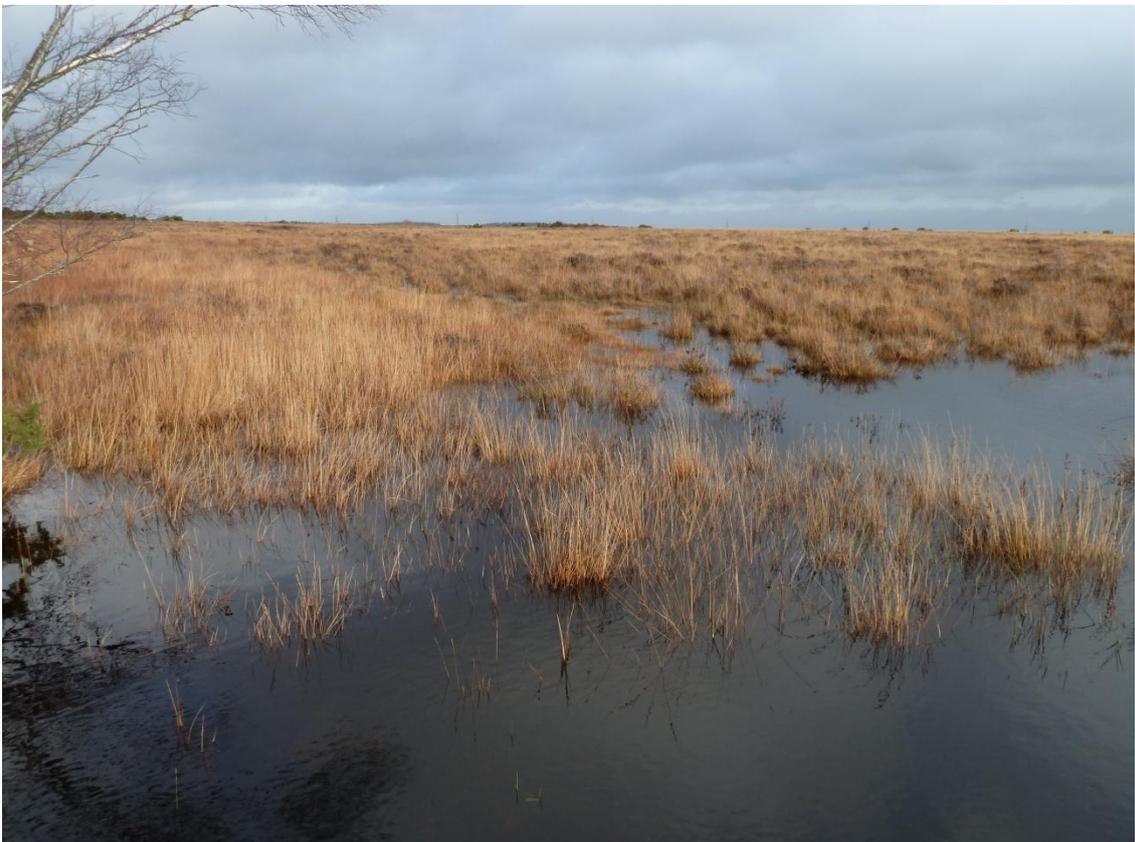
Figure 1-12: Ponding upstream of the road in *Molinia* mire (M25a)

An engineering assessment would be required for modification to any structures under the road.
