Natural England Commissioned Report NECR140

New Forest SSSI Geomorphological Survey Overview

Annex E: Picket Bottom Restoration Plan - SSSI Unit 91

1 Picket Bottom Restoration Plan - SSSI Unit 91

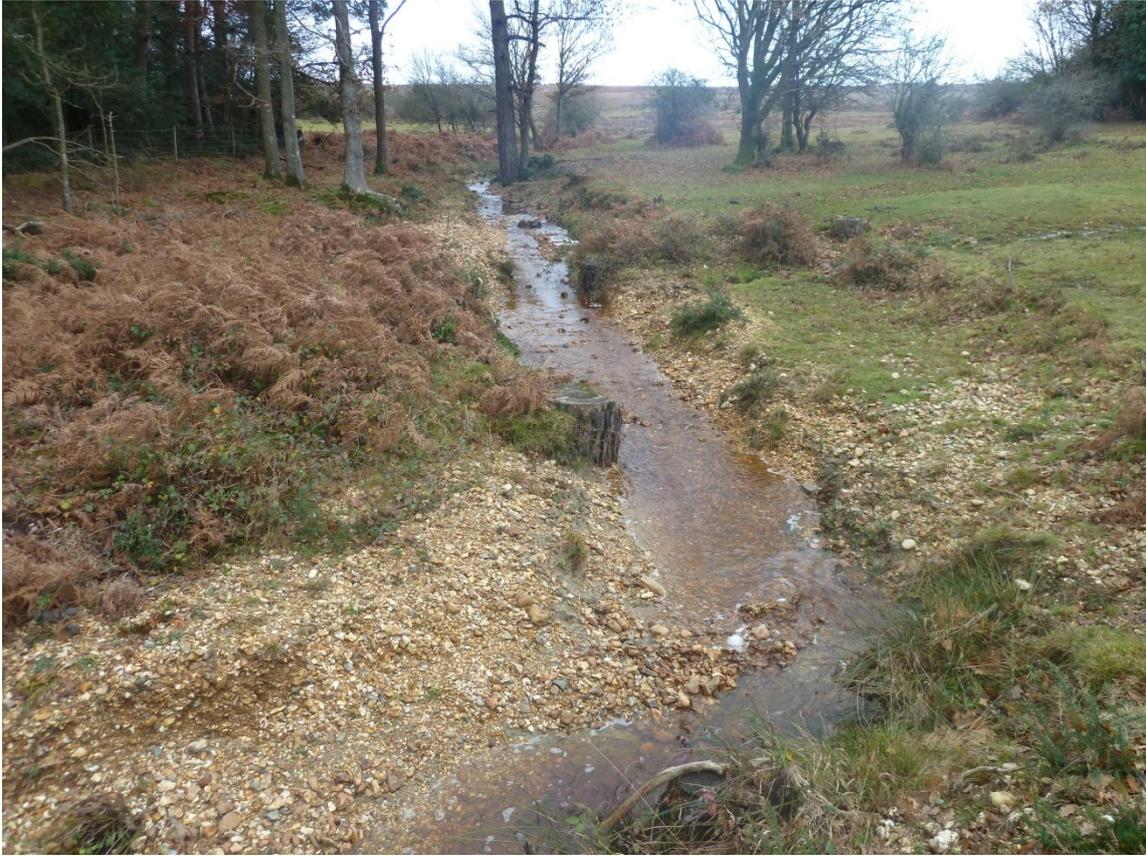
The stream at the downstream end of Unit 91 is an active single thread channel with significant ongoing incision (Figure 1-2). Within the mire section, the main flow route is well connected to the floodplain in most places, with significant spreading occurring (Figure 1-3), in some sections flow coalesces to form a weakly defined channel (Figure 1-4). The gradient is relatively low within the mire sections (Figure 1-5 - B). Incision within the stream at the downstream end (Figure 1-5 - A) has exposed some gravels but there are generally low inputs of gravels from upstream.

Figure 1-2: Active channel characteristics at downstream end of unit - displaying incision evidence

There is little evidence of significant channel straightening upstream of the incision, either from the audit or the LIDAR. However, significant straightening appears to have been undertaken within the stream at the downstream end of the unit (Figure 1-2), extending all the way to Linford Brook. This is a likely cause of the significant incision within the stream, alongside channel deepening that will have occurred concurrently, leading to a steepening of the channel increasing flood shear stress levels. Erosive energy is consequently increased and focused on eroding the channel bed in this instance.

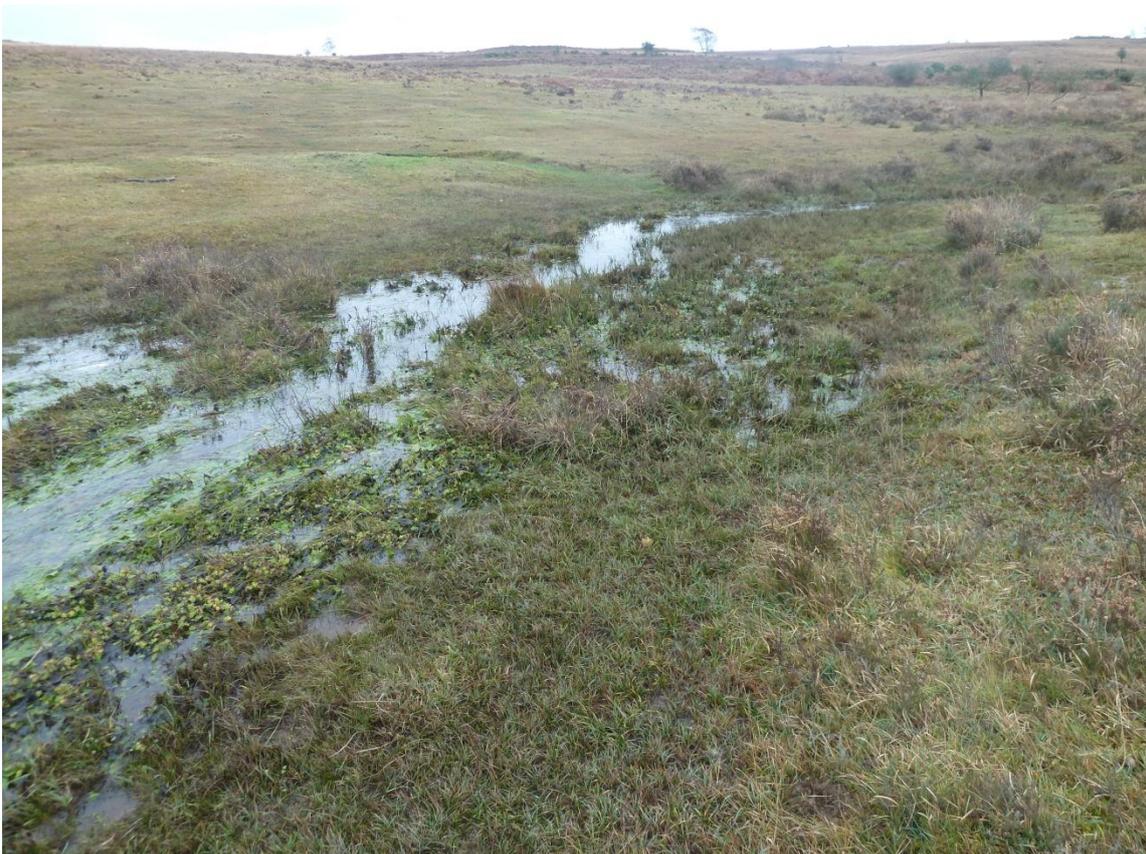
Figure 1-3: Spreading (M29) areas within the mire section

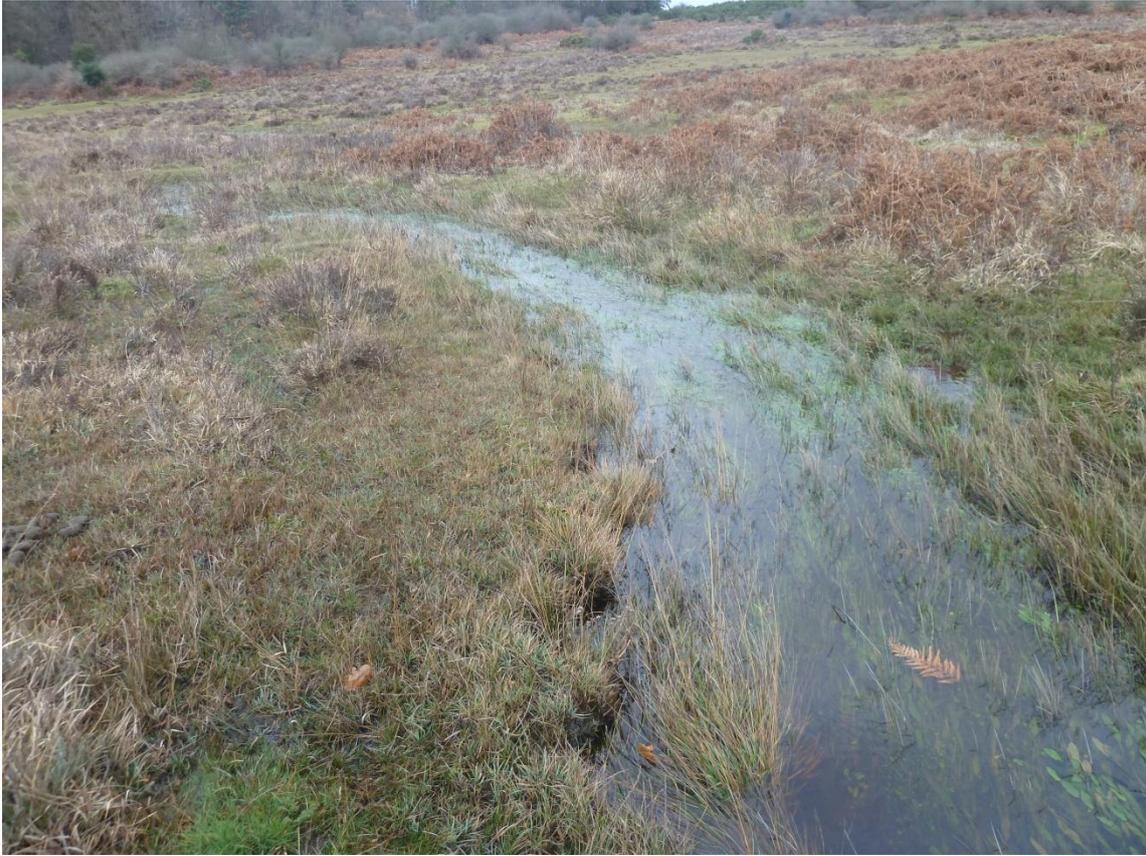
Figure 1-4: Weakly defined channel sections within mire area

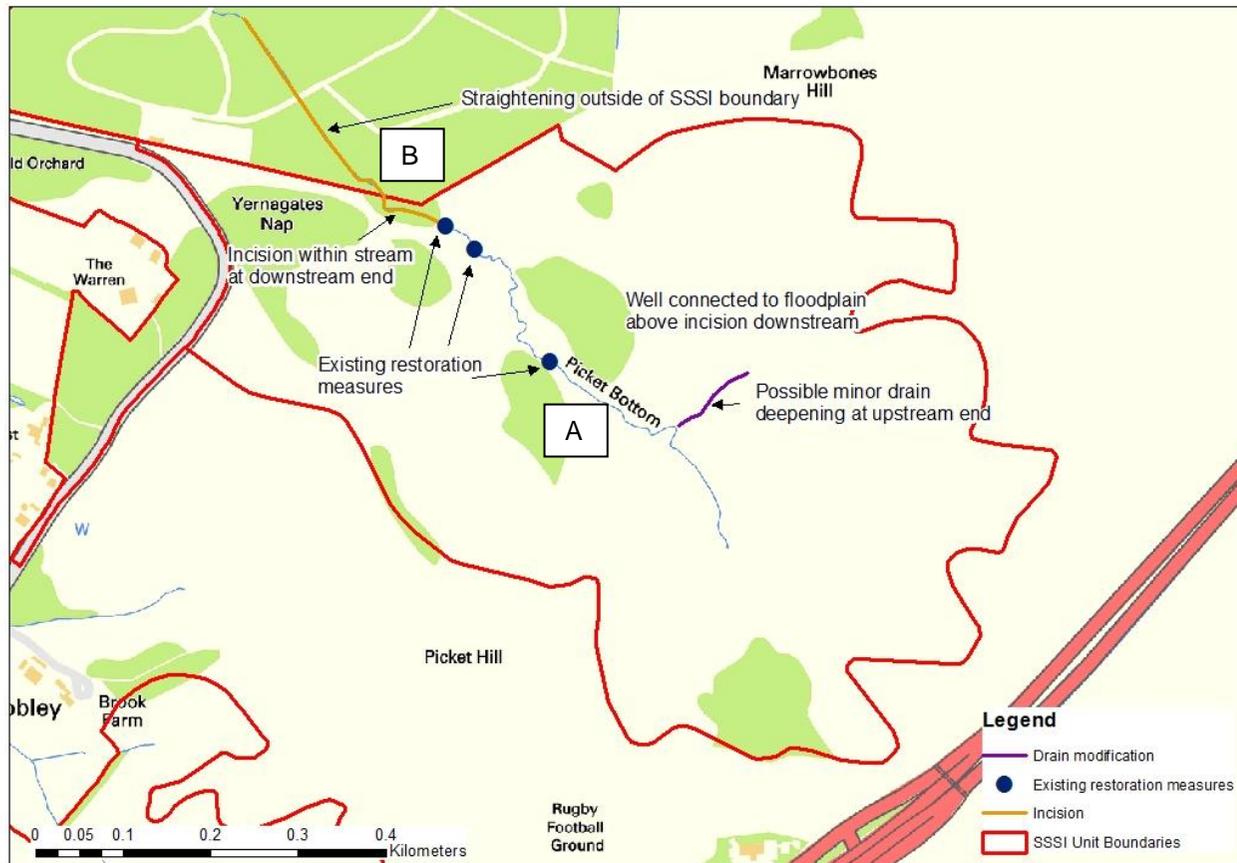
The source for the unit is Picket Hill. Figure 1-5 summarises the existing hydromorphology and pressure impacting unit 91.

Figure 1-5: Current hydromorphic conditions and pressures

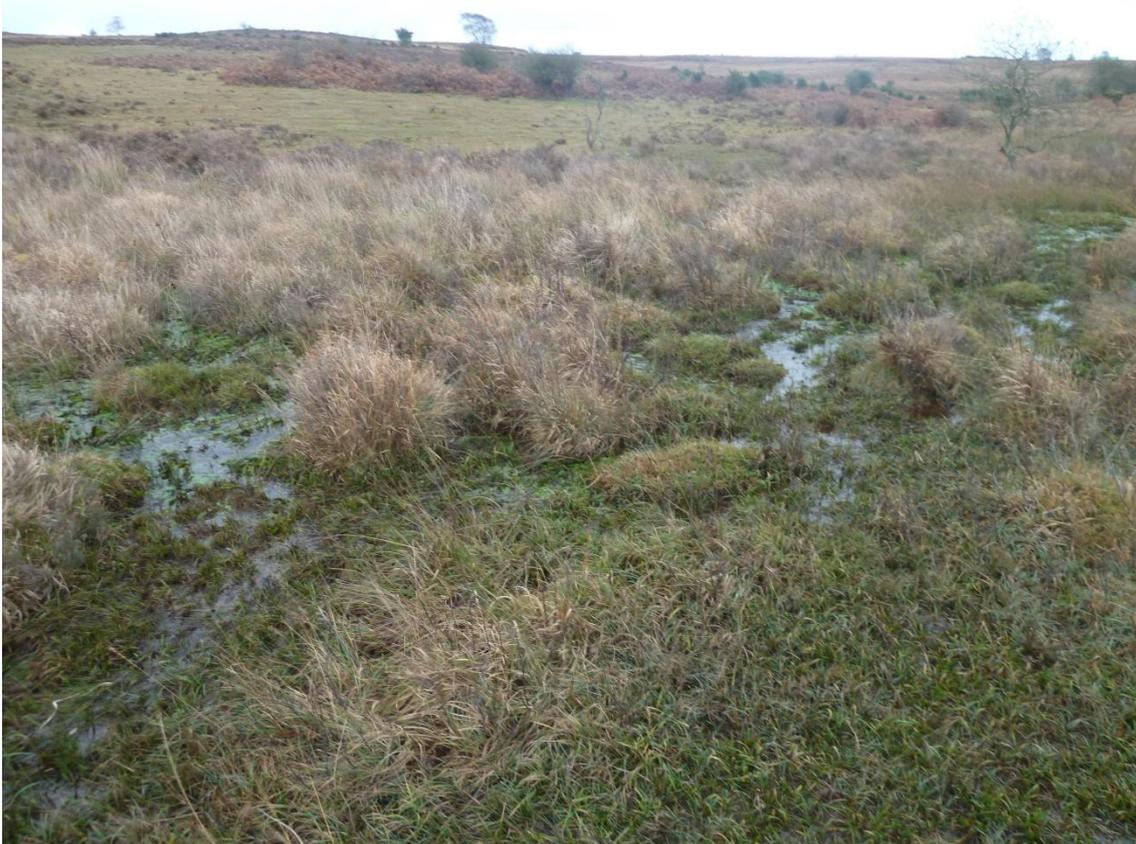
The gradient within the main flow route for the mire section of this unit is generally low, allowing flows to spread over the floodplain locally. The bed is generally silt dominated (Figure 1-6) due to the low energy flows and where there are gravels within the mire area, there is suspicion these have been artificially introduced either as part of restoration measures to raise water levels or for cattle crossing purposes (Figure 1-7). There is some flow biotope variation where various interfluves across the floodplain are activated (Figure 1-8).

Figure 1-6: Silty bed within spreading (M29) section

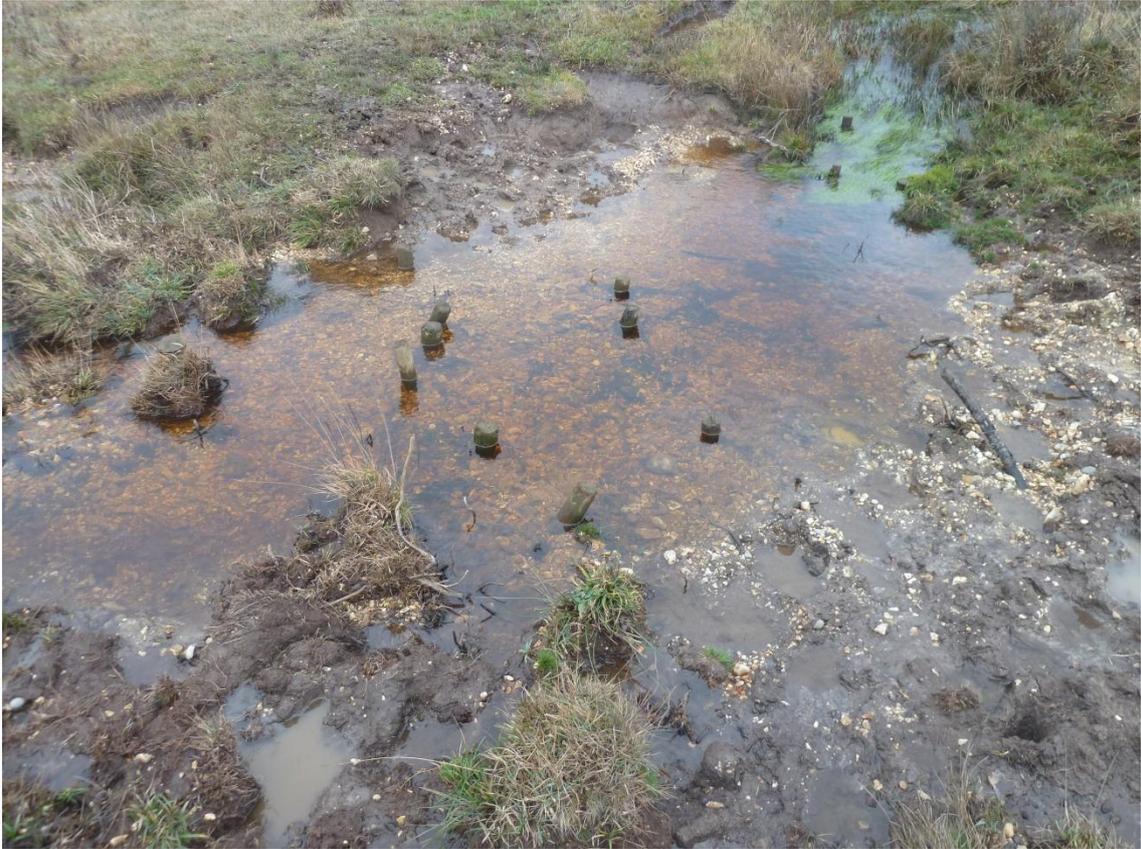
Figure 1-7: Small gravel sections associated with animal crossing points

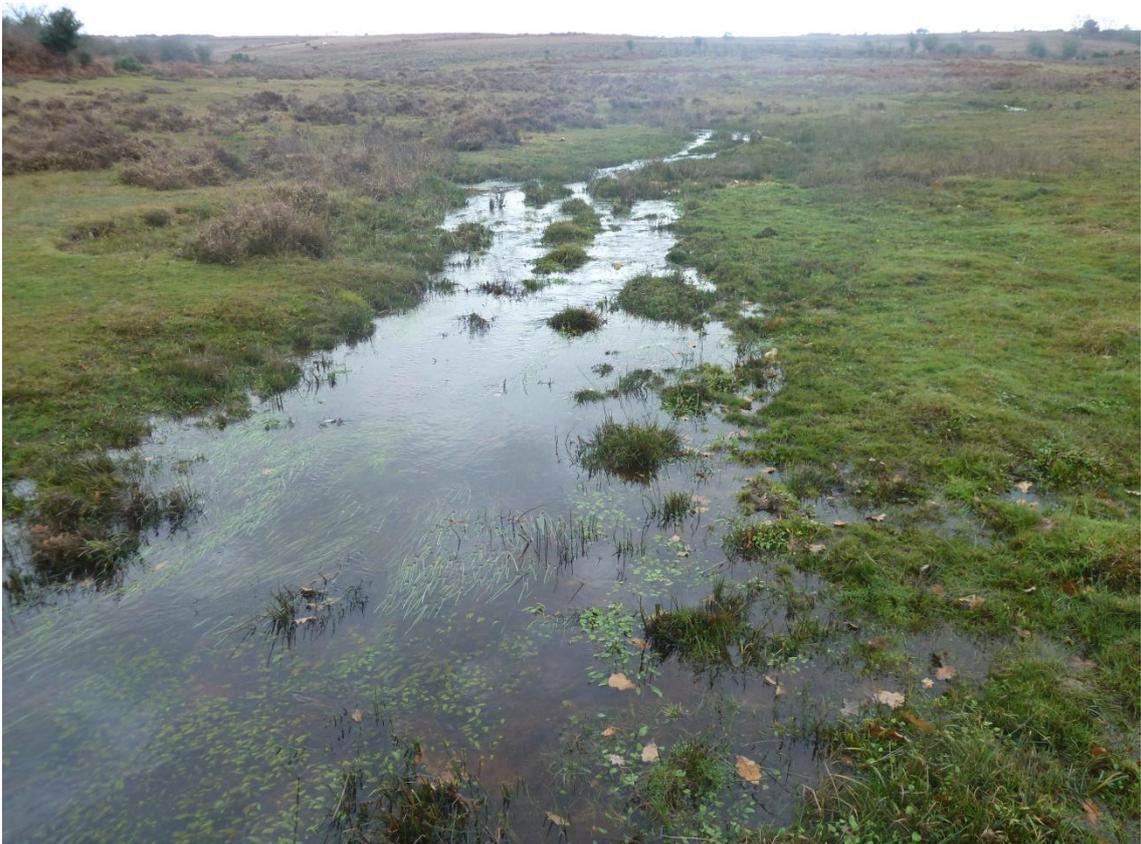
Figure 1-8: Biotope variation in spreading section (M29, M23a, M25a)

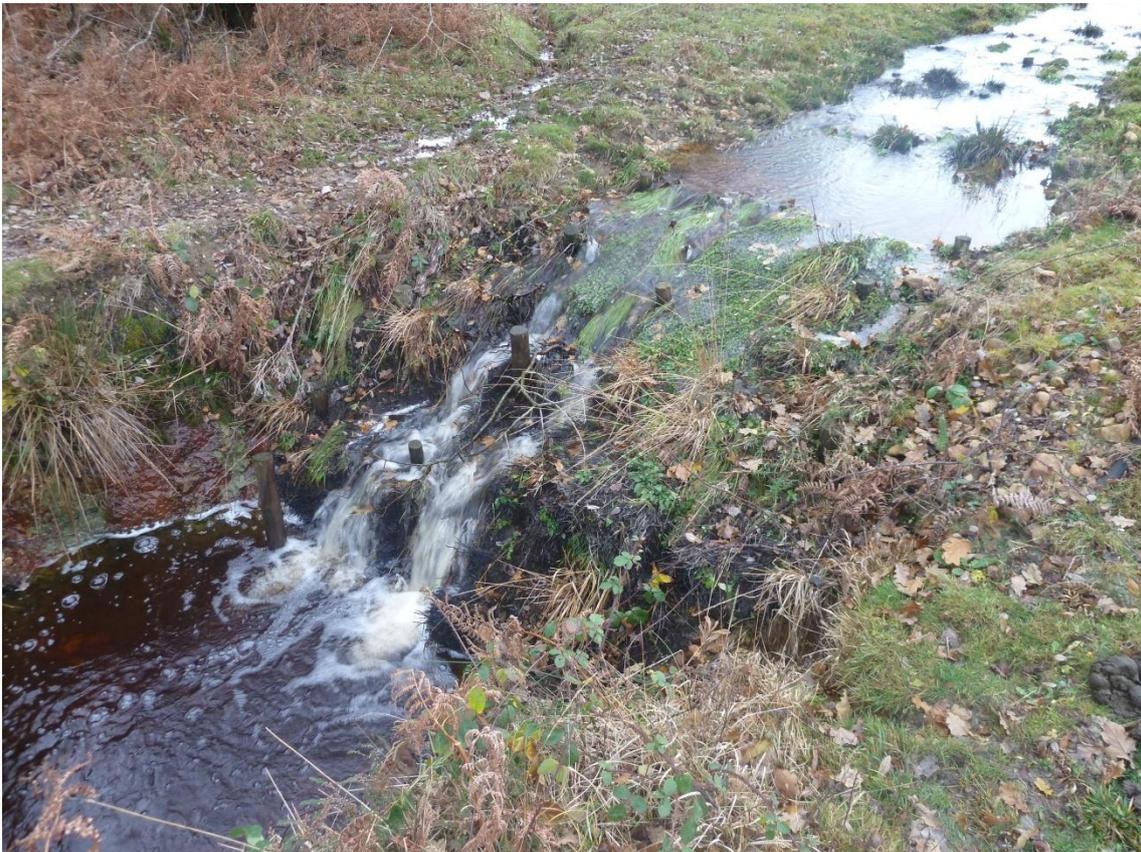
Current restoration measures to manage the downstream incision (Figure 1-5 - A) and to raise water levels within the mire section are shown in Figure 1-9 to Figure 1-11. These have been partially successful in managing ongoing incision and ponding water upstream to improve floodplain wetting, however the staked bales to manage incision at the downstream end of the unit (Figure 1-9) may not survive in the long term.

Figure 1-9: Downstream restoration measure to manage incision

Monitoring of the downstream restoration measure (staked bales) to manage incision should be undertaken as this may need replacing in the short to medium term.

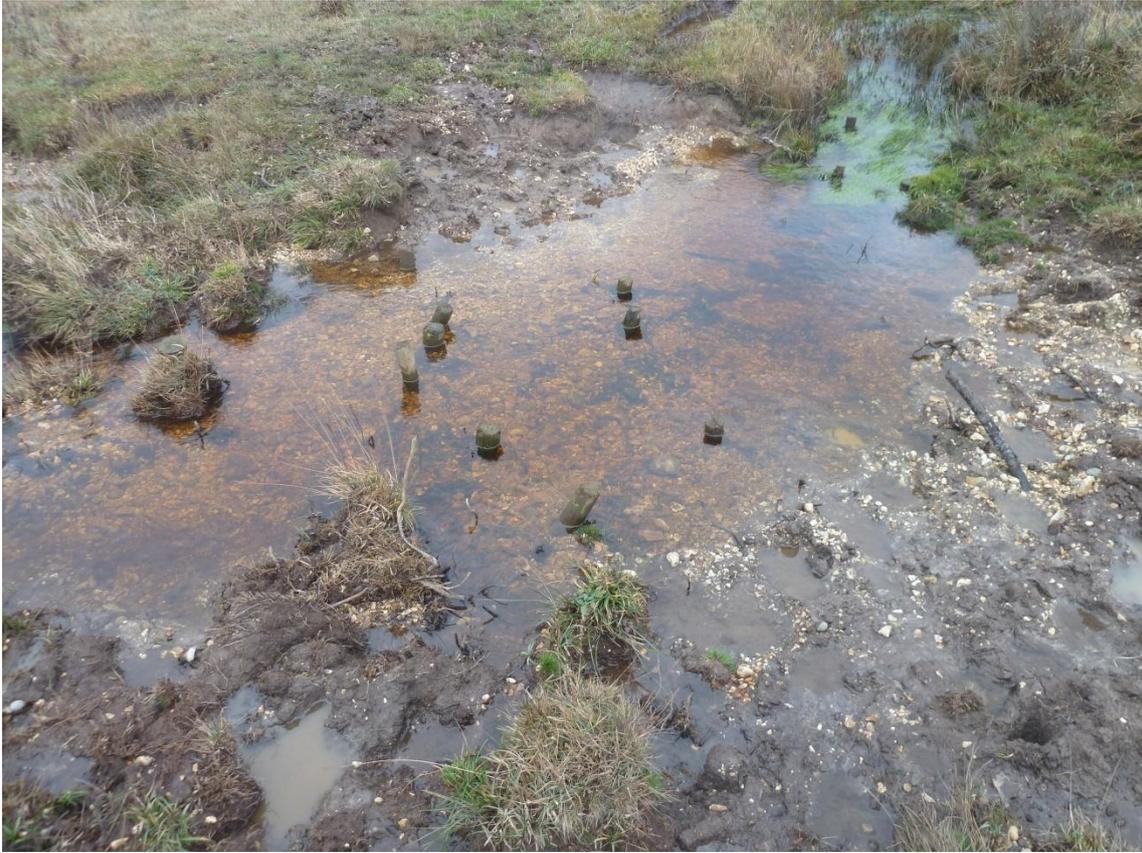
Figure 1-10: Infilled staked bales to raise water levels

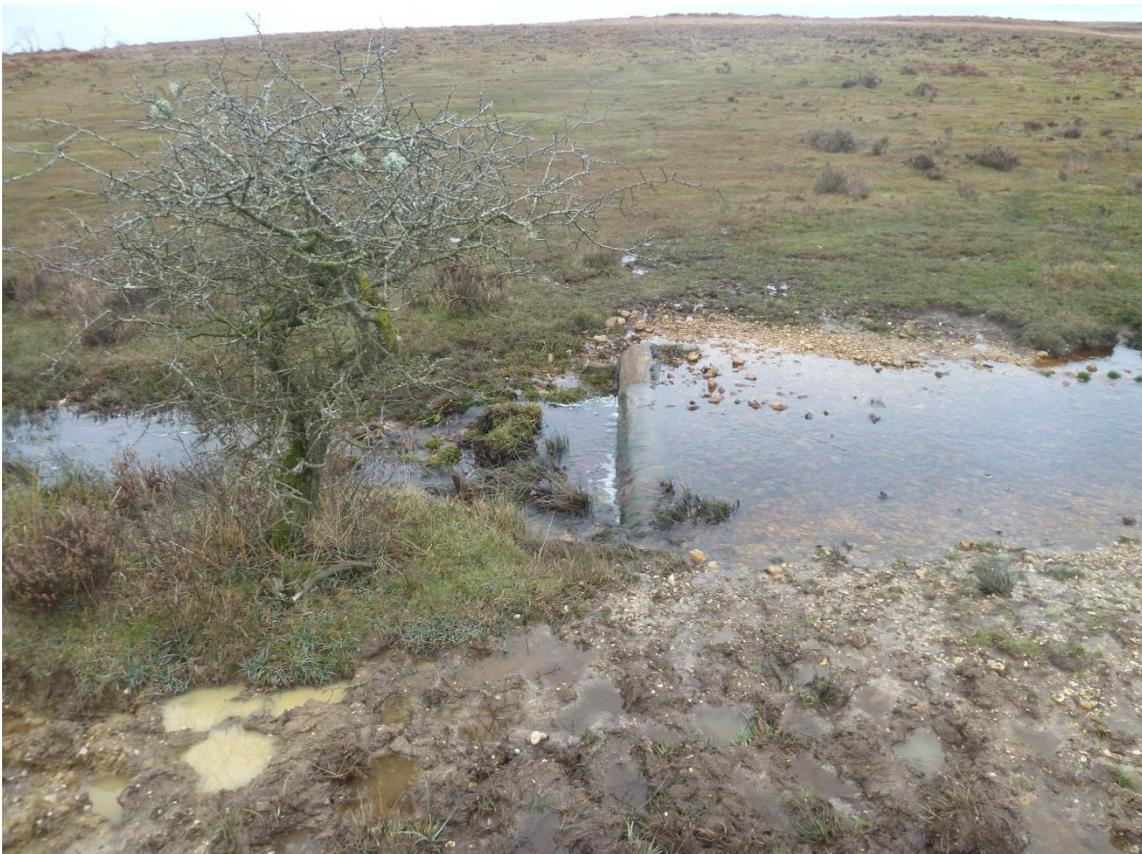
Figure 1-11: Log dam to raise water levels

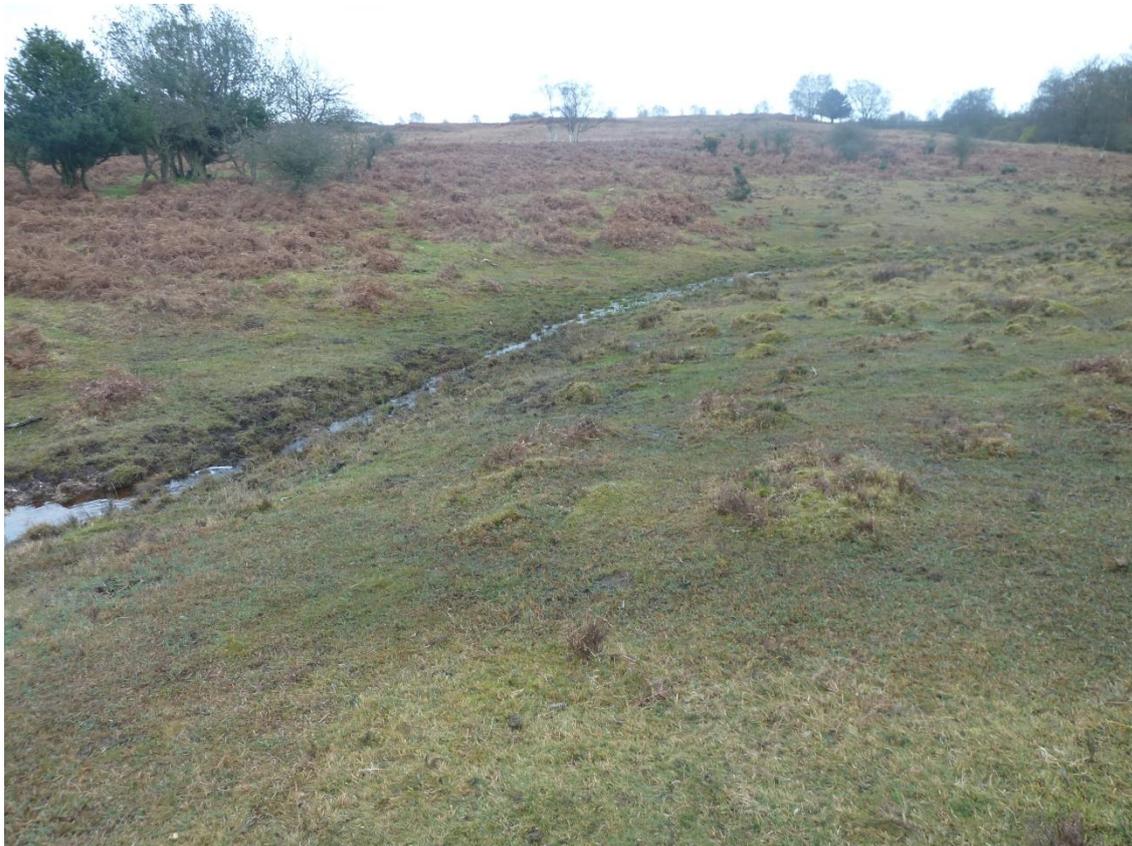
The flow and drainage lines in Appendix A confirm that there is little evidence of significant artificial drainage within this unit. There has possibly been some deepening of the drain route at the upstream end over the right bank (Figure 1-12), although this is not significant. There are very few straightened drains and both the audit and LIDAR confirm no presence of embankments along either the main channel or the drains.

Figure 1-12: Right bank drain showing possible deepening
