Improvement Programme for England's Natura 2000 Sites (IPENS) – Planning for the Future IPENS 072

# Border Mires Monitoring zones – Habitat Extent Mapping

Border Mires, Kielder – Butterburn Special Area of Conservation (SAC)

# **Final Report**

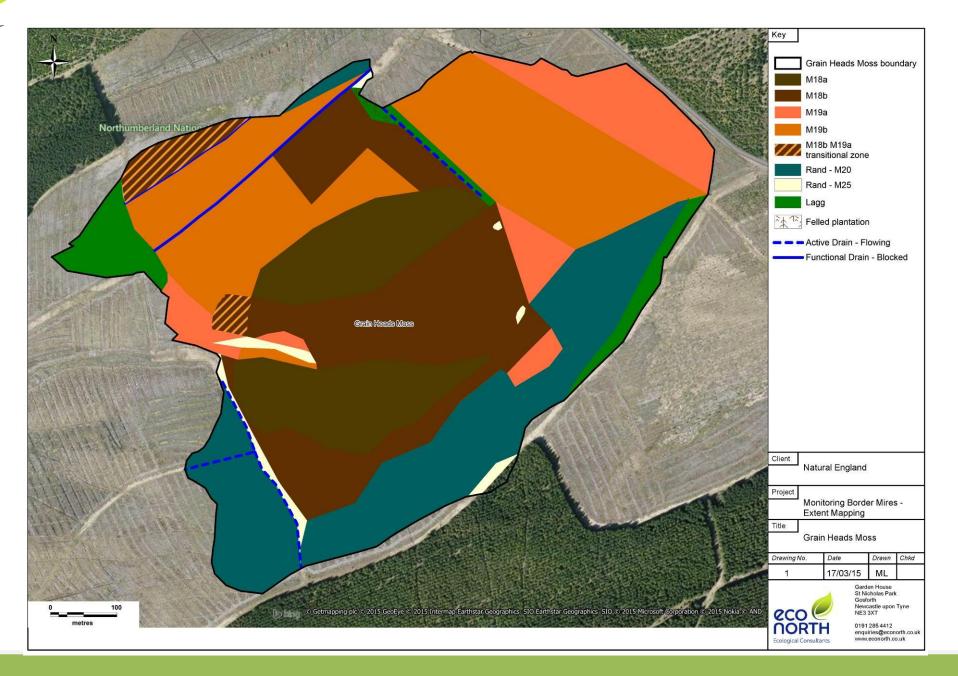
#### 4.1 Grain Heads Moss

The central section of this mire is good quality and is classed as M18a and M18b where there is good cover of sphagnum moss *Sphagnum spp* with bog asphodel *Narthecium ossifragum* and deer grass *Trichophorum cespitosa*. The north western section of the mire is felled plantation and has been categorised as lagg for this survey. The ground here is very tussocky with a mixture of purple moor-grass *Molinia caerulea*, hares-tail cotton grass *Eriophorum vaginatum* and various moss species (not sphagnum species). There is a lot of dead wood in this section and it is not very wet. Habitat improves to the south of this lagg section where it is categorised as M19a habitat and this extends to the centre where it habitat gradually improves to good quality mire.

Hares-tail cotton grass (M20 habitat) dominates the south western and southern section of this mire. This is an area of felled plantation with a lot of dead wood. Habitats improve moving northwards to the centre of the site and it is likely that this section (M20 habitat) could regenerate to better quality mire in time.

There are small areas of flush – Rand M25 habitat – throughout the mire which are purple moor grass dominated and generally associated with drains or considerably wet areas.

There are three active drains on site and two functional drains. The active drains could be dammed to improve condition on the site, most pertinent is at the north eastern active drain which is draining steeply to the north and is taking water from the felled plantation preventing wet habitat accumulating and therefore from good mire habitat from forming to the east of the drain.

- **Grains Head Moss**: Install a series of dams along the active drains, to west and north in particular.
- Felicia Moss: Repair and install series of dams along drains around west, north and east perimeters of site, to retain water in these areas

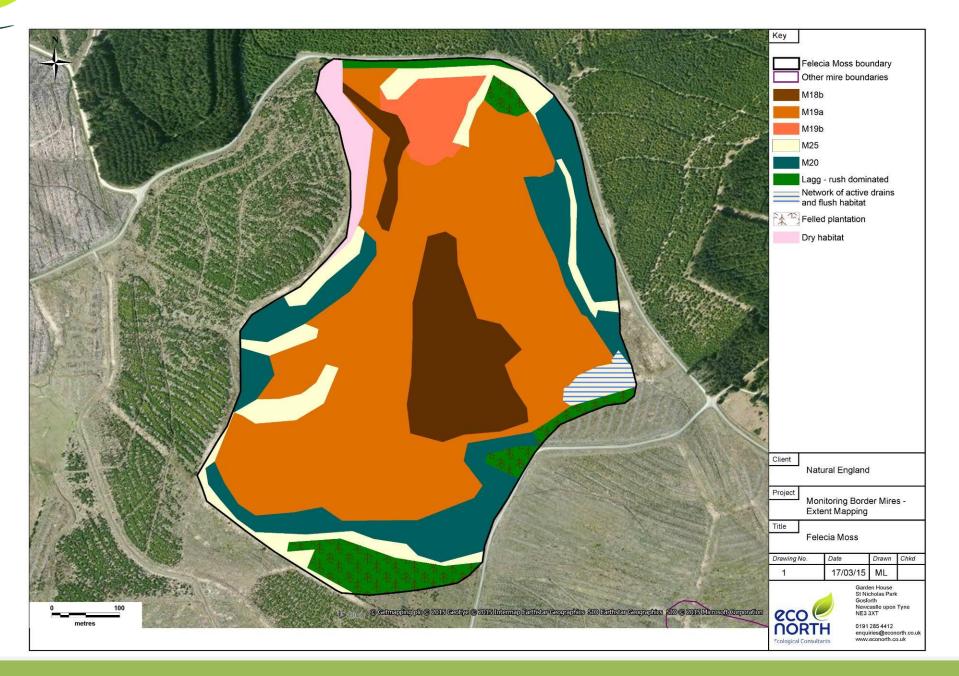
#### 4.2 Felecia Moss

Mire habitats on Felecia Moss could be improved. The very central section is classed as M18b and this area demonstrates good mire habitat with little heather *Calluna vulgaris*, dominated by hares-tail cotton grass, bog asphodel and sphagnum moss. The surrounding habitat is M19a and has potential to be improved with management to become better quality mire.

A network of active drains was recorded in the south east section of the site. There are some dams here but all are failing and therefore a lot of water is likely draining from the site to this area taking water offsite. Similarly with areas of flush (M25 habitat) to the west and south which is likely draining water offsite given the gradient of the land here (west and south gradient respectively).

The sections of felled plantation on site are dominated by dead wood and are classed as lagg habitat. These areas are somewhat wet underfoot but do not represent mire habitat and are dominated by rush *Juncus spp* and sedges.

The dry habitat to the west of the site is felled plantation but is on a hill therefore likely all water is draining to the southern area where it is dominated by moor-grass and hares-tail cotton grass

Overall there is scope to block up active drains on this mire to prevent further degradation of central mire where there is a relatively small section which is good quality. The habitats surrounding this central area are classed as M19a which can be upgraded to better quality mire through management of the active drains and flush areas on site.

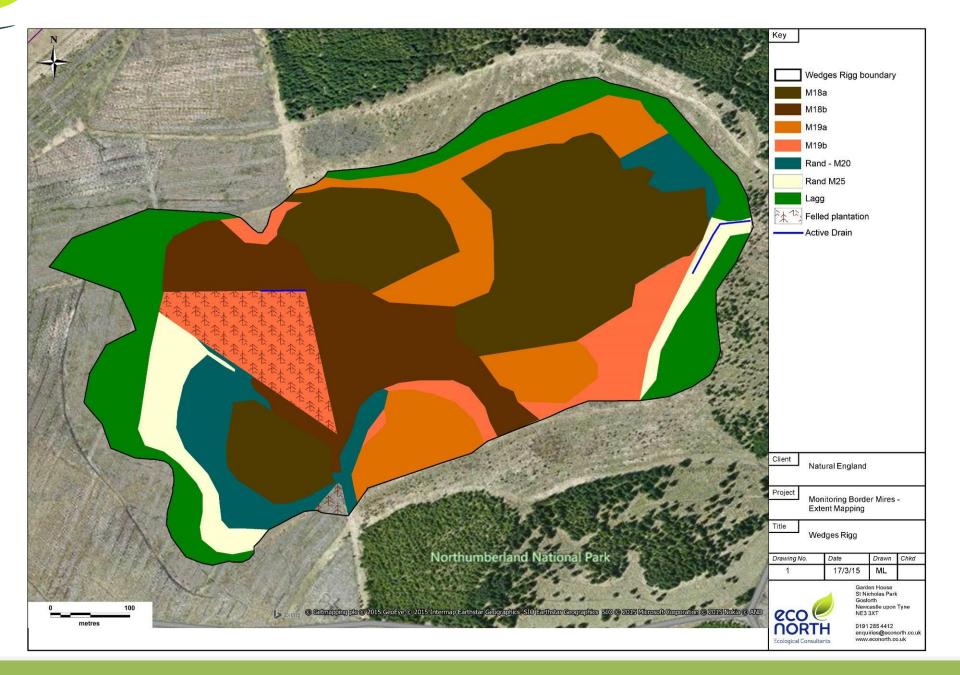
## 4.3 Wedges Rigg

Overall Wedges Rigg represents good quality mire habitat with the best quality mire in the centre classified as M18a, dominated by sphagnum mosses, bog asphodel and cranberry *Vaccinium oxycoccus*. There is little management required in the central section of this mire.

Mire habitat decreases towards the west of the site. There is an area of felled plantation which has been categorised as M19b and is dominated by heather with little cross-leaved heath *Erica tetralix* nor sphagnum. This area is dominated by dead wood and also there is evidence of some tree regeneration which will draw up water.

Further west the area changes to M20 sub-community dominated by hares-tail cotton grass with some small pockets of water visible between tussocks and dead wood. There is a large area of flush here (M25 classification) which is quite wet. No active drains were recorded but given that this habitat is dominated by moor-grass it is likely to be active at some point and therefore draining surrounding habitats, reducing mire quality.

One active drain was recorded on this mire on the eastern boundary. This drain is surrounded by moor-grass (M25 habitat) and could be dammed to hold water thereby increasing the surrounding habitats which are currently classed as poor quality mire M19b.

- Wedges Rigg: Install series of dams on eastern drain in particular to retain water in the eastern half of the site.
- Berry Hill East: Install series of dams along main drain flowing east out of the site, on the northern perimeter and southern perimeter – all of which are rather active. In addition, large scale conifer sapling removal should be undertaken in this eastern section as this threatens some of better areas of mire in this part of the site

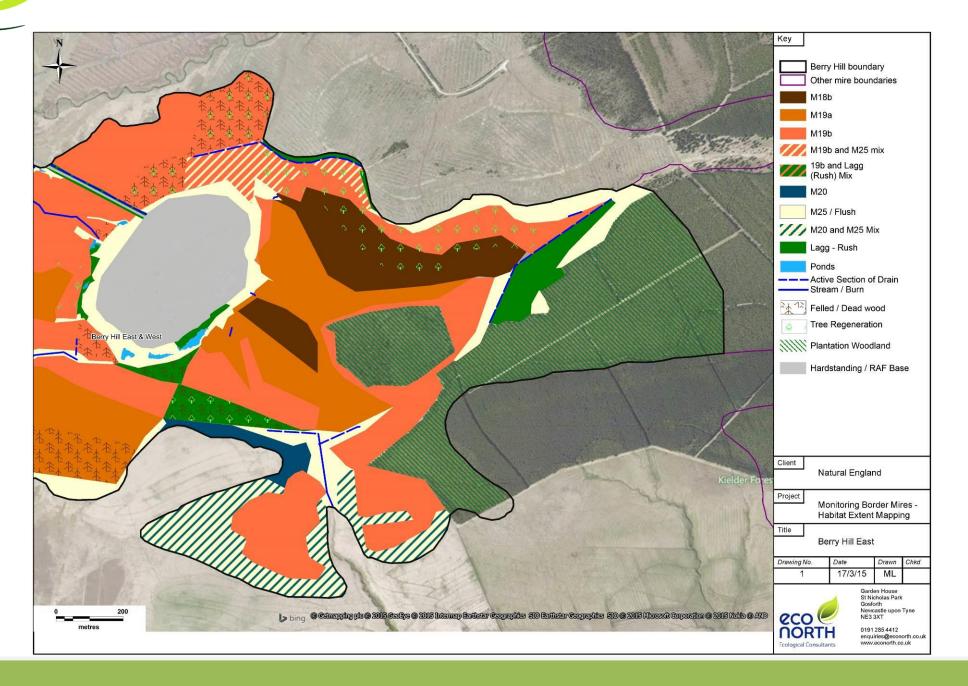
#### 4.4 Berry Hill East

Berry Hill East is dominated by moderate mire habitat, M19a and M19b type with some representation of good mire, M18b, also found. The M18b habitat is dominated by cranberry and cross-leaved heath with a good cover of sphagnum and bog asphodel.

The M19a habitat which surrounds M18b is dominated by heather tussocks and crossleaved heath with little sphagnum mosses. This M19a habitat is also dominated by tree regrowth. There is a lot of tree regeneration in these areas which could be causing the site to be drier than it should.

The eastern section of the site is covered with planation woodland with typical lagg and flush habitat on the border.

There are a number of active drains on the site the main ones located to the north and south of this section of the mire. The drain to the north of the site is significant but appears to drain water from the north which is a hill of felled plantation woodland and not within the mire boundary. This drain could be managed to improve mire habitat to the south and similarly with the drain to the east.

There is a stream in the southern section which has two active drains flowing into it, likely draining the surrounding habitat which is all low quality mire habitat. This southern section is fenced off and is grazed by sheep which may also contribute to the low quality of the mire where sheep will actively graze on heather, leaving moor-grass and rush to dominate.

The area surrounding the RAF base is dominated by wetland, ponds, flush (M25 habitat) and felled plantation. Immediately beyond these habitats are moderate quality mire, with some patchy areas of sphagnum and bog asphodel dominating, particularly east towards the central section where the habitat improves and transitions from M25 to M19a and to M18b. There is a little tree regeneration within these habitats (M19a and M18b) and this should be managed to increase the quality of the mire.

Overall management on this section of Berry Hill should be focussed on removing the trees which have begun to regenerate on the site, particularly within the M18b and M19a habitats to improve the quality of the mire and to prevent further degradation. The active drains on the site should also be inspected for potential for damming.

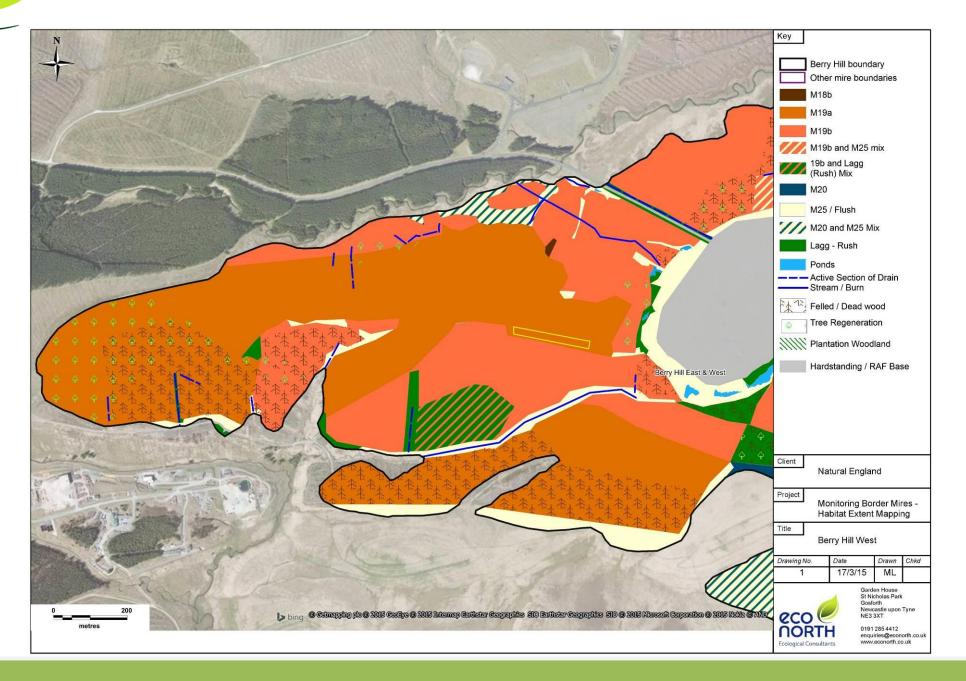
## 4.5 Berry Hill West

Berry Hill West is dominated by poor to moderate mire habitat (M19b and M19a) with some tree regeneration in the western section. There are at least six active drains on site which could contribute to the quality of mire.

There is a large area of flush (M25 and M20 mix) in the north western section of the site which is also where some drains flow to a perimeter stream. This stream is outside of the mire boundary but likely takes a lot of water from the mire. Active drains to the south and south western sections of the mire should be inspected for the potential to dam as they will be taking a lot of water offsite, in particular to the burn / stream which flows through the mire (southern section).

Berry Hill West is dominated by felled plantation there is a lot of dead wood still present on site (indicated by felled plantation key on map). Within these sections of the mire there is a lot of tree regeneration which should be managed to prevent degradation of the mire.

Overall the active drains on site and tree regeneration should both be managed to increase the quality of the mire. There is scope for the mire to be improved to the level of the eastern section. There are small patches of the mire which demonstrate good quality mire, most notably towards the RAF base (highlighted yellow on map) and also where a small section of M18b is identified. Within these areas there were denser carpets of sphagnum mossed identified and also patches of bog asphodel, cranberry and cross-leaved heath and with management these areas could be extended to improve the overall quality of the mire.

- Berry Hill West: The small sections of active drains in the extreme west of the site should be dammed as this area is responding well to tree removal, and similar should be employed along the small drains to the north of this area. The main stream within the site to the south may be difficult to dam due to its size and function though smaller upstream sections could be attempted and monitored. Conifer sapling removal should be undertaken in the south east side of Berry Hill West as this area is also recovering well after large scale plantation removal.
