Coulton Bank Soil Erosion

Yorkshire Derwent Catchment

CSFO: David Rees

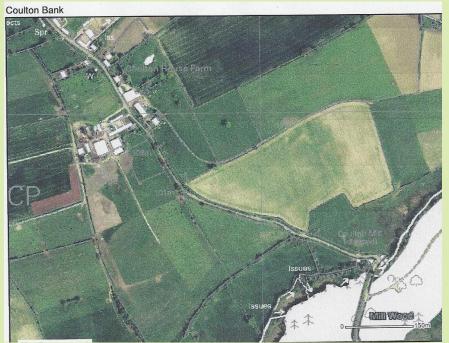
Soil erosion from sloping arable land (light green centre of map) washed sediment down the road to Coulton Mill (bottom right) and into a tributary of Marrs Beck.

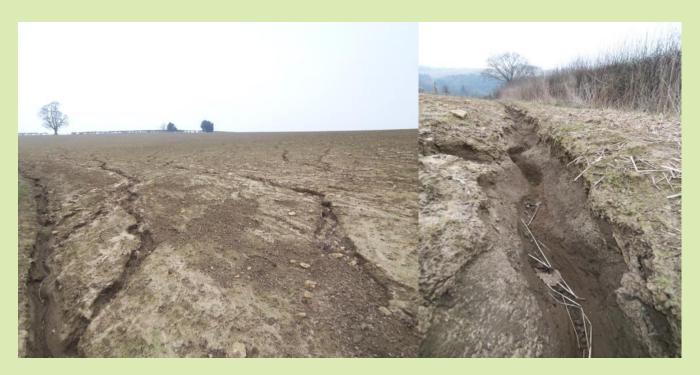
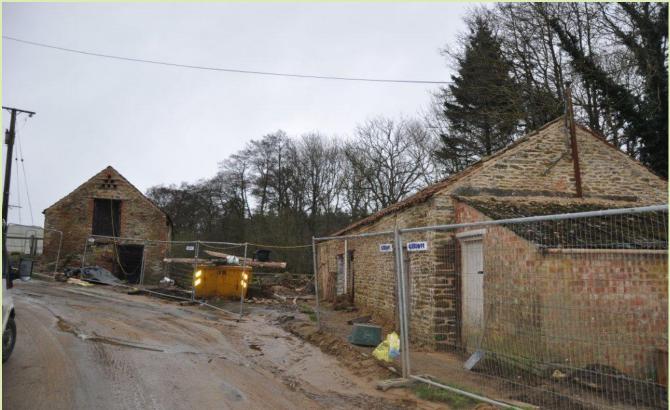
A site visit showed run off travelling down inside the field hedge before washing out through the hedge and through a gap onto the road. Road drain grids had filled with sediment, turning the road down to the mill into a temporary watercourse whenever it rained.

Coulton Mill HLS Heritage Restoration project inundated with sediment from Coulton Bank

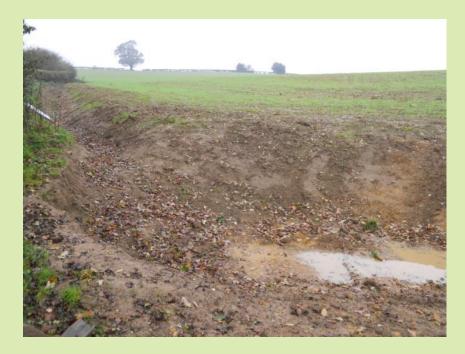
The farm was within the Capital Grant Scheme target area and a successful application was made for a sediment trap / pond in the bottom corner of the arable field (see photo below). This work was completed in November 2013 to further improve resilience to extreme weather events affecting this high risk sloping field.
