# **Definition of the zone of hydrological influence relating to Bostraze Bog, West Penwith, Cornwall. (2018)**

## Definition of the zone of hydrological influence relating to Bostraze Bog, West Penwith, Cornwall

Dr Rob Low (Rigare Ltd)

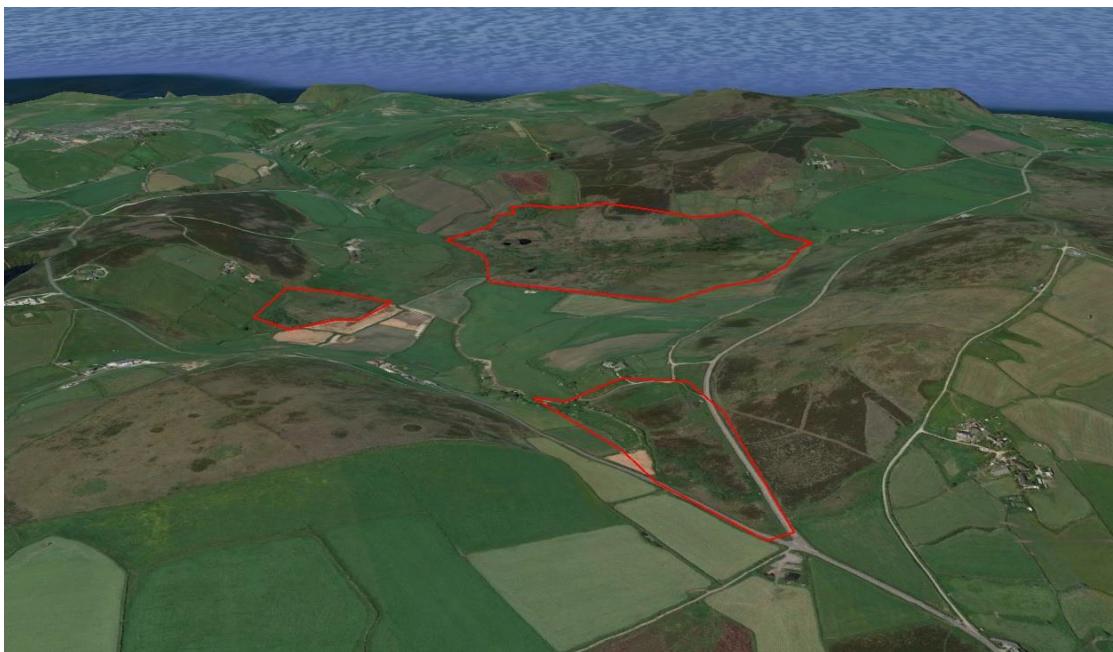
Figure 2.3-2. Screenshot from Google Earth Pro, looking north-west across the Bostraze Bog basin, with the polygons containing the bog communities shown in red.

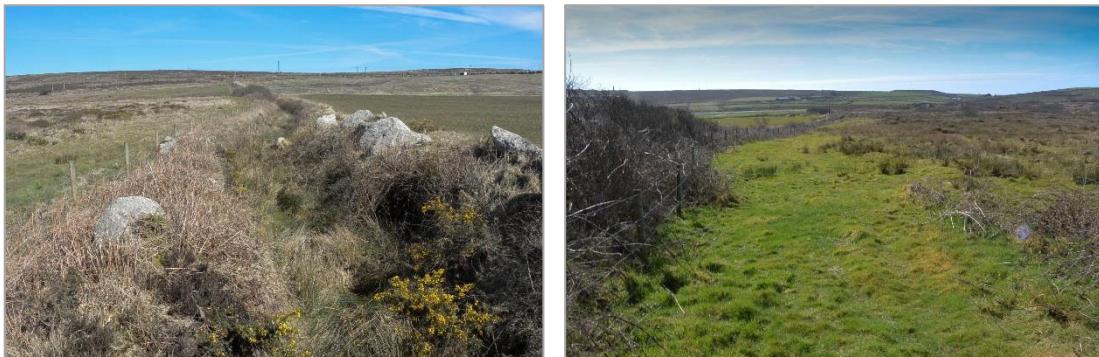
Excavation of the ditch has caused a significant lowering of water level along its course, and this will be having a drawdown effect on the water table within the wetland habitat

to the north-west. Figure 3.1-2b shows the 5-10 m-wide strip of drier grassland to the north-west of the ditch; this is probably a result of this drawdown, but could also partly be a result of the slightly elevated ground caused by ditch risings.

Figure 3.1-2. a) Significant ditch running downslope along the south-eastern edge of the Central Area of wetland habitat (looking upslope), b) slightly raised strip hosting drier grassland communities along the ditch (looking downslope).

Whilst it is inevitable that the ditch will be having a drawdown effect on the water table in the wetland habitat, it is difficult to predict the magnitude and lateral extent of this effect with the available evidence. Both will be positively related to the hydraulic conductivity of the substrate; this appeared to be relatively low in the clayey gravel at shallow depths where it could be sampled with the hand auger, but refusal of the auger probably indicates increasing dominance of gravels and an increase in hydraulic conductivity.

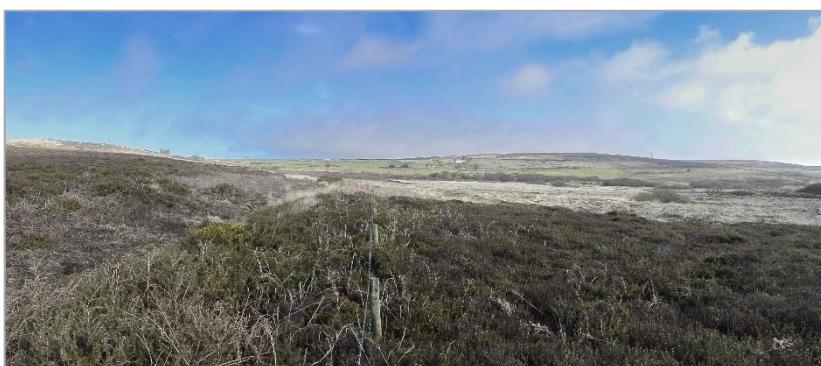
Figure 3.1-3. Unimproved H4 *Ulex gallii*-*Agrostis curtisii* heath to the left separated from M25a mire to the right by a fenceline.

Truthwall Common forms the north-western boundary of the Central Area, and specifically the large area of M25a. Figure 3.1-3 was taken at “8” looking north-eastwards, and shows upland heath to the left and M25a to the right, separated by a fenceline.

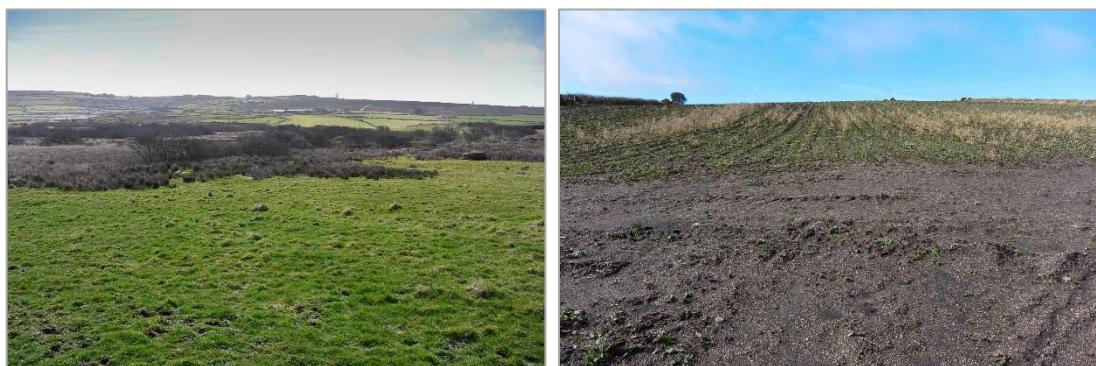
Figure 3.1-4. a) Marginally improved grassland, and b) ploughed bare soil, along the western boundary of the Central Area of wetland habitat.

Along its western boundary the Central Area lies against marginally improved grassland (north-west of “7” and Figure 3.1-4a) and ploughed fields (“9” and Figure 3.1-4b). The latter were bare soil during the field visit, and erosion gullies were developing with related deposition on the boundary of the wetland habitat downslope.

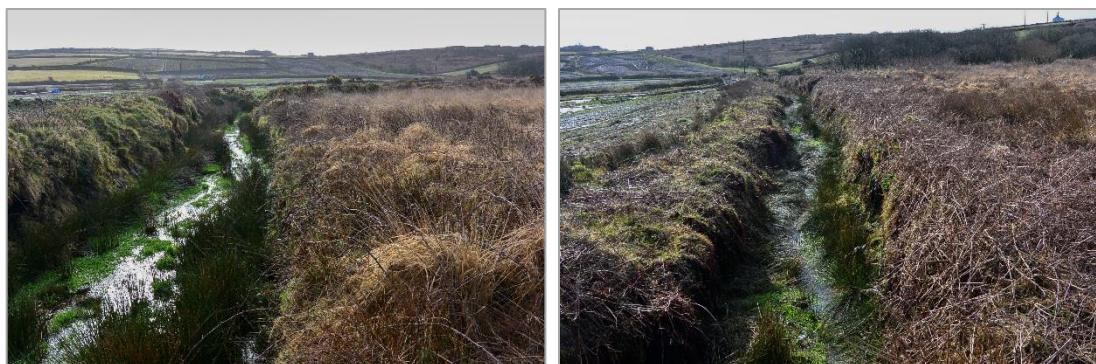
Figure 3.2-1. a) Wider (c. 5 m) ditch marking the northern part of the downslope boundary of the Southern Area, and b) the same ditch, although narrower (c. 2.5 m) further upstream on the southern part of the downslope boundary of the Southern Area. Note the light green instream vegetation in both cases, which could indicate nutrient enrichment.

The Southern Area slopes downwards in a north-easterly direction, downslope of the Cryor farm buildings. Its downslope, north-eastern boundary is the ditch (stream) ("11") which drains the southern part of the larger catchment. The ditch is 5 m wide x 1.5 m deep and was flowing at c. 15 l/s during the visit (Figure 3.2-1a); the width decreases to c. 2.5 m further upstream within the Southern Area (Figure 3.2-1b). Instream vegetation was a light green colour during the visit, which could indicate nutrient enrichment. It was not possible to ascertain during the visit whether the ditch floods onto the site.

The depth of water in the ditch was 0.1-0.2 m during the visit, and was therefore almost 1.5 m below the top of the bank on the western (site) side. An auger hole c. 30 m away from the ditch ("12") showed 0.2 m of black crumbly peat over damp, buff-coloured, stiff, clayey, gravelly (fine), silt (Figure 3.2-2a) to 0.4 m where the auger was refused by harder ground (increased gravel content?).

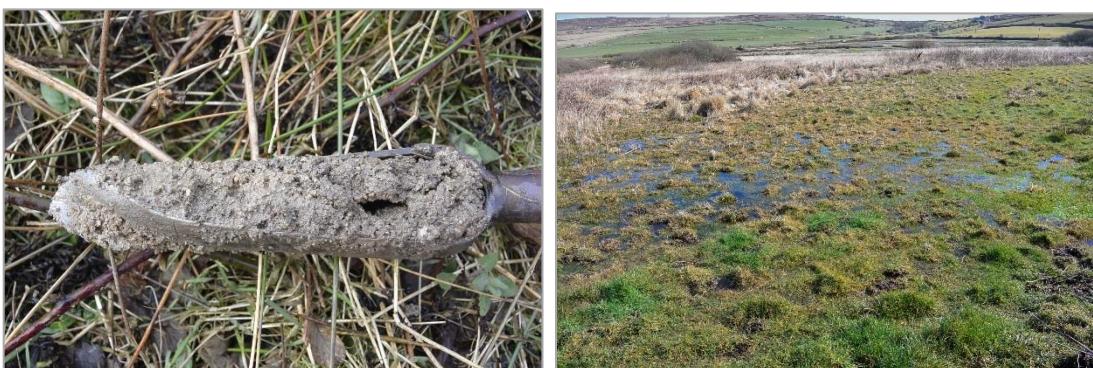
Figure 3.2-2. a) Damp, buff-coloured, stiff, clayey, gravelly (fine), silt sampled between 0.2 and 0.4 mbgl, beneath black crumbly peat, around 30 m from the ditch, and b) spring with quaking ground on the upslope (south-western) boundary of the Southern Area.

The vegetation within c. 15-20 m of the ditch had a notably drier aspect than further upslope, marked particularly by the presence of extensive bracken and brambles, and gorse (*pers comm.*, Richard Penny, during the field visit). This is consistent with the low water level in the ditch (relative to the ground surface within the site) having a drawdown effect on the water table within the site. Again, it is difficult to predict the magnitude and lateral extent of this effect with the available evidence (see comments in Section 3.1).

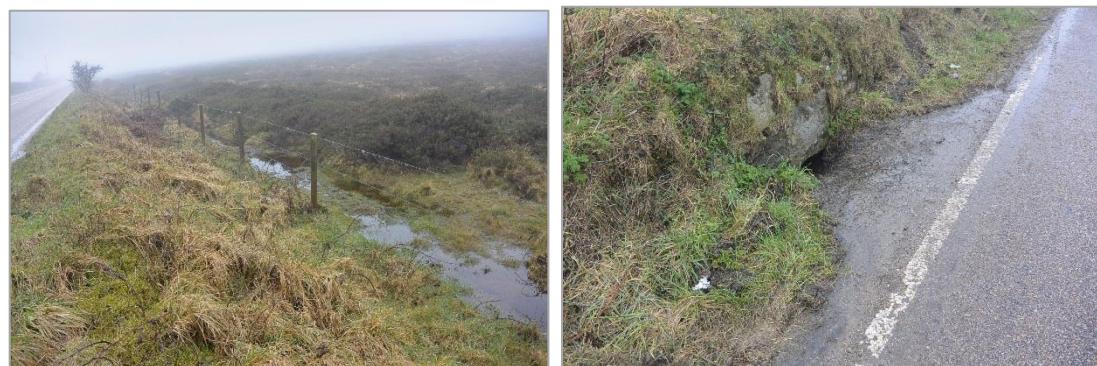
The South-eastern Area is bounded along its upslope, northern side ("15") by the B3318 road. Unimproved moorland extends upslope of this road to the catchment boundary, and after significant rainfall water was seen ponding against the upslope side of the road (Figure 3.3-1a); no cross-road culverts were observed during a brief inspection. Direct runoff from the road is allowed into the site through road-side culverts (Figure 3.3-1b).

Figure 3.3-1. a) Moorland upslope of the South-eastern Area and B3318, with water ponding against the road after significant rainfall, and b) roadside culvert allowing runoff from the road into the site.

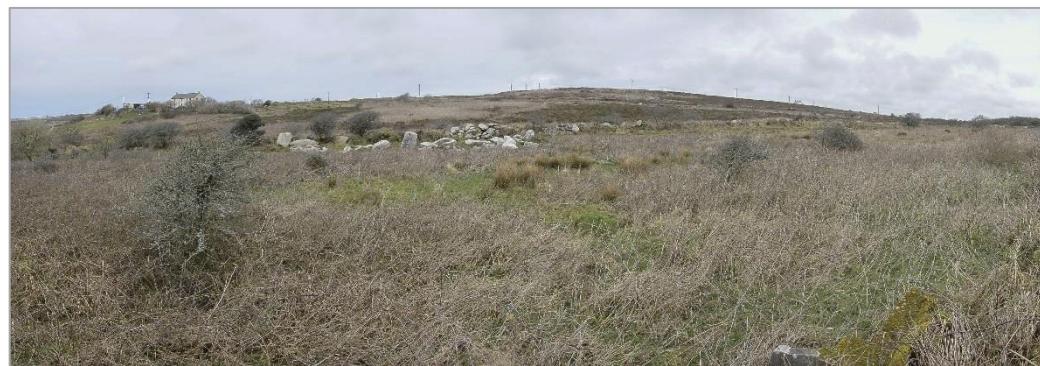
Figure 3.3-2 is a panoramic photograph of the South-eastern Area, taken from "16" in Figure 3.1-1 looking north-eastwards. The site is beyond the line of large rocks in the middle-ground, the latter being more-or-less coincident with the watercourse which has been deepened (*pers comm.*, Vaughan Robbins, during the field visit). The area is relatively steeply sloping (this is difficult to appreciate from Figure 3.1-1), which is thought to preclude any direct hydrological influence of the watercourse on the site, i.e. 1) no drawdown influence on the water table within the site, and 2) no flooding of the site from the watercourse.

Figure 3.3-2. Panoramic photograph showing the South-eastern Area, beyond the large rocks in the middle-ground.
