Natural England Commissioned Report NECR141

New Forest SSSI Ecohydrological Survey Overview

**New Forest SSSI
Ecohydrological Survey
Overview**

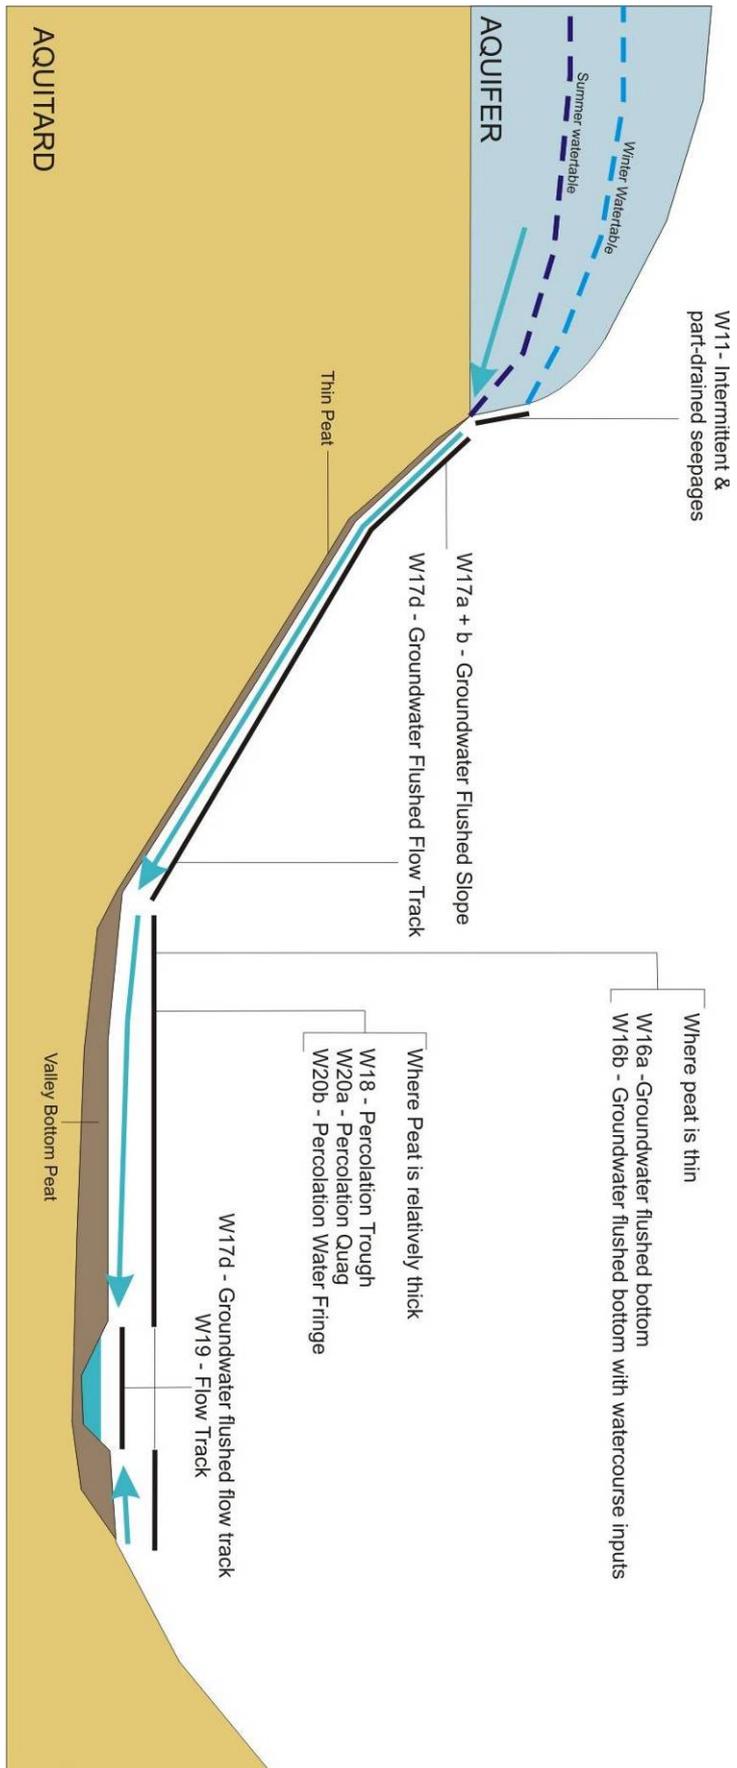
Figure 3-10: Flush Dominated Wetlands

Within New Forest types studied in this project, the Flush Dominated Wetlands are more common than the Seepage Dominated Wetlands. Valleys are frequently cut through bedrock aquitards (or relatively low permeability aquifers). On their upper slopes the valleys also often cut through relatively high permeability river terrace gravels. At the junction between these deposits a seepage line is commonly found. The groundwater from this runs downhill over the low permeability bedrock forming WETMEC 17 - Groundwater Flushed Slopes and supplying water to the valley basins and troughs below.

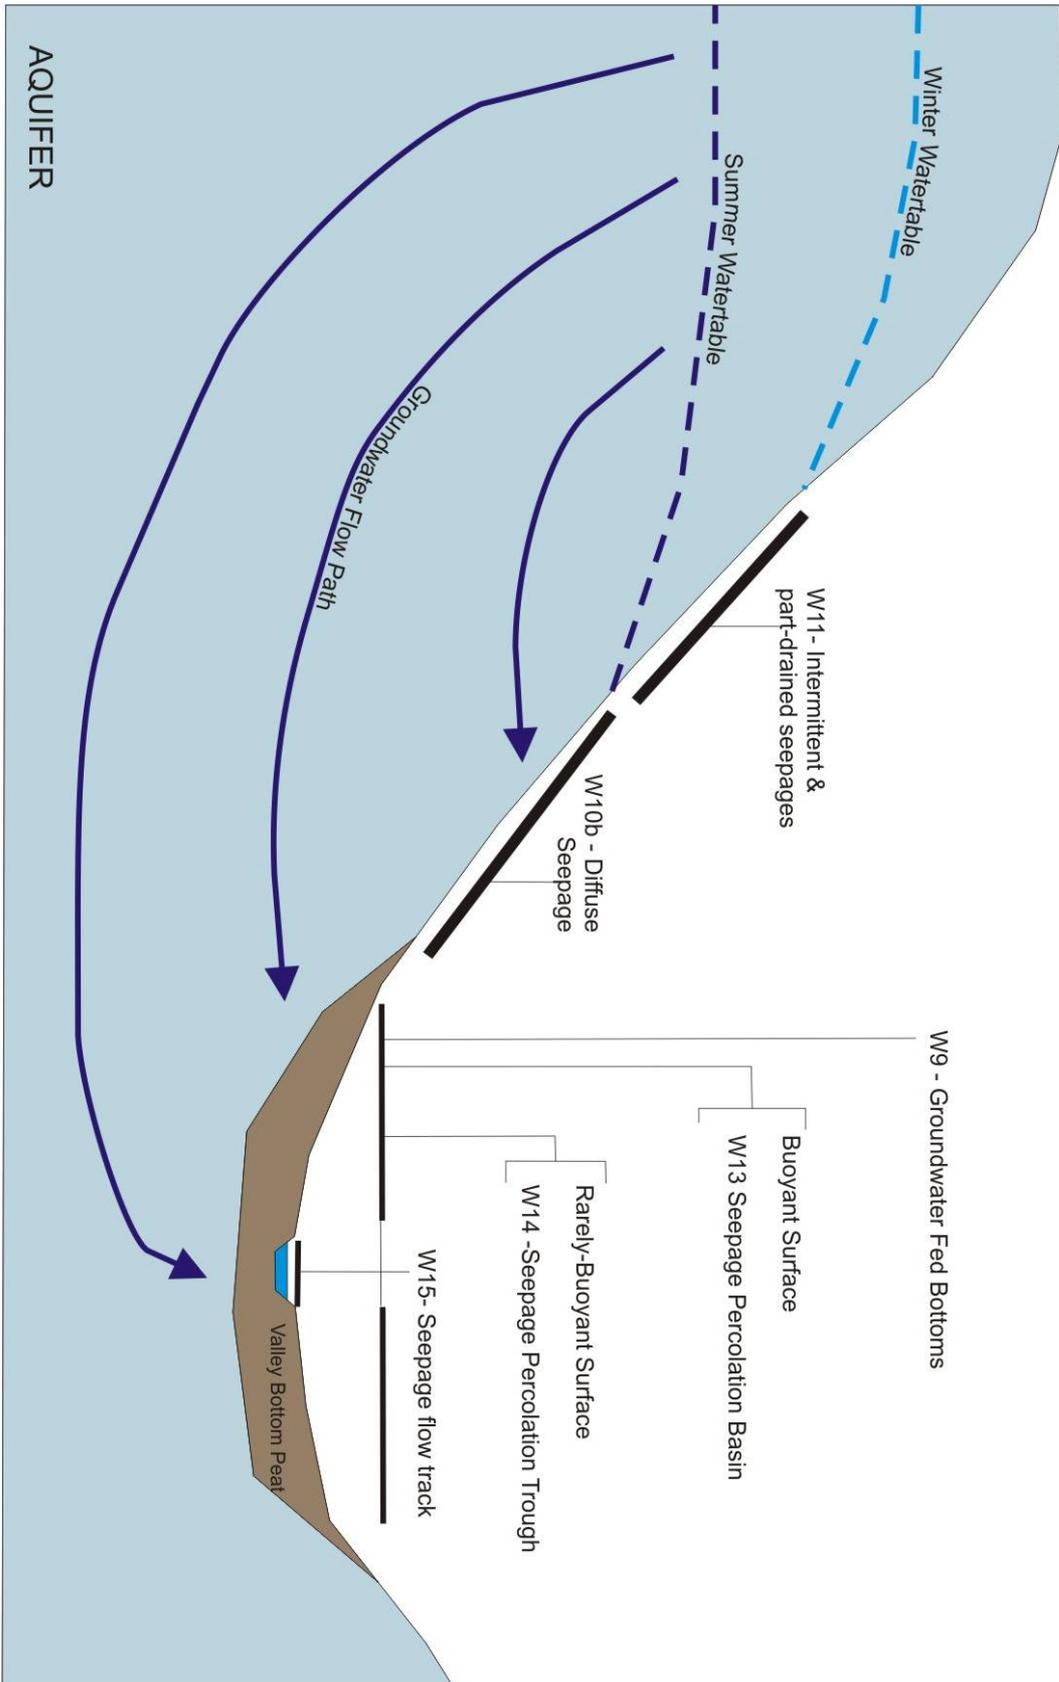
Figure 3-11: Seepage Dominated Wetland

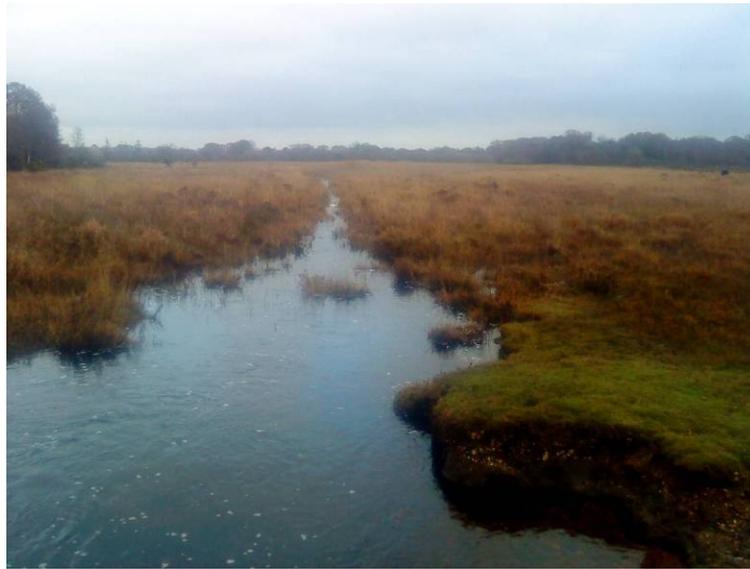
Figure 3-12: Valley Basin Central Drain on Hinchslea Bog

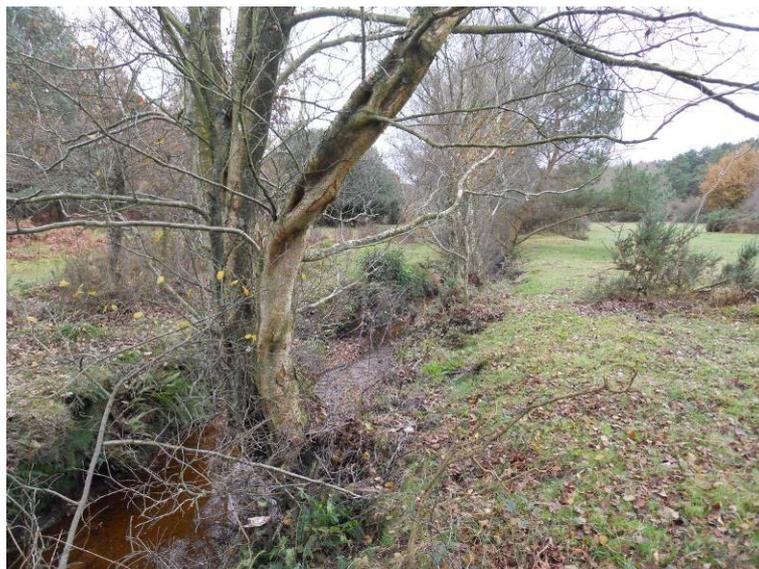
Figure 3-13: Enlarged, straightened and deepened valley basin stream at Millersford Bottom (with floodplain modified to wet grassland)

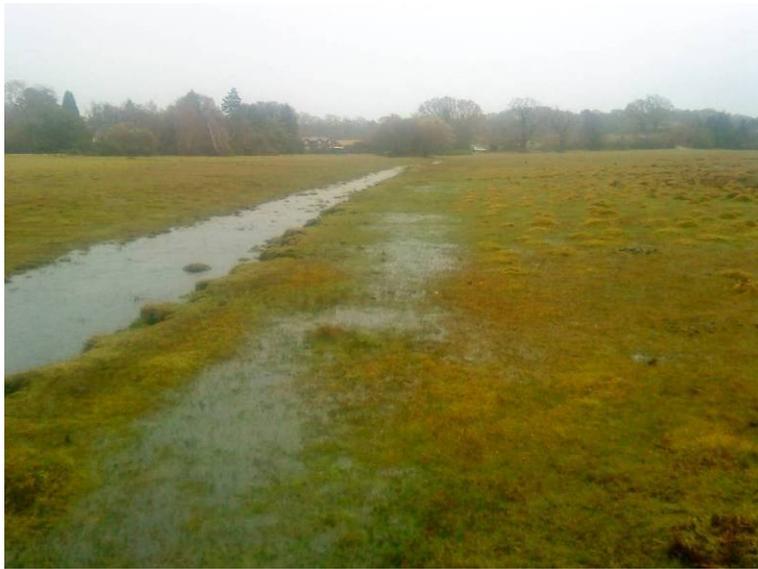
Figure 3-14: Drainage for lawn creation at South Weirs

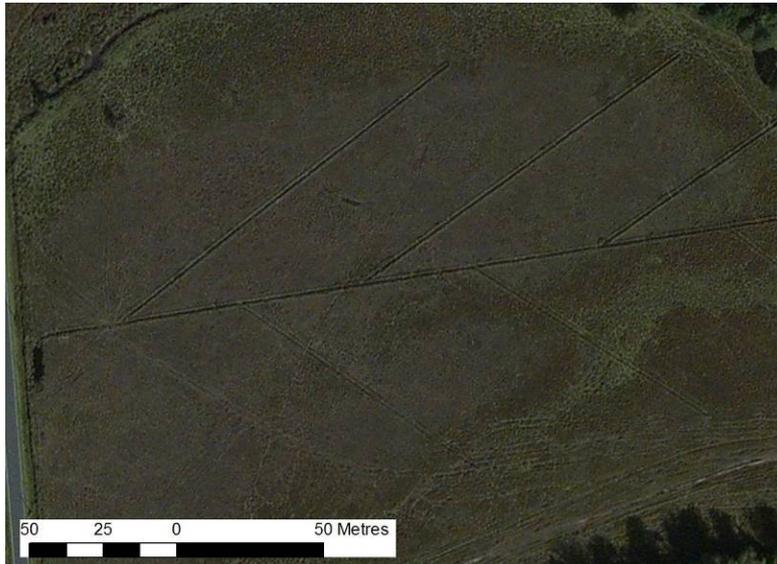
Figure 3-15: Aerial photography of herringbone drainage south of Dibden Bottom

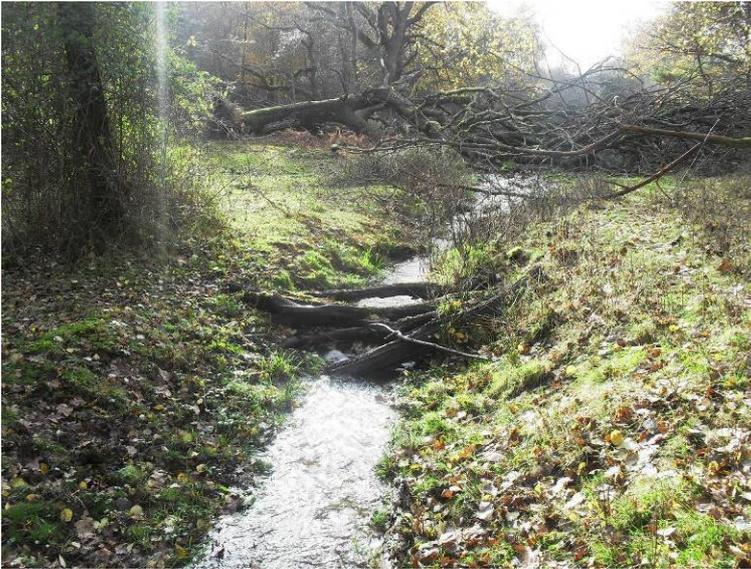
Figure 3-16: Ditch cut to drain a depression at Long Heath Mire

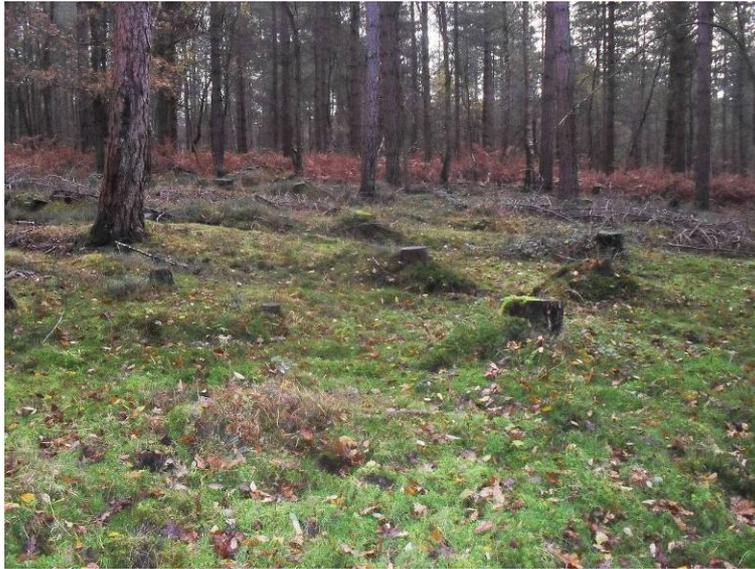
Figure 3-17: Forestry Drainage at Little Wooton Inclosure

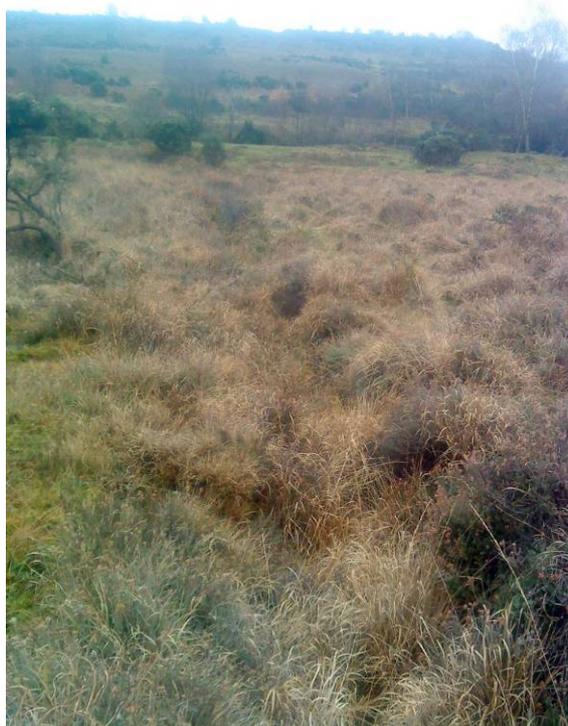
Figure 3-18: Regular valley side drainage at Millersford Bottom

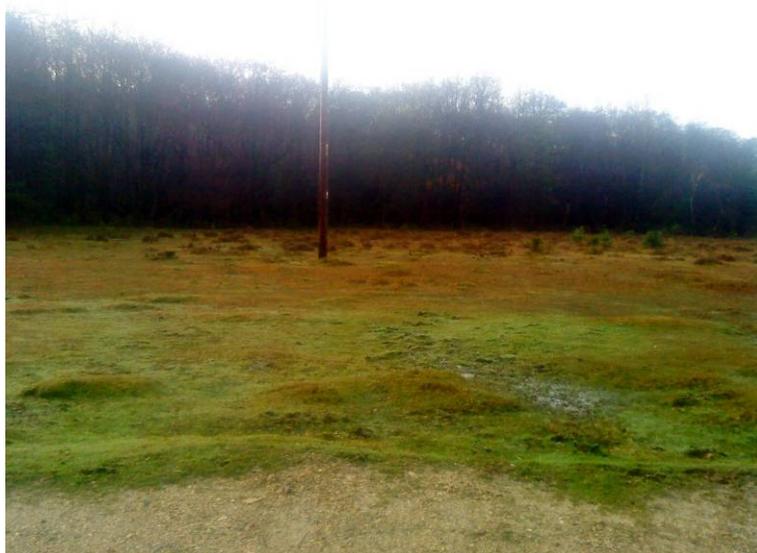
Figure 3-19: Path with culvert through (bottom right) collecting and focusing flush flows at Longdown Mire

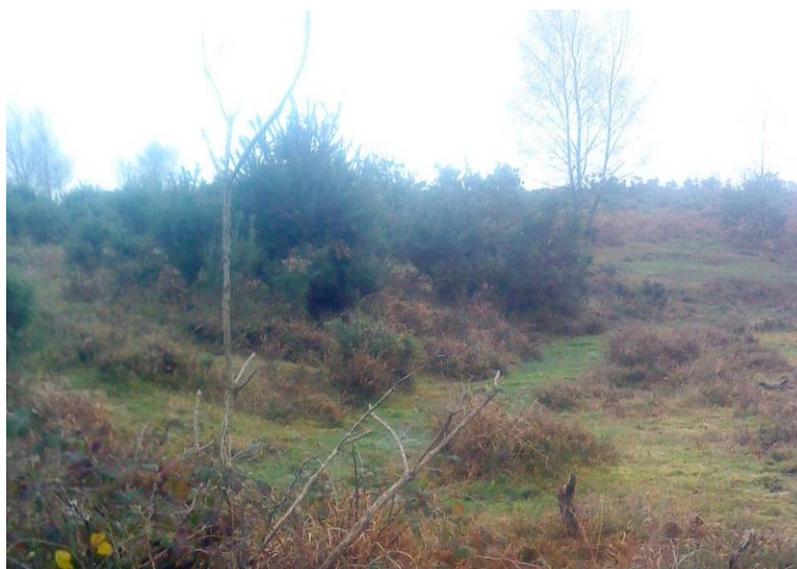
Figure 3-20: Historic parallel seepage collection drain at Sway Mire (bright green linear feature)

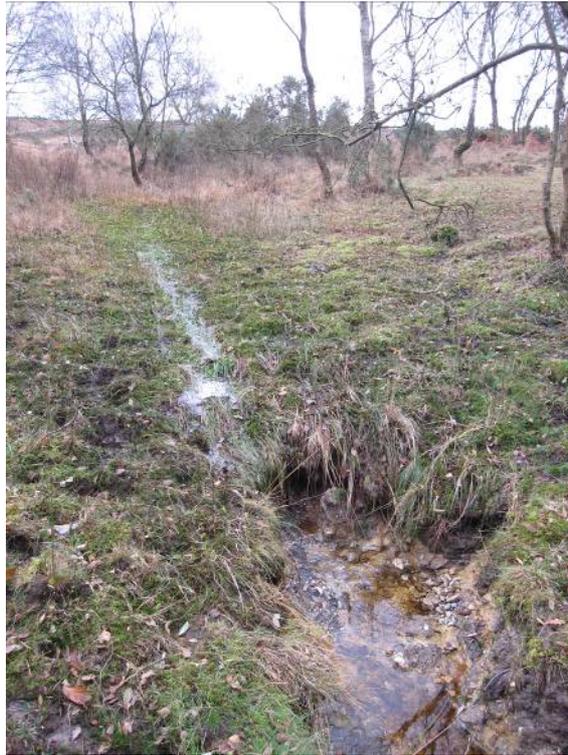
In all these situations natural processes can then act to enlarge the drains and cause headward and downslope erosion. In addition, footpaths (with or without deliberate drainage) can act to drain wetlands.

Figure 3-21: Headward Erosion on Vales Moor 2

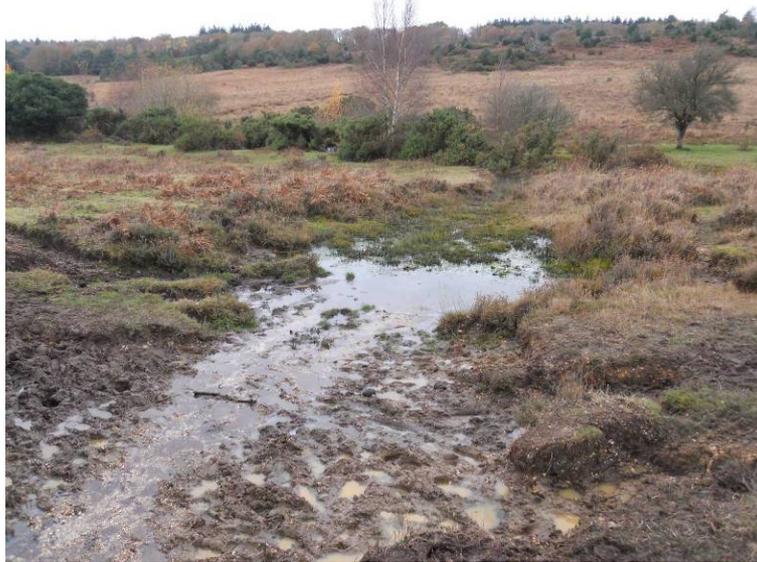
Poaching collapses the banks and can led to the spread of flows across a wider area. Where this wider area is formed from peat or peaty soils (or any easily erodible surface) significant local damage can be caused to the wetland, with vegetation cover completely removed over very localised areas. Fords can also cause deeper sections of streams to form which leads to headwater and downslope erosion.

Figure 3-23: Ford on a drain at Millersford Bottom leading to the collapsing of banks

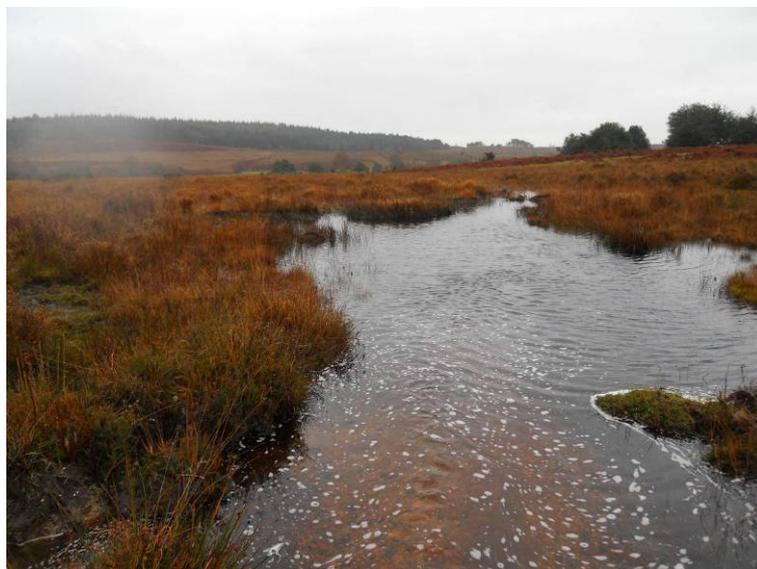
Figure 3-24: Animal fording point at Lay Gutter Valley leading to the creation of a large pool with head ward erosion

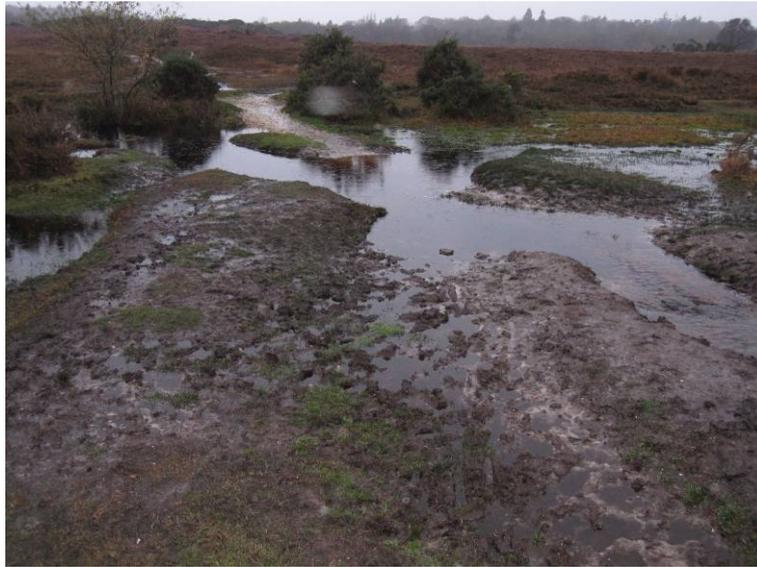
Figure 3-25: Poaching and footpath erosion causing significant problems across watercourse at Whiteshoot Bottom

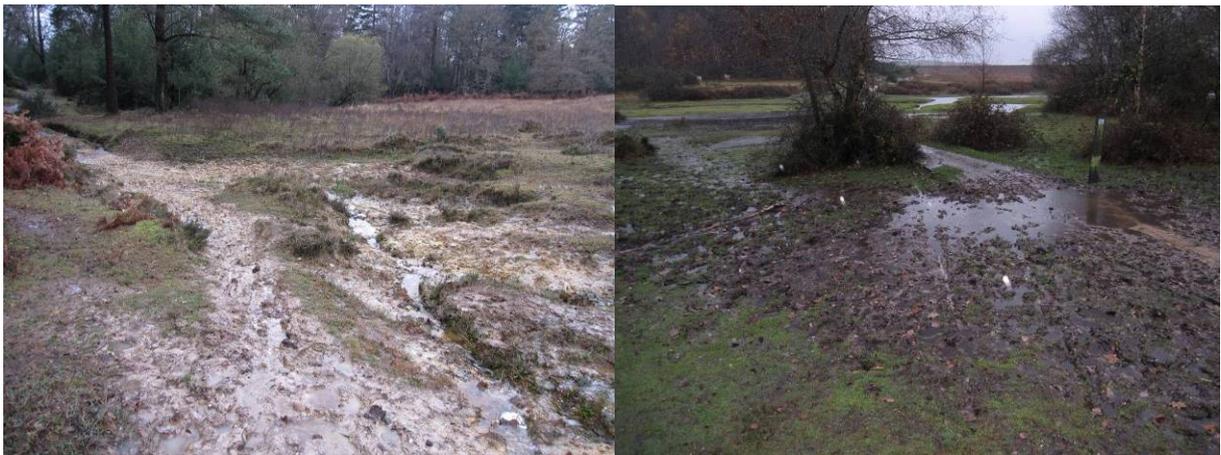
Associated with the crossing points of footpaths, water was frequently observed to pond, both upstream and downstream of the structures, as the current structures present an impediment to the movement of water. Where water has ponded, the mire community has frequently been replaced by a much wetter, bog pool over a localised area usually upstream of the structure. Downstream there may also be ponding due to the deposition of material eroded (scoured) from around the structures themselves.

Figure 3-26: Significant footpath erosion in unit 341 (left) and near the car park in the north of Dibden Bottom (right)

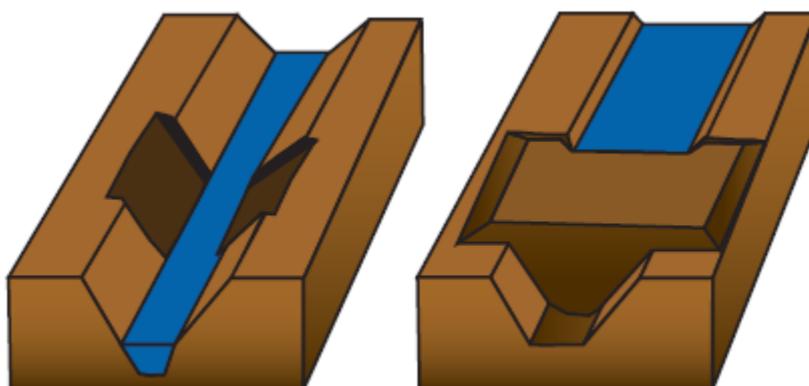
Where a drain is cut through peat, with no mineral substrate revealed, plugs of earth and stone may contaminate and change the vegetation. In many cases, peat plugging is likely to be the best solution. This involves a 'peat plug' being placed in the drain to effectively block the flow and dam surface water upstream from that point. The peat plug material is cut out by machine close to the dam.

Figure 3-3031: Installation of a peat plug (from Quinty and Rochefort, 2003)

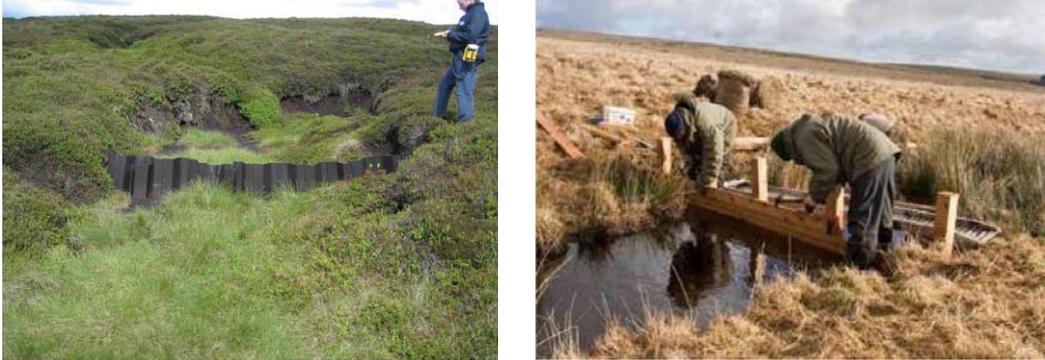
Surface water from flashy storm events enter gullies and cause erosion, thus structures used in their restoration must be able to stand running water passing over them. Many types of simple plugs are not suitable as they are easily washed away. Evans *et al.* (2005) consider that both plastic piled and wood dams are suitable techniques for blocking gullies (Figure 3-32).

Figure 3-32: Plastic Sheet Pile Dam (left) and Wooden Pile Dam (right) (from Evans *et al.*, 2005 and http://www.exmoor-nationalpark.gov.uk/wetland_award_project_final_report.pdf)

Both plastic (including recycled plastic) and wooden dams have their advantages and disadvantages. Wooden dams tend to be more expensive than plastic dams, and are harder to install in remote locations because of their weight. However, their overall visual impact may be less. In addition to this, plastic dams can be built taller than wooden ones which means that they can be spaced further apart. Within the proposed restoration scheme, only plastic dams are referred to, however, depending on several factors, those who install the dams may prefer in some instances to install wooden dams instead (especially if the wood is readily available locally).

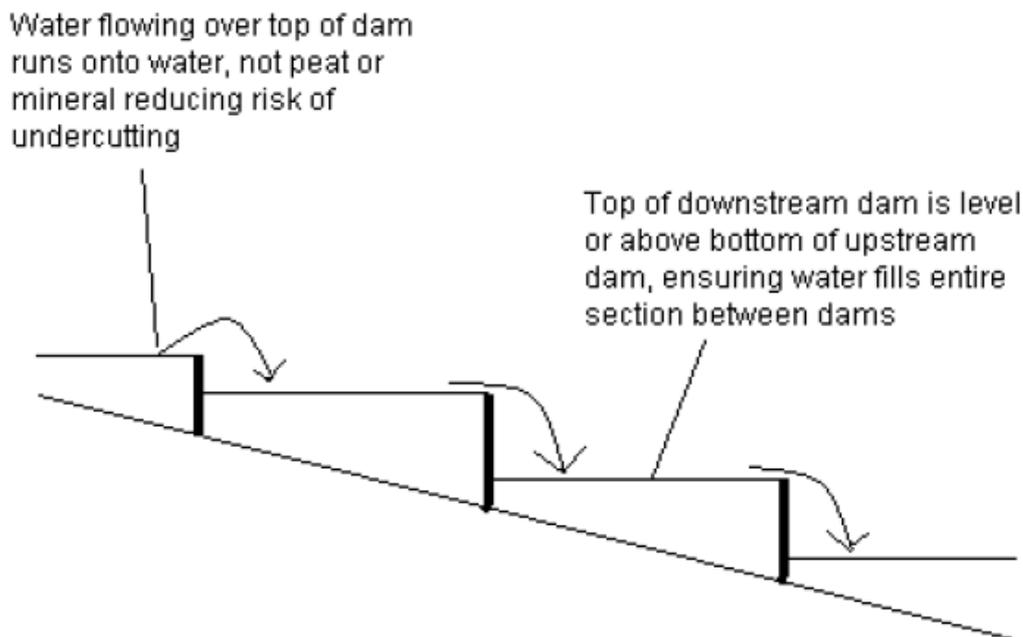
The spacing of plastic/wooden dams along the length of the gully is important. They should be placed such that the water spilling over a dam hits the surface of the pool created by the next dam further downstream rather than bare ground, as this would cause erosion and undercutting of the dam (Figure 3-33). Some erosion is still likely to happen when heavy rainfall following a dry period, where downstream pools are not filled up, but the degree of erosion will be restricted.

Figure 3-33: Spacing of Dams in a Gully (from Evans *et al.*, 2005)

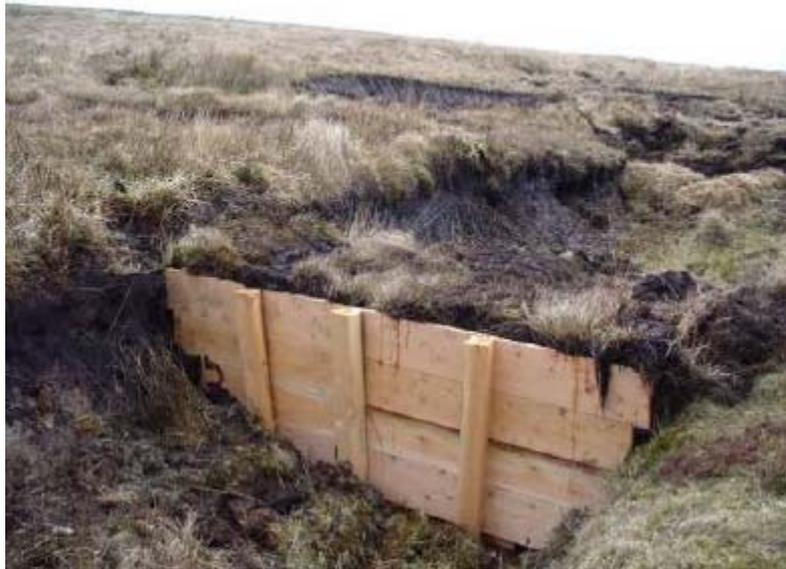
It is important to seal the seams and/or reinforce the dams on their upstream surface with a peat plug (see Figure 3-34).

Figure 3-34: Peat Use to reduce the permeability of a dam (from http://www.exmoor-nationalpark.gov.uk/wetland_award_project_final_report.pdf)

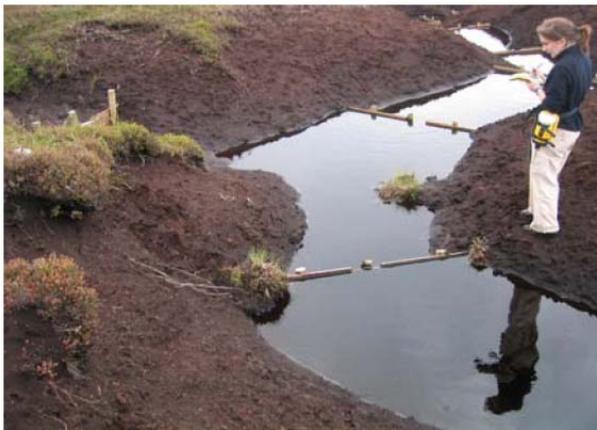
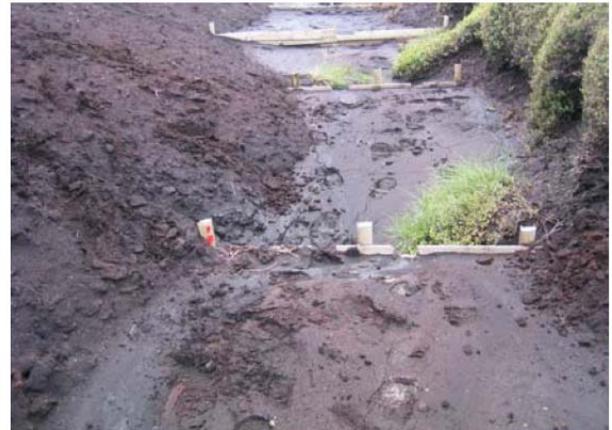
Successful gulley damming a should result in sediment build up behind the dam and in certain situations revegetation (see Figure 3-35 and Figure 3-36)

Figure 3-35: Infilling of a gulley with sediment behind wooden dams (from Evans et al., 2005)

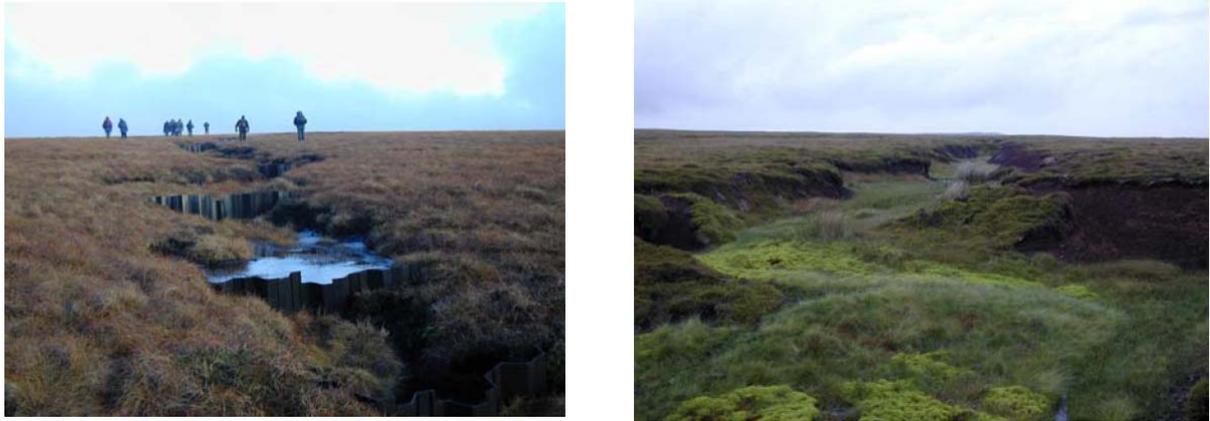
Figure 3-36: Infilling a gully with vegetation after the installation of plastic sheet piling (from Evans et al., 2005)

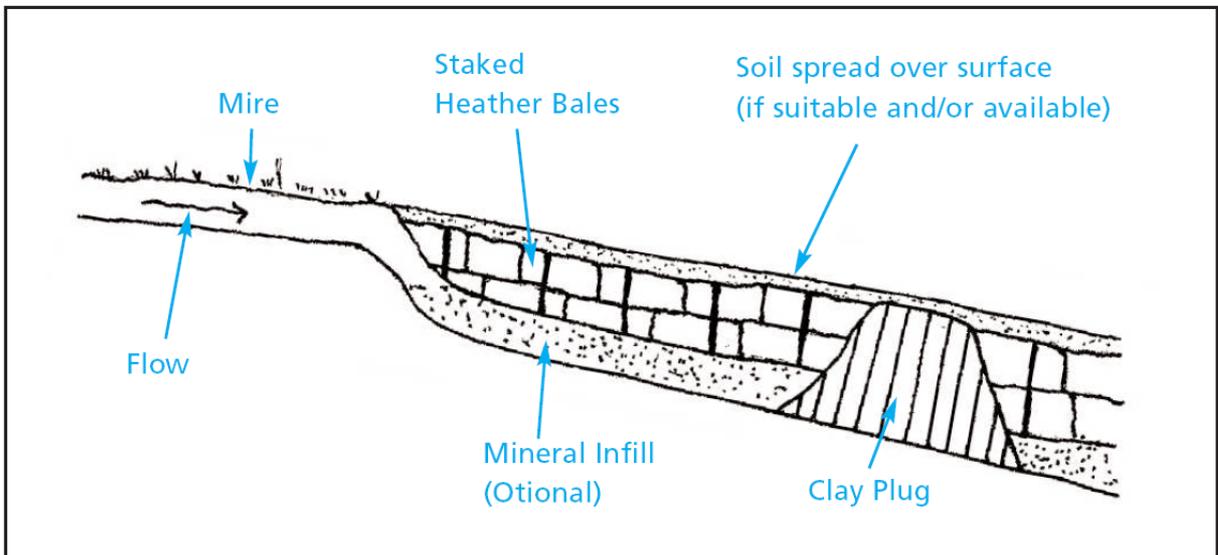
An alternative to regular dams along a gully is infilling. In the New Forest, this has been trialled already using heather bales and clay plugs (Forestry Commission, 2006) (see Figure 3-37). This immediately limits the impact of gullies on draining mires; however, their continued success is dependant on the heather bales withstanding the erosional force of water that may continue to run over the new raised surface of the infilled gully line (see Figure 3-38).

Figure 3-37: Gully Infilling Technique (Forestry Commission, 2006)

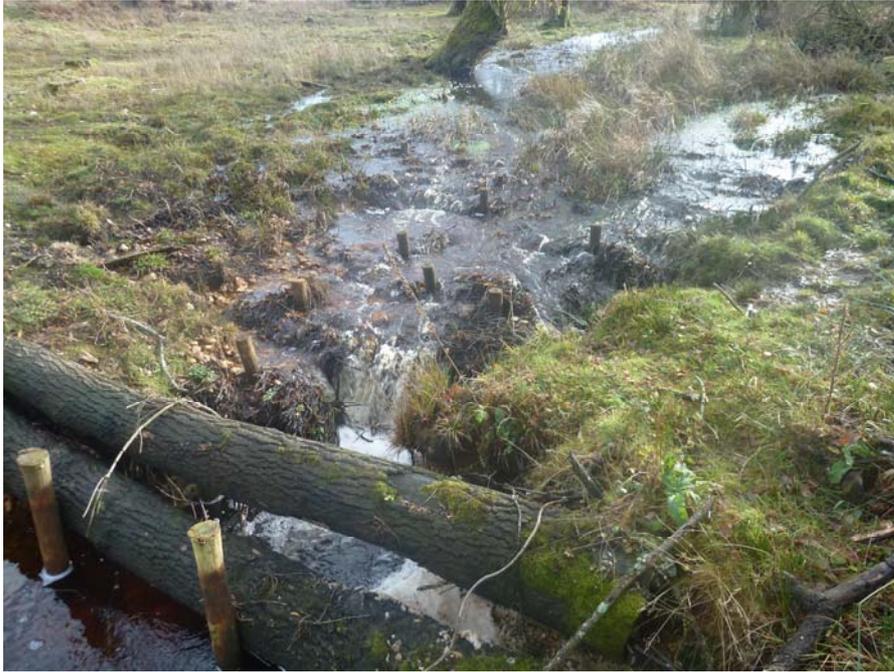
Figure 3-38: A failing staked heather bale infill in SSSI Unit 95

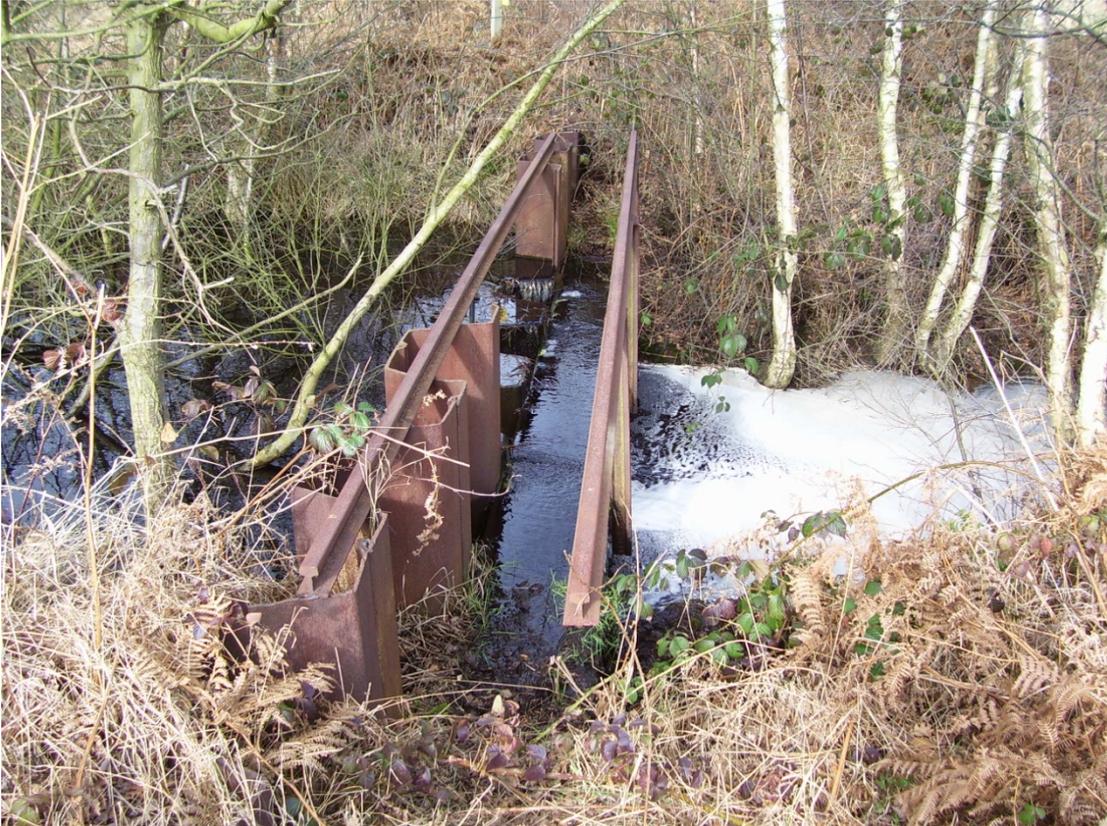
Figure 3-39: An example of a simple steel sheet pile dam on Thorne Moors (Photograph A Jones)
