# Northey Island set-back scheme Report 2 August 1991 to January 1992

Institute of Estuarine and Coastal Studies
University of Hull
February 1992

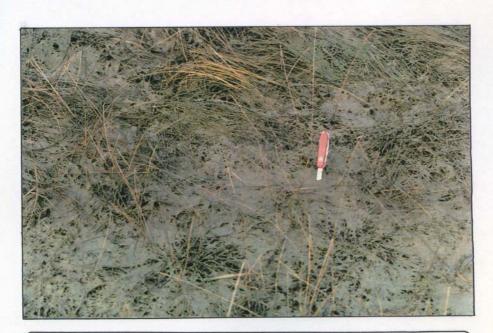
There has, however, been a significant amount of accretion of sediment over the surface of the vegetation on the setback site, as shown in plate 2. This is somewhat irregular in distribution but the measurement of sediment accumulated on one vegetation sample recorded 0.078g of sediment per square cm. Assuming a density of 1.6g cm<sup>-1</sup>, and a void ratio of 0.6 this weight of sediment would result in a vertical accretion of 0.0748cm over the 6 month period.

Plate 2. Accretion of marine sediments on the vegetation

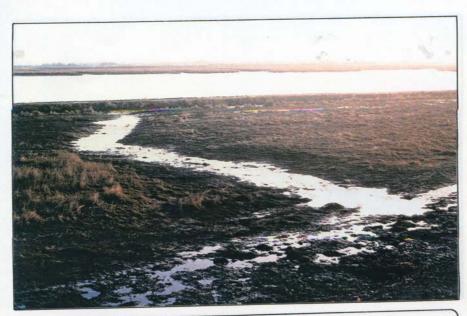
The single relic creek through the centre of the site remains in the same conformation, following the same course as recorded during the original survey, with a depth of 20cm as before. During the early stages of the flood tide this creek carries the flow to the back of the marsh, then spilling into the rear borrow pit which spreads the flood water along the back edge of the site. This is shown in plates 3 and 4. Similarly the borrow pit immediately behind the original sea wall carries water to the western end of the site before the main area of marsh is covered. The two borrow pits are therefore altering the pattern of flow from that which would be expected in the drainage topography of a normal saltmarsh site.

Plate 3. Relic creek with standing water through the centre of the site

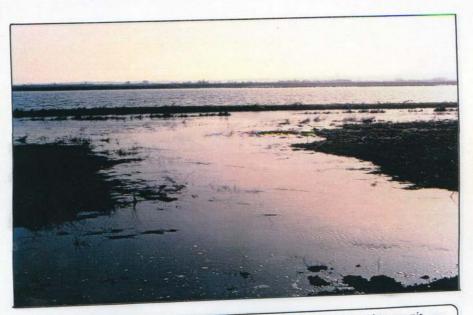
Plate 4. Flow of flood water through the relic creek and into the rear borrow pit

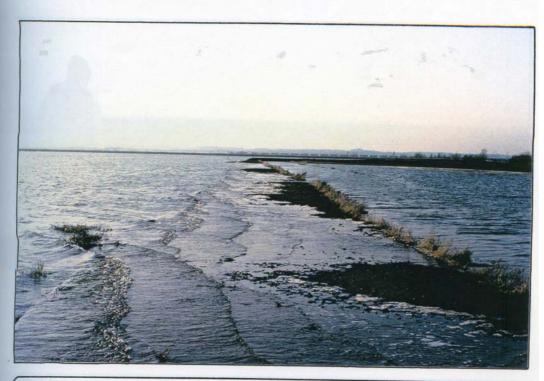
Plate 5 shows that the height of the spillway, combined with the patterns of flow through the creek and borrow pits means that most of the set-back site is covered before the water tops the front wall.

Plate 5. The surface of the set-back area is covered before waves break over the front wall

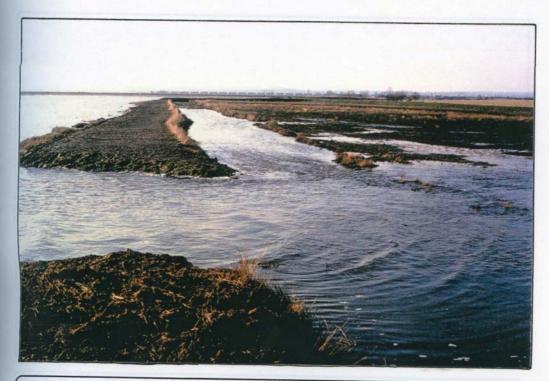
Observations during visits to the site indicate that tide rates entering the site are faster than the predicted 15cm/sec, possibly causing ripping around the edges of the spillway. This is demonstrated in plate 6 which was taken at the east end of the site looking west across the spillway during an early stage of the rising tide. This shows

waves breaking around the corner of the spillway and fast currents running into the borrow pit behind the outer wall. Later in the rising tide, as shown in plate 7, when the surface of the site is covered, the flow continues to be fast around the corner of the spillway but there is a still area immediately behind the wall over the line of the borrow pit with the current sweeping in a wider curve over the marsh surface.

Plate 6. Early rising tide showing current flow around the edges of the spillway and into the front borrow pit

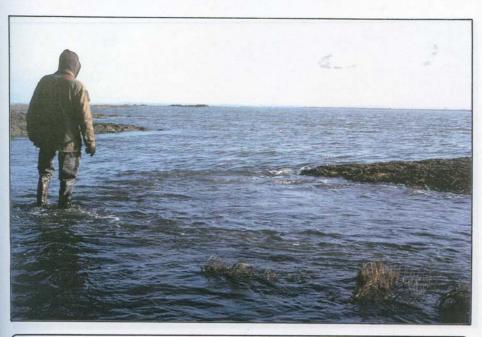
Plate 7. Mid tide currents fast through the spillway and around the borrow pit, but now calm over the borrow pit itself

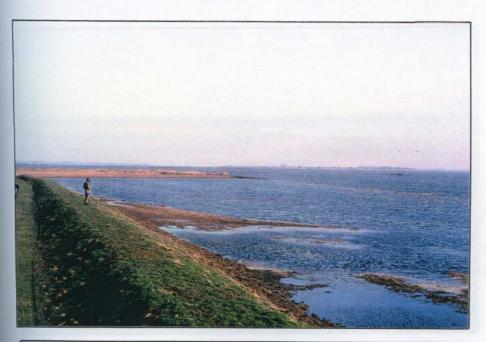
Plate 8 shows the extent of a spring high tide demonstrating which areas at the back of the marsh are not normally covered. The bank-full situation is shown in plate 9. It is important to note the waves breaking on the original sea wall at the front of the site, which is therefore protecting the seaward edge of the marsh from these erosive forces.

Plate 8. Extent of later stages of a spring high tide showing the high marsh areas which are covered least often

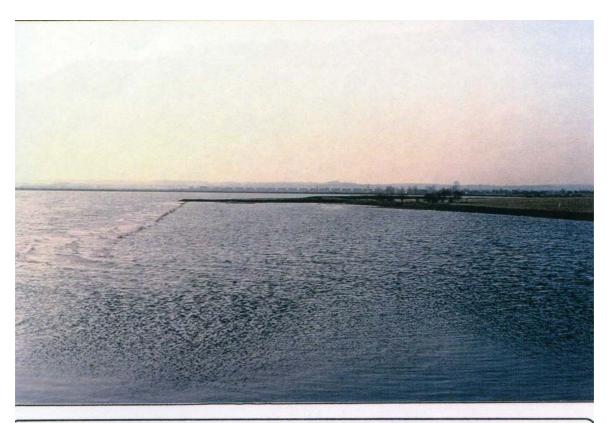
Plate 9. Bank-full situation showing waves breaking on front wall and wave refraction through the spillway

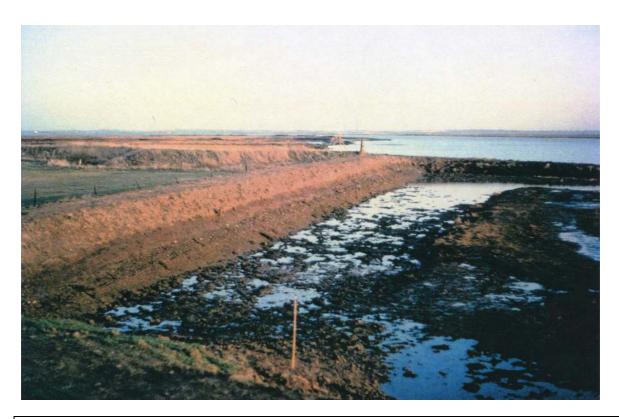
The current velocities, possibly combined with winds generated across the site may be responsible for the observed erosion of the enclosing wall at the east end of the site. Plate 10 shows the height of the tide up this wall, the worst erosion occurring at the far end of the wall on this photograph. Plate 11 shows an example of the erosion in this area which extends intermittently with varying degrees of severity for approximately 10m. Plate 12, taken at high tide, shows that there is seepage through lower parts of the wall in the same general location as the eroded sections described above.

Plate 10. Low water at the east end of the site, showing the high water mark on eastern wall.

Note tide marker post in the foreground

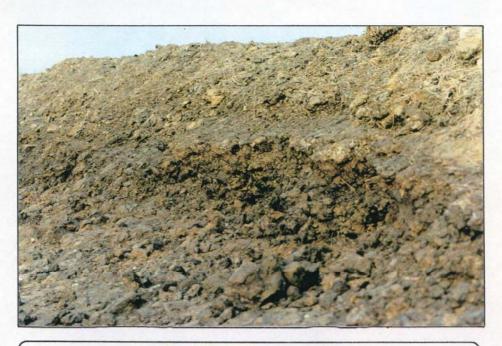
Plate 11. Erosion of the eastern wall

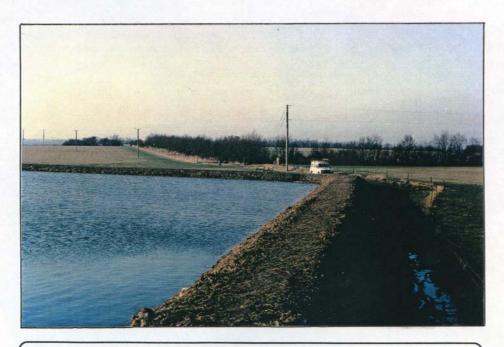
Plate 12. High tide at the east end of the site showing seepage through the eastern wall
