Natural England Commissioned Report NECR140

New Forest SSSI Geomorphological Survey Overview

Annex E: Picket Bottom Restoration Plan - SSSI Unit 91

1 Picket Bottom Restoration Plan - SSSI Unit 91

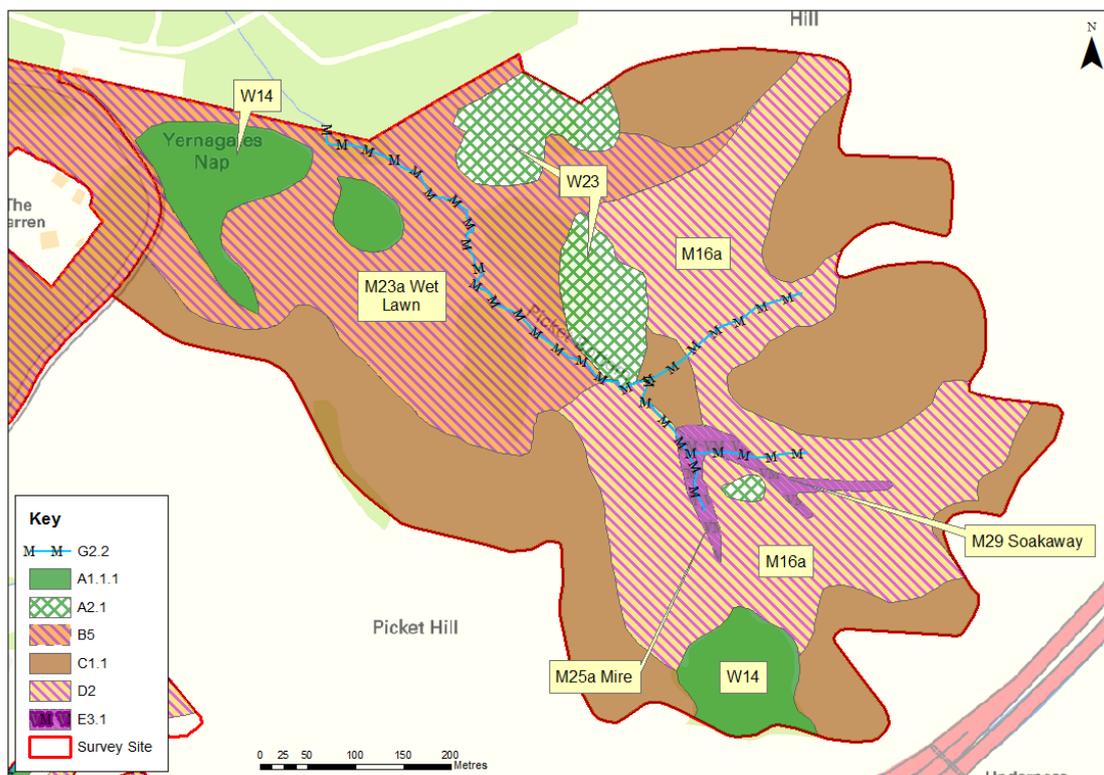
Figure 1-13: Phase 1 Habitat Map

The mire and wet heath habitats appear to be degraded and reduced in extent due to the effects of drainage. However, the valley mire habitat on the higher ground, at the upstream end of the unit, was in good condition with extensive areas of Purple Moor Grass *Molinia careulea* dominated mire.
