Natural England Commissioned Report NECR140

New Forest SSSI Geomorphological Survey Overview

Annex G: Roe Inclosure South Restoration Plan - SSSI Unit 117

1 Roe Inclosure South Restoration Plan - SSSI Unit 117

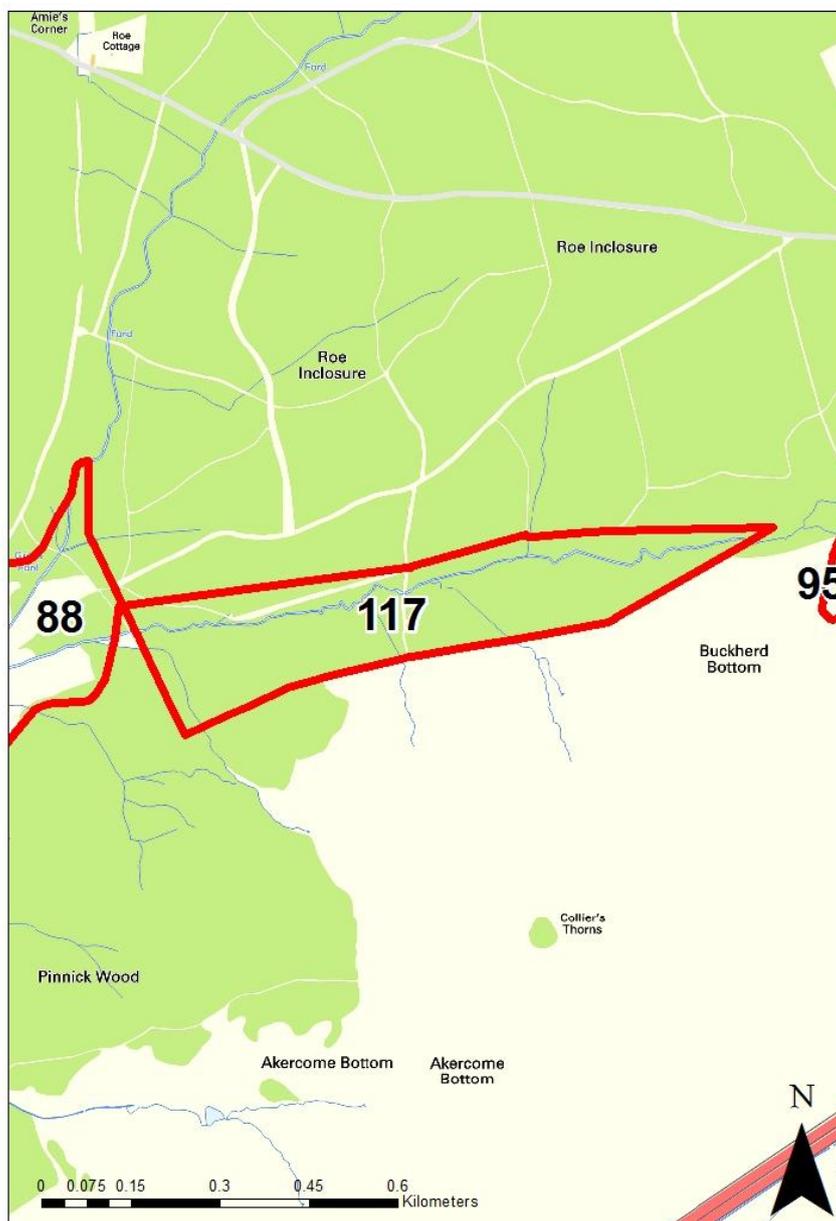
Figure 1-1: SSSI Unit 117 location (flow direction is right to left)

Roe Inclosure South (Unit 117) is one of the tributaries feeding the Linford Beck in the downstream SSSI unit 88 (Figure 1-1). The SSSI unit is considered to be in an unfavourable recovering condition. It is approximately 15.78ha in size.

It is essential that incision in the downstream 88 SSSI Unit (Linford Beck) is also mitigated as any works undertaken with Unit 117 risk being compromised in the future if this is not undertaken. It is also important that incision within this unit is managed to reduce the risk of continued upstream incision propagation impacting Unit 95 upstream.
