Natural England Commissioned Report NECR143

Latchmore Brook Restoration Options Appraisal

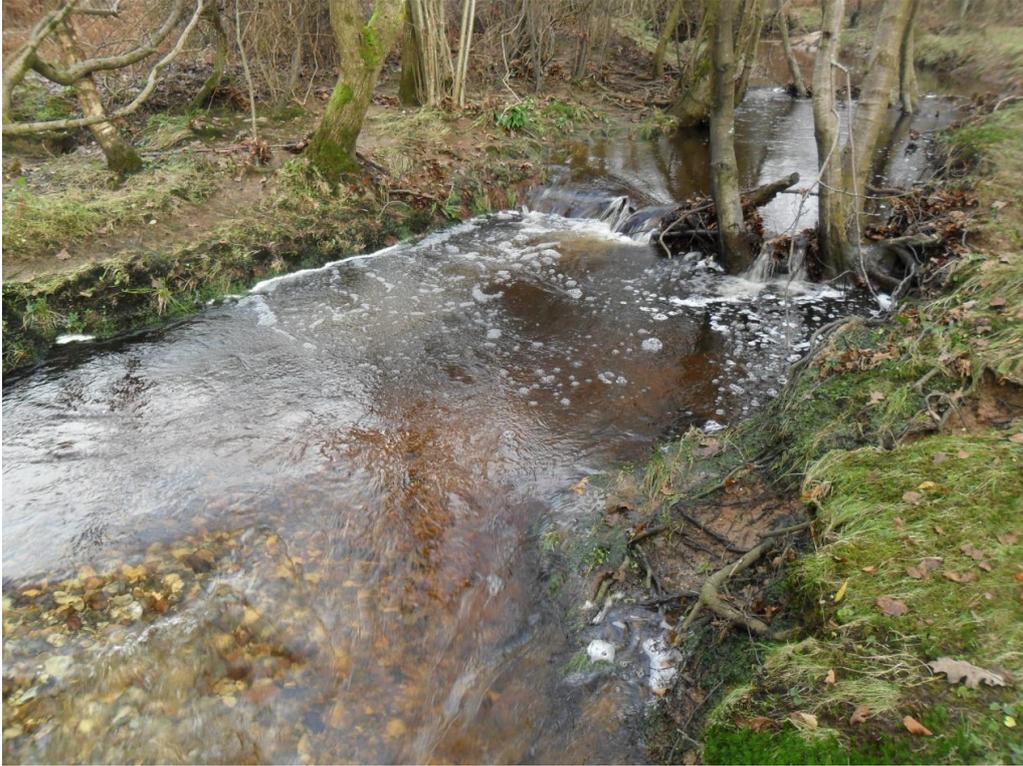
Figure 2-2: Weakly anastomosed lower course of Latchmore Brook SSSI Unit 48

- A weakly anastomosing lower course characterised by a wooded local floodplain and multi-channel flow network (Figure 2-2).
- A single thread mildly incised channel running through floodplain woodland with disconnected palaeo-channel features including a well defined sinuous single thread channel on the left bank (Figure 2-3).

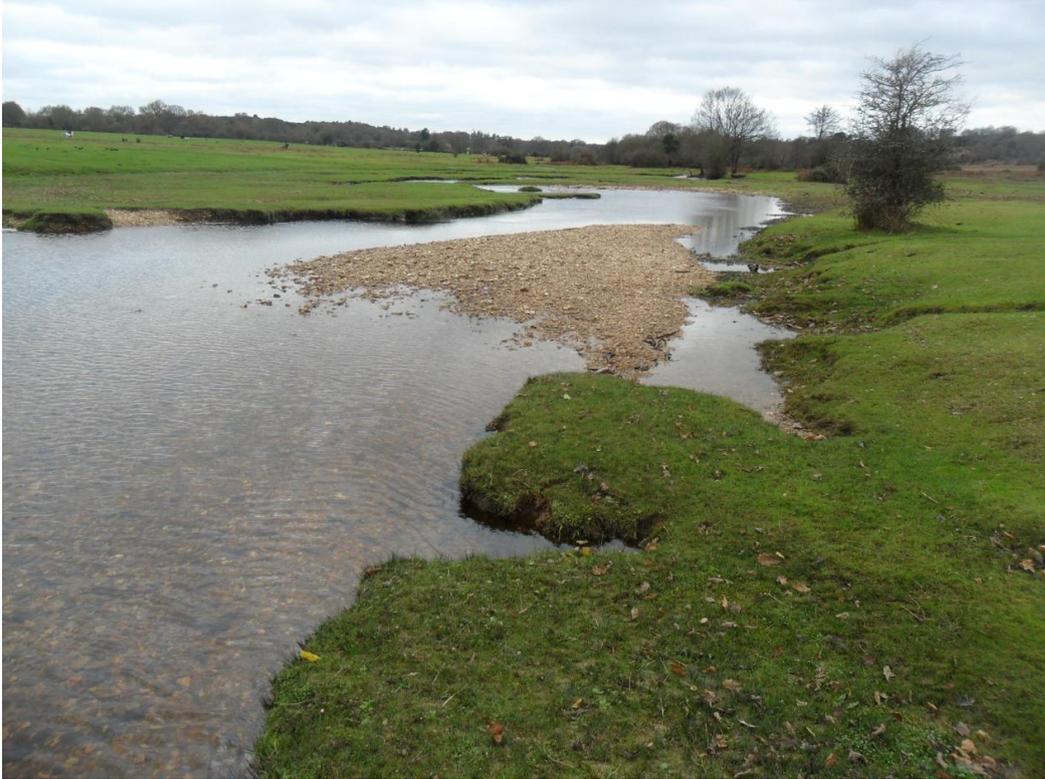
Figure 2-4: Stabilised wandering reach of Latchmore Brook SSSI Unit 48

- A stabilised wandering reach characterised by an inset floodplain and numerous vegetated gravel bars dissected by a shallow dominant channel and several sub-channels all with abundant mobile gravels accumulating as shoals and more permanent riffle zones (Figure 2-4).

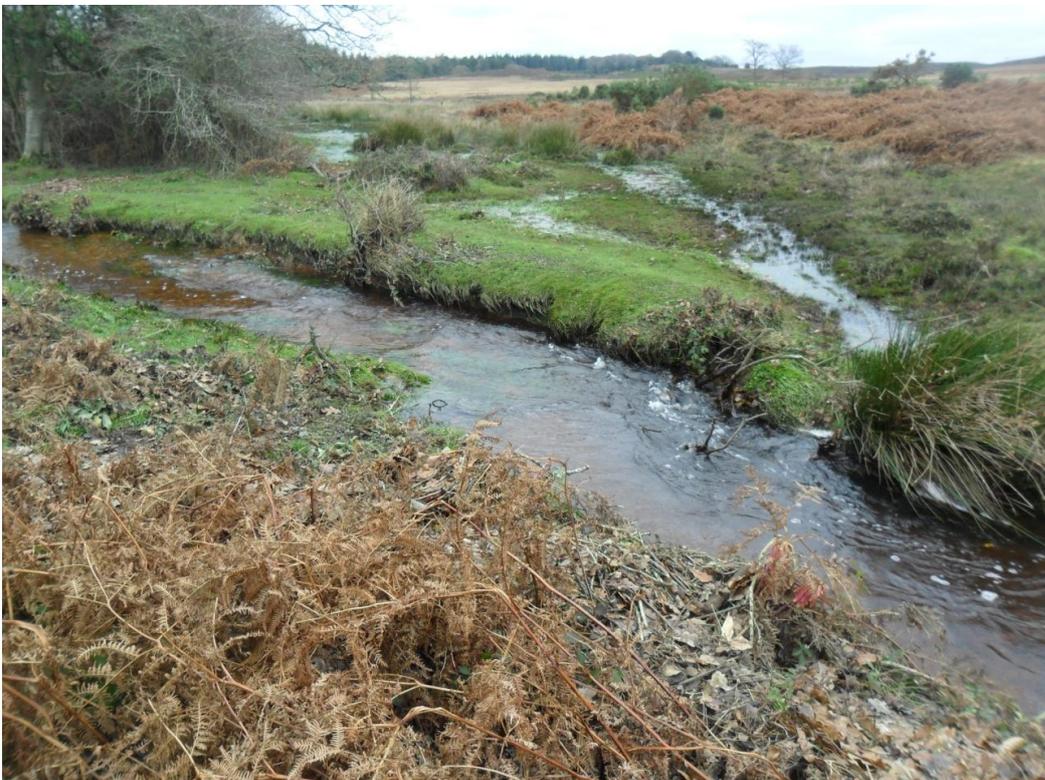
Figure 2-5: Prominent palaeo-channel associated with Latchmore Brook SSSI Unit 48

- A second incised single thread reach again with abundant mobile gravels accumulating as mid channel bars and riffles. Floodplain palaeo-channels are prominent in places (Figure 2-5).

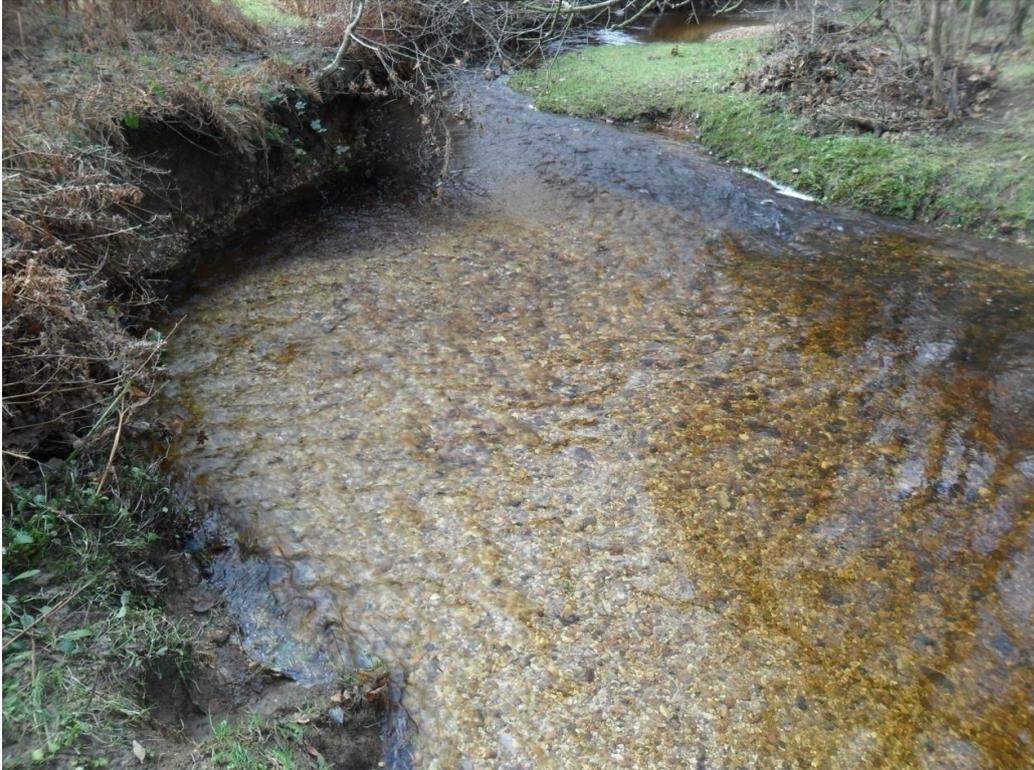
Figure 2-6: Plane bed single thread reach of Latchmore Brook SSSI Unit 48

- A short 'infilled' plane bed single thread reach characterised by a shallow, generally uniform, mobile gravel bed and strong floodplain connectivity (Figure 2-6).

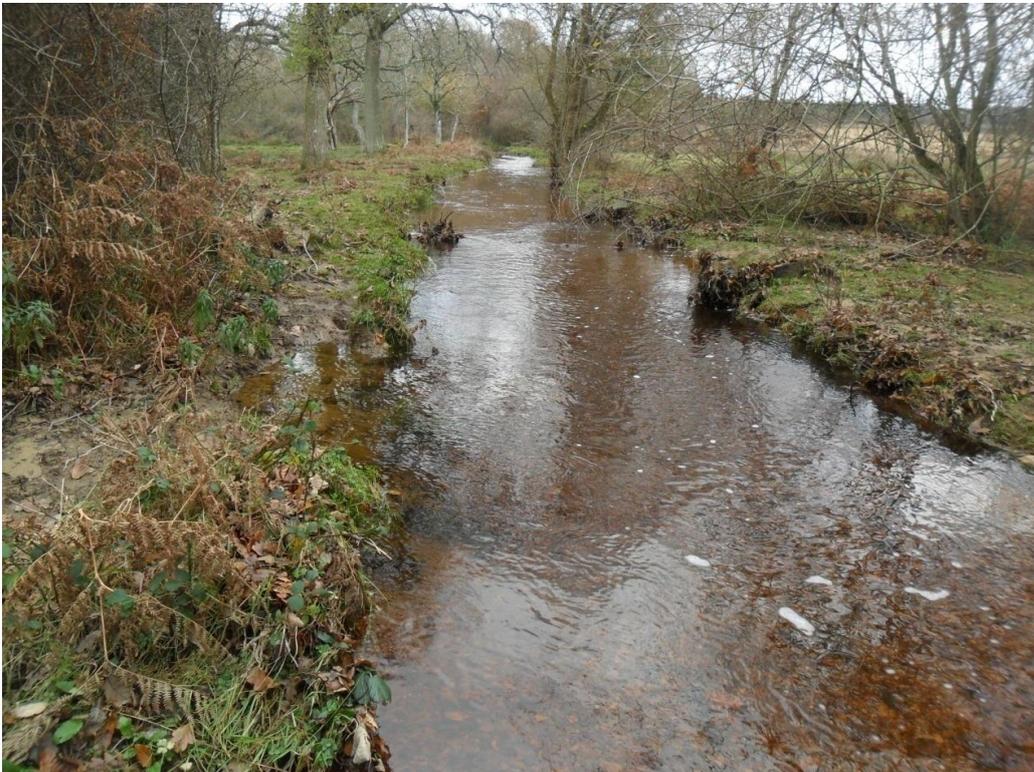
Figure 2-7: Forested single thread reach of Latchmore Brook SSSI Unit 48

are prominent in places. This channel type extends into the plantation woodland where the channel has also been straightened historically and a prominent left bank palaeo-channel can be traced (Figure 2-7).

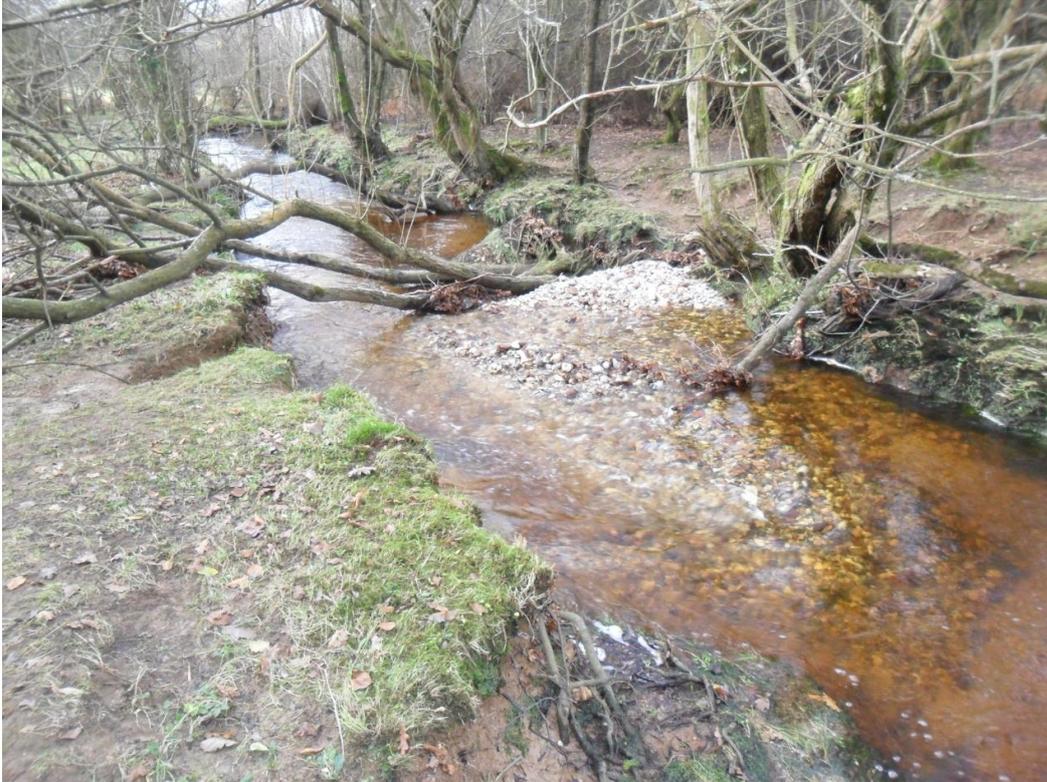
Figure 2-10: Woody Debris on Latchmore Brook

Floodplain connectivity improves through anastomosed reaches within the wooded lower section of the SSSI unit, although several channels remain disconnected from the main channel. The anastomosed network is assisted by debris dams which have provided local improved floodplain connectivity (Figure 2-210).

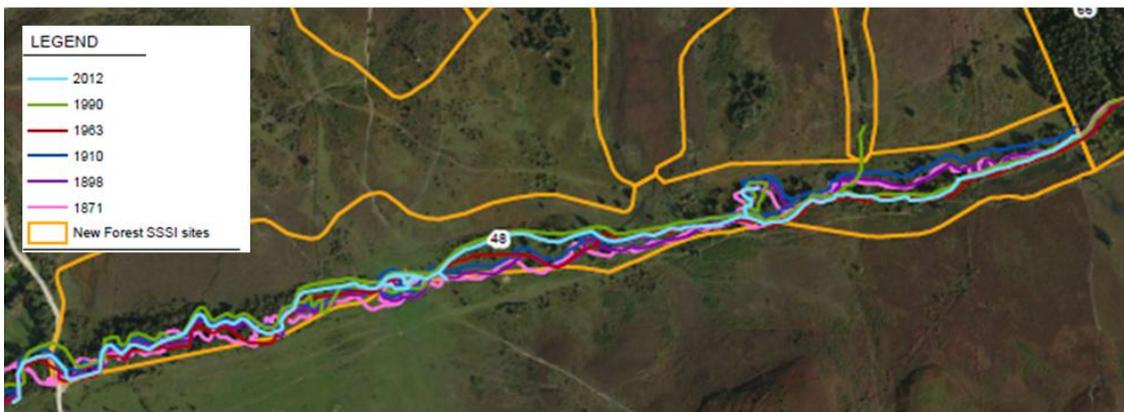
Figure 2-11: Historic channel position of Latchmore Brook based on Ordnance Survey mapping

Historic Ordnance Survey mapping of the Latchmore Brook (Figure 2-11) indicates that the channel has been subject to natural movement (although the level of local change shown in the mapping is within the error on the cartography) and realignment with major straightening between the 1910 and 1963 map. Aerial mapping from 1946 (Figure 2-12) suggests that the straightening occurred after this date. The image is also interesting as it highlights the development of anastomosed wet woodland at the western end of the reach close to Ogdens Bridge.

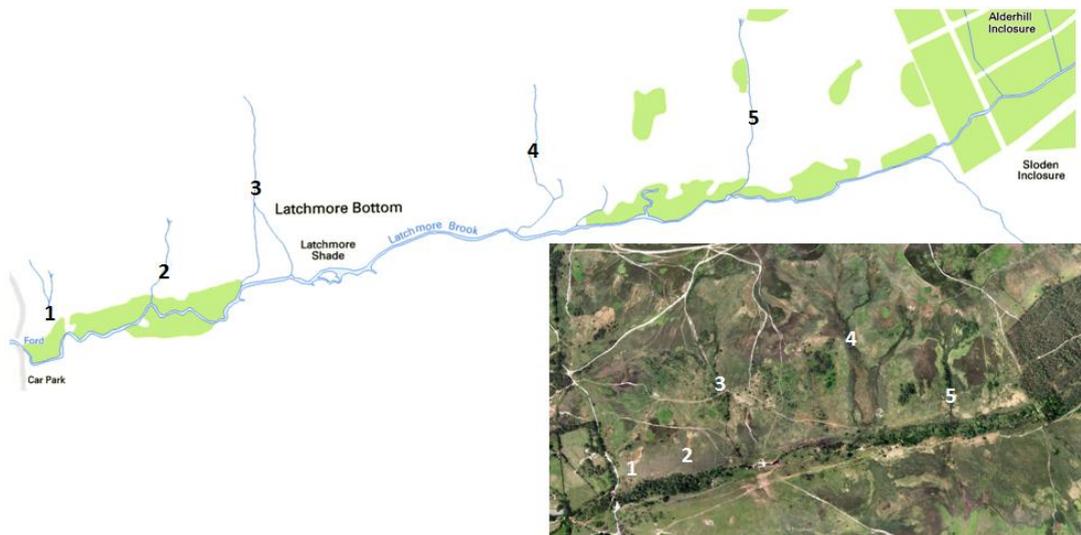
Figure 2-13: Drainage into Latchmore Brook from the mire systems to the north

A number of watercourses (both artificial and natural) drain the mire systems to the north of Latchmore Brook (labelled 1-5 on Figure 2-13). These are in a variable state with instability noted during the walkover survey on watercourses 1 - 3. This instability can be linked to the incision episode on the main river linked to channel straightening. Multiple knick point development is now evident (Figure 2-14). The condition of the drainage lines is summarised in Figures 2-15 to 2-19.
