# **Natural England Commissioned Report NECR141**

# New Forest SSSI Ecohydrological Survey Overview

Annex A: Holmhill Bog, Silver Stream, Redhill Bog, White Moor, North Weir, Trenley Lawn and Hincheslea Bog

First published 06 March 2014

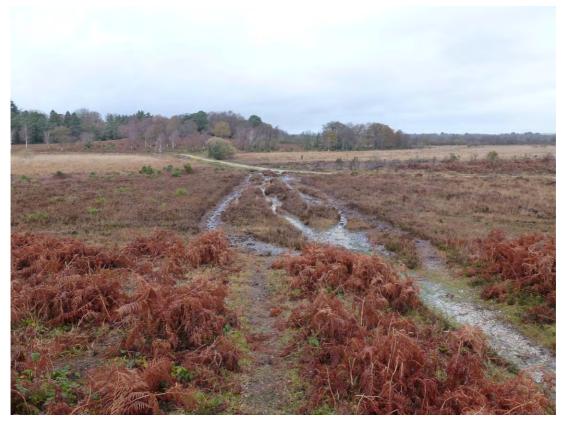
Hincheslea Bog forms the most southerly valley of the assessment area. The upper parts of the valley are outside the assessment area. The valley is long and thin and within the bottom is a valley mire with significant peat deposits which, like Holmhill bog, has a slight dome to its profile. There are two raised causeway paths (incorporating bridges) across the valley mire. At these points there has been some limited drainage and damage to the mires caused by causeways.

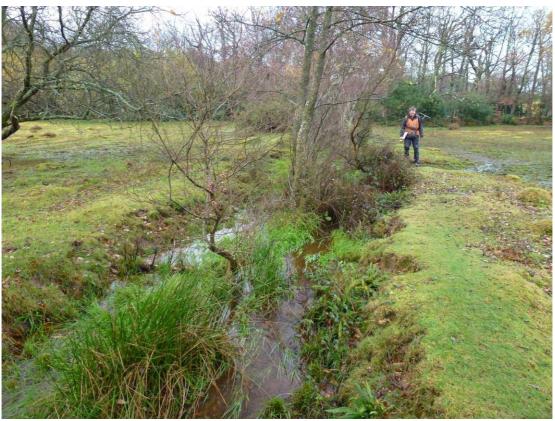
Trenley Lawn is a smaller valley just to the north of Hincheslea Bog. There is only a very low watershed between the two. More extensive drainage has occurred in this valley with a straight centre drain cut through its length. The upper parts of the area have turned into grassland as a result of the drainage.

Figure 1-12: Centre Drain in lower part of Trenley Lawn (NGR 428485, 101005)

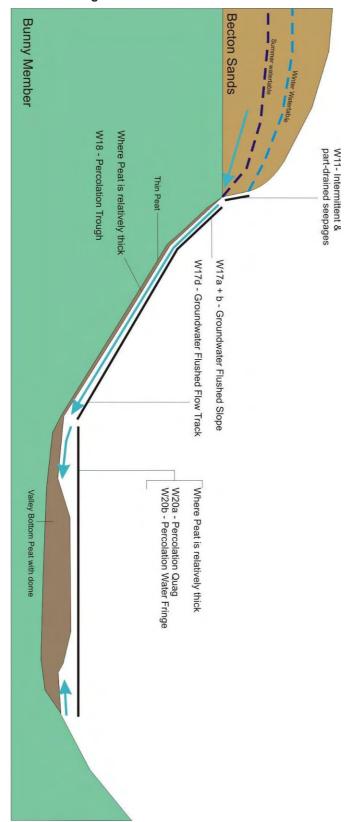
Figure 1-15: Conceptual Model Diagram - Holmhill Bog, Silver Stream, Redhill and Hincheslea Bog

It appears that all the wetlands are flush dominated, however, the quality of the geological mapping makes this harder to confirm this here than at other sites in the New Forest. The fact that the wetland at Redhill only appears suddenly at a distinct point down the valley gives some confidence to the assumption that the seepage arises from a geological junction between the Becton Sands and the Bunny Member. Two Conceptual Model diagrams are presented for the site below.
