Bossington Estate

Tackling run-off on a mixed farm in Hampshire

River Test and Itchen Catchment (29) CSFO: Serena Leadlay

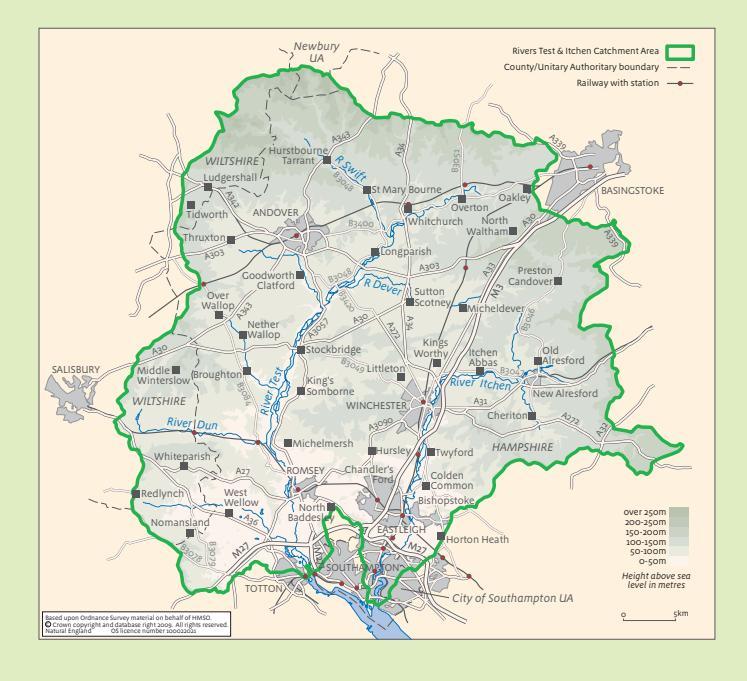
Broughton Road field is used in the outdoor pig rotation. When pigs are present, there is a possibility of soil run-off following intense rainfall. Due to the absence of mitigation measures at the time, connectivity between the field, the road and the Wallop Brook - within 15 metres was high, therefore a site deemed high risk due to it's location was compounded by high risk due to management.

As illustrated by image 2, the field is currently spring barley undersown with grass, with 1. an 8-metre grass strip; 2. a 12 metre conservation buffer strip; and 3. a newly planted hedgerow. This relates to the HLS application option HJ5 'In-field grass areas to prevent erosion and run-off'. It is the intention to return pigs to this field as part of the rotation in Autumn 2007, however these measures combined with a reduced stocking density will offer a reduction in connectivity and increased protection.
